Preliminary Damage Report from the April 2018 Flood Event

The Watershed Implementation Project for the Ahupua'a of Waipā

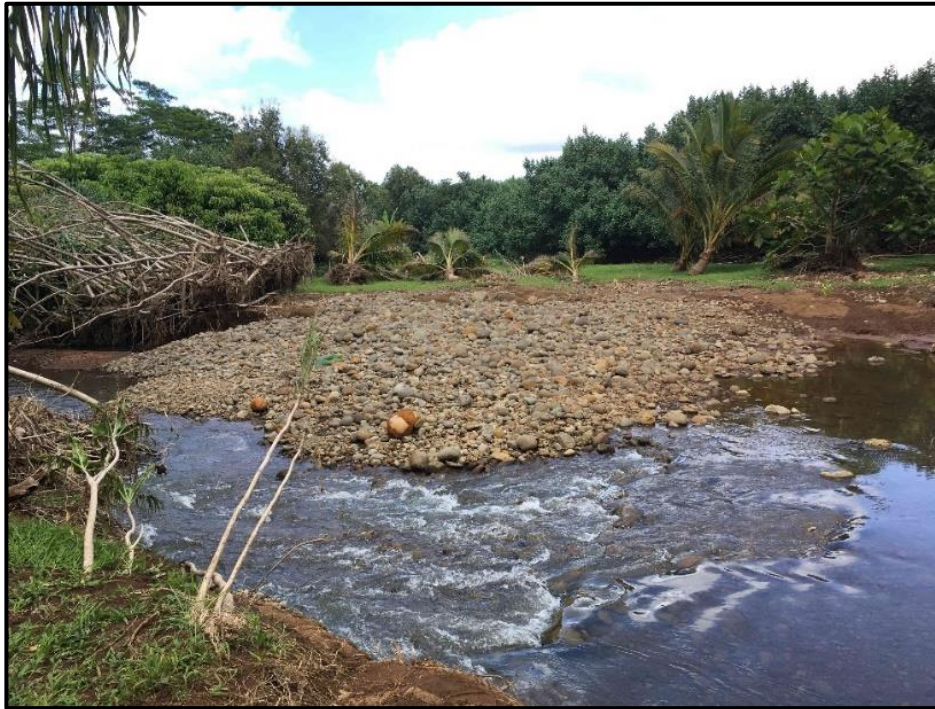
Extensive flood damage occurred along Waipā Stream including stream segments within the restoration area as well as upstream and downstream. Damage included erosion of streambank and riparian vegetation, erosion of streambank soils, and deposits of flood debris throughout the stream corridor,

including organic material (tree trunks, stumps, and branches) and mineral sediment. Deep scour of the streambed occurred at many of the pool segments and downstream channel filling was evident throughout the area. Sediment deposits on the floodplain up to 2 feet thick have been observed in some areas. In the area of Hau Bush removal within the Stream Restoration BMP site, Hau stands left along the banks were eroded out (at left in photos) and out-

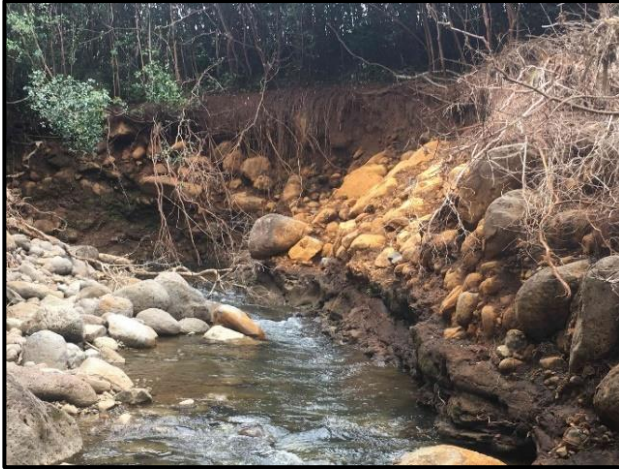
plantings behind the Hau buffers were pushed over forcefully by the floodwaters. These included well-established Coconut Palm (4-5 years old) and Hala trees that typically have deep, strong root systems (center in the photo here). A large volume of coarse sediment (gravel to boulder size) was moved down the stream channel and deposited in this area of the stream channel as well as in the right bank floodplain area. Restoration treatments in this and several other areas will have to be repeated, following flood debris removal.

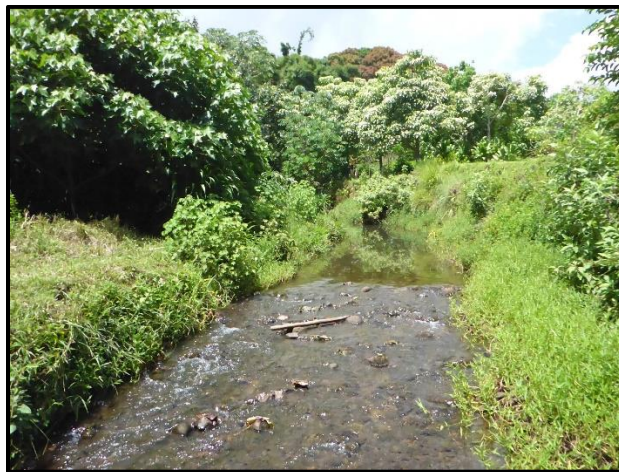
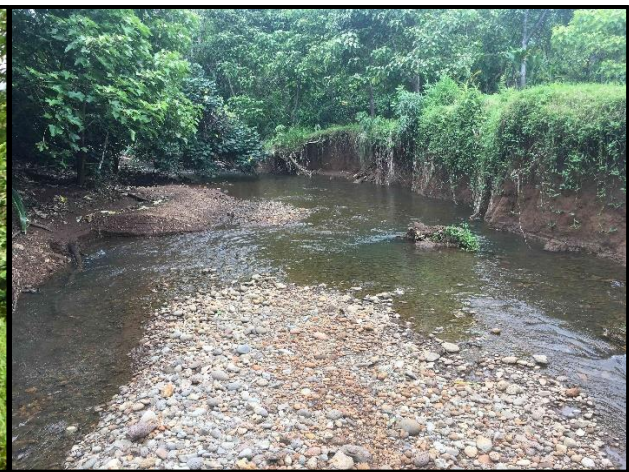
Substantial streambank erosion from the flood has been observed throughout the stream network, both within and outside the stream restoration area. Stream channels seem to have systematically widened with this flood event by eroding banks, responding to the massive flood discharge. This is not an unexpected outcome for a flood of this magnitude. In addition to smaller-scale bank erosion, several large bank slumps have been observed where landslides essentially ran out into the stream channel. Many new, larger landslides are visible on the hillslopes throughout the ahupua'a, but these were not visited or assessed for this report. Collectively, these areas of mass wasting were likely a significant source of material

contributing to the widespread deposition of silt and sand in downstream channels (including the Waipā and Waikoko irrigation ditch system) and floodplain areas. An example of streambank failure from upstream of the restoration area is shown above, and an example of channel widening within the restoration area (as before and after) is shown below.

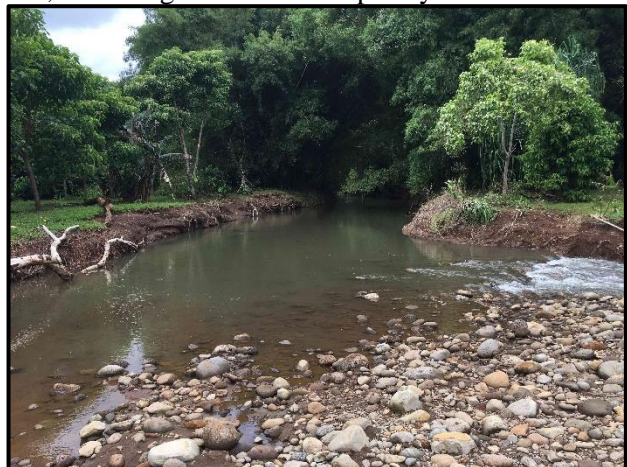
Streambank erosion in the area shown in the photo below has removed virtually all vegetation including many large Hala trees and hundreds of out-plantings that were thriving in the banks here. New restoration BMPs are now being installed in this stream reach now, including the use of temporary erosion control fabrics and new out-plantings. The Hawaii Youth Conservation Corps are assisting Waipā project staff and interns with this work. While we have observed extensive erosion and flood damage throughout the Waipā Stream corridor from the historic April storm event, we feel fortunate that the damage was not worse. In comparison, nearby waterways like the mainstem Hanalei River and Waioli Stream experienced major reconfiguration and realignment during the flood, creating new channels that bypassed important irrigation water intakes, requiring extensive earthwork to "repair". Flow was restored to the Waipā auwai within a few days after the flood as the manowai (diversion

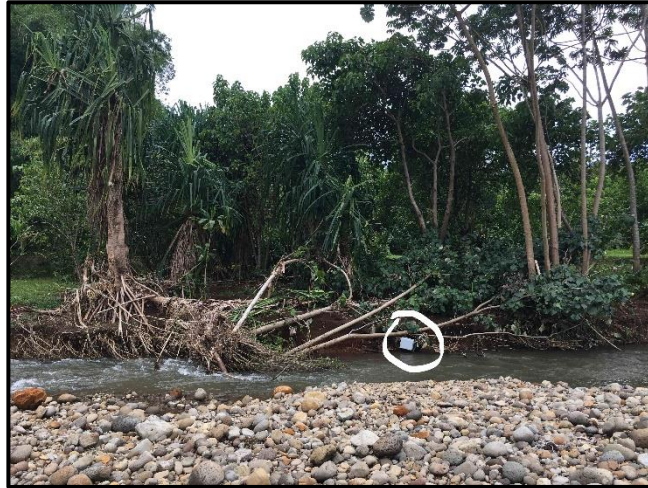
Two of the three gaging stations along Waipā Stream were destroyed during the flood event. The first, installed and operated by landowner Kamehameha Schools, was located just upstream of the area shown in the pictures above. This real-time monitoring station, which measured various water quality parameters as well as water levels, was completely washed out and ended up deposited along the bank in the flood debris across the channel from the boulder deposit in the photo. The station's waterproof enclosure that housed the electronics and battery can be seen in the photo at left, while the water sensors and cables were buried in sediment just upstream of this area. Kamehameha Schools has already replaced this monitoring station in a new location, and it is back online reporting data.

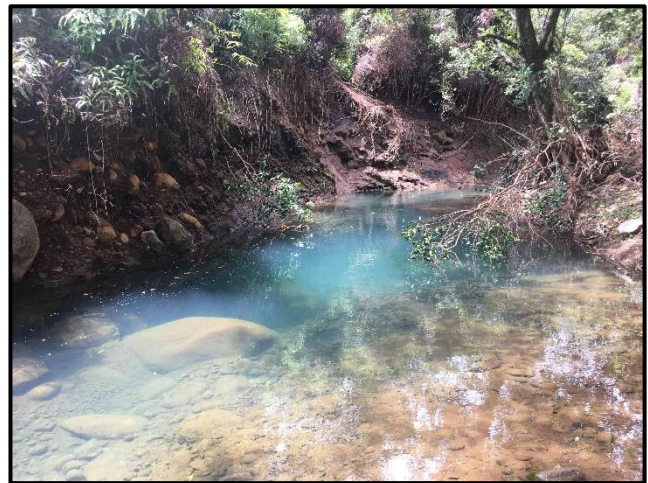
A second station called the Waipā Stream Gage, operated by the Waipā Foundation, was also washed out in the flood. This rated stream gage had a multi-probe sonde deployed for continuous measurements of water level, streamflow, and water quality at a point upstream of all stream restoration work at Waipā. The station had been in place for over ten years in the same location, but the April 2018 flood caused extensive scour along the streambank where the gage was located and a large bank failure occurred that wiped out the gage's stilling well (left side of channel in the photo here) and snapped the power cable for the measurement device. Fortunately, the sonde got wedged in some boulders just downstream and was retrieved after the flood, and extra fortunately, it still works! The stilling well for this station is currently being re-built and the gage should be back up and running soon.

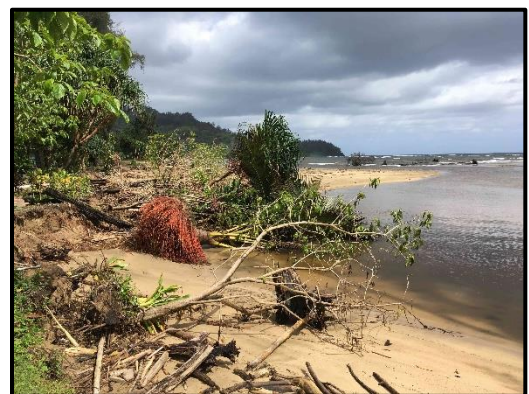
Observations of flood damage along Waioli Stream in the ahupua'a of Waipā have been limited to the stream mouth area where a large swath of land was eroded by the floodwaters. Similar to the damage observed along Waipā Stream, large trees with deep, strong roots systems (e.g. Hala, Coconut Palm, Ironwood) were eroded out and washed away by the floodwaters. During the flood, the Waioli Stream formed a new channel in a westerly direction along the beach of Hanalei Bay (to the left in this photo) which eroded land from the ocean shoreline as well. Overall, a half-acre or more of land was eroded from this area, and existing banks along Waioli Stream and the

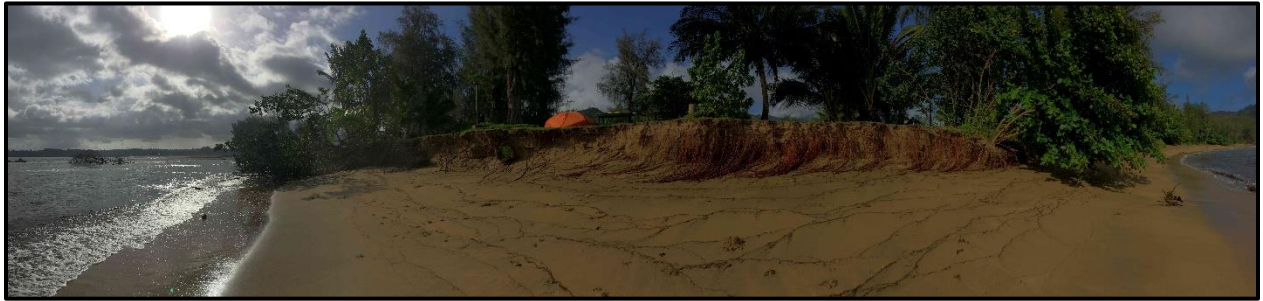
Hanalei Bay shoreline are now under vulnerable conditions. The photo below shows the Bay shoreline near the Waioli Stream mouth.
