# ***Phase I Environmental Site Assessment***

## **Kaka'ako Waterfront Redevelopment Property Honolulu, Oahu, Hawaii**

January 23, 2006  
Clayton Project No. 85-06123.00

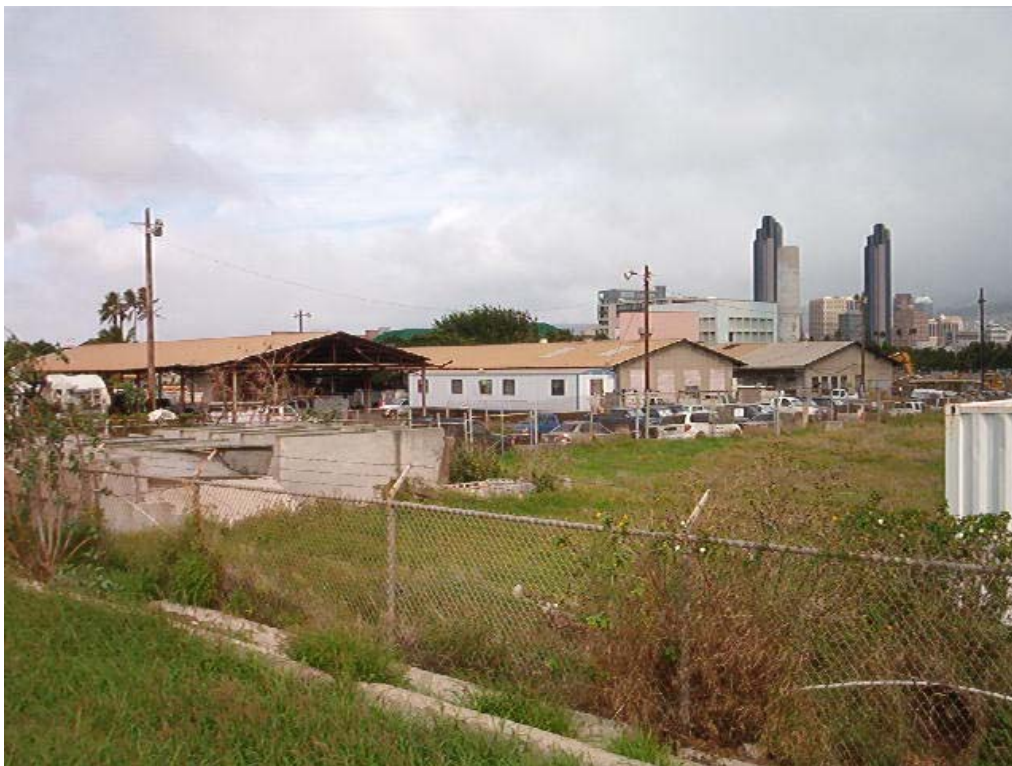
<b>Clayton Project Number</b>  85-06123.00	<b>Description</b>	Overview of DWWM Facility on Unit 2 of Site 1, looking north	<b>Photo 1</b>
	<b>Site Name</b>	Site 1, Unit 2, Kaka'ako Waterfront Redevelopment, Honolulu, Hawaii	<b>Photo Date</b>
	<b>Client</b>	Alexander & Baldwin, Inc.	11/1/2005

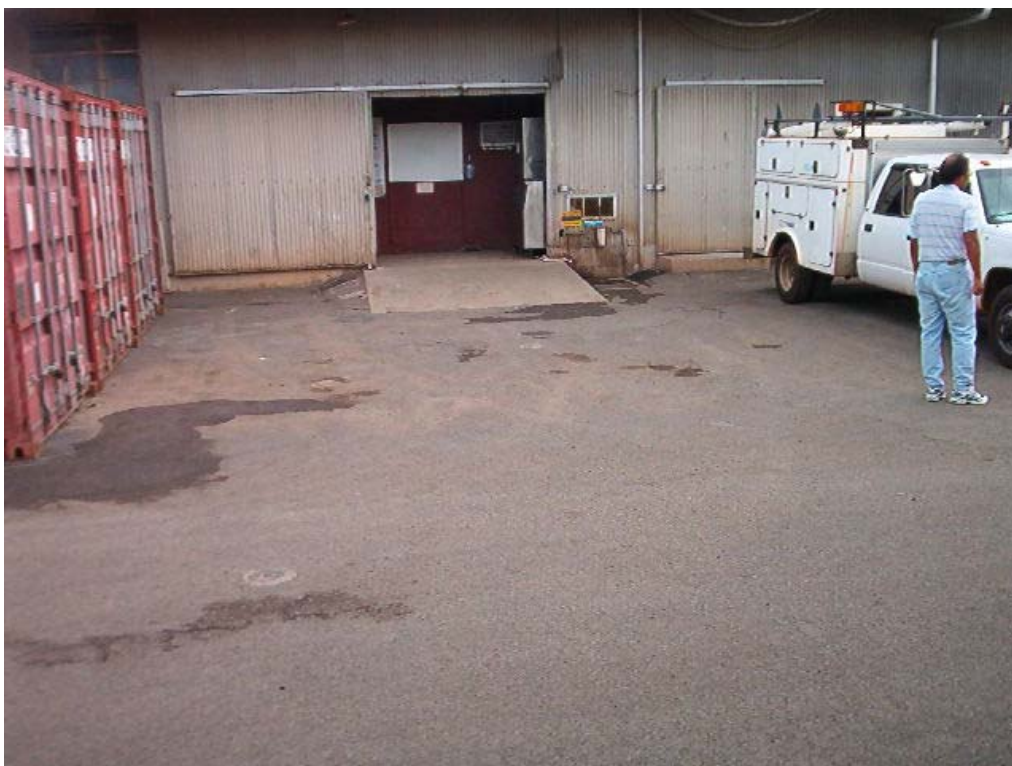
<b>Clayton Project Number</b>  85-06123.00	<b>Description</b>	Area of former LUST site in front of Office/Shop building at DWWM facility	<b>Photo 2</b>
	<b>Site Name</b>	Site 1, Unit 2, Kaka'ako Waterfront Redevelopment, Honolulu, Hawaii	<b>Photo Date</b>
	<b>Client</b>	Alexander & Baldwin, Inc.	11/1/2005

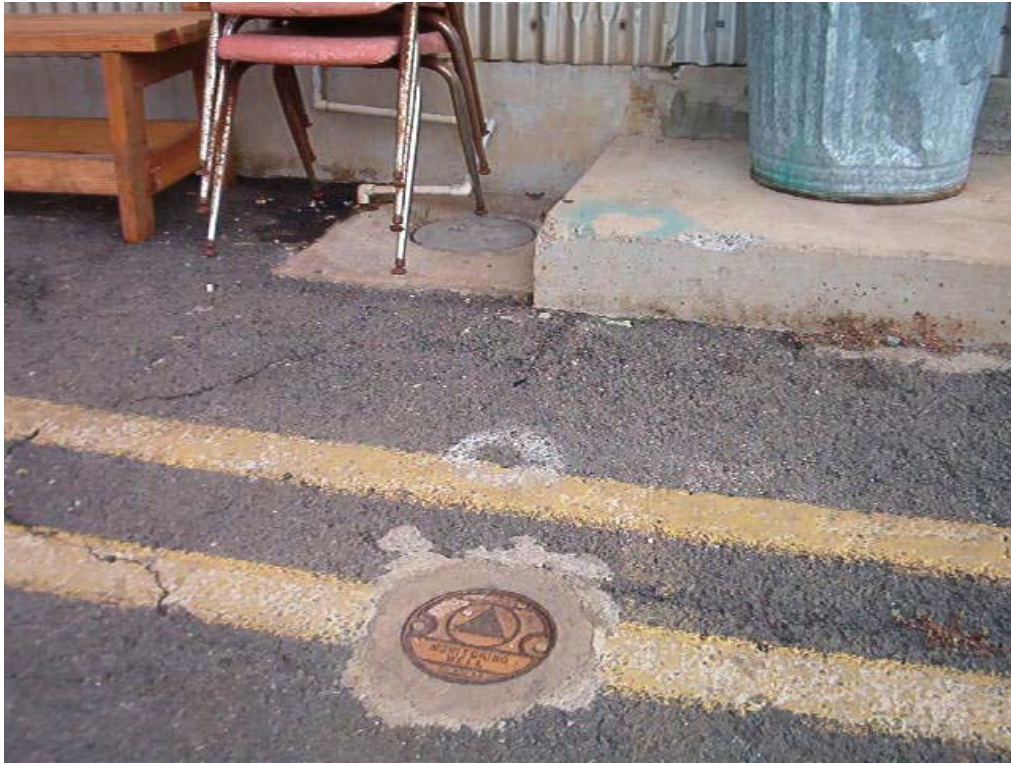
<b>Clayton Project Number</b>  85-06123.00	<b>Description</b>	Groundwater monitoring well associated with former LUST site	<b>Photo 3</b>
	<b>Site Name</b>	Site 1, Unit 2, Kaka'ako Waterfront Redevelopment, Honolulu, Hawaii	<b>Photo Date</b>
	<b>Client</b>	Alexander & Baldwin, Inc.	11/1/2005

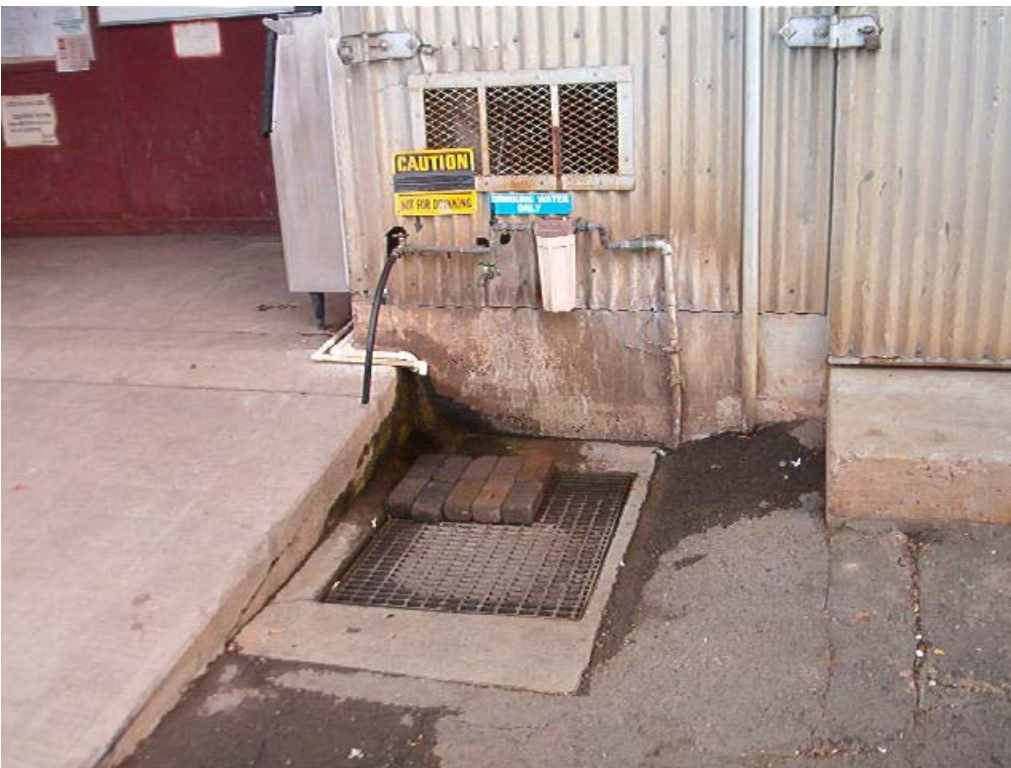
<b>Clayton Project Number</b>  85-06123.00	<b>Description</b>	Dry well in front of Office/Shop building at DWWM facility	<b>Photo 4</b>
	<b>Site Name</b>	Site 1, Unit 2, Kaka'ako Waterfront Redevelopment, Honolulu, Hawaii	<b>Photo Date</b>
	<b>Client</b>	Alexander & Baldwin, Inc.	11/1/2005

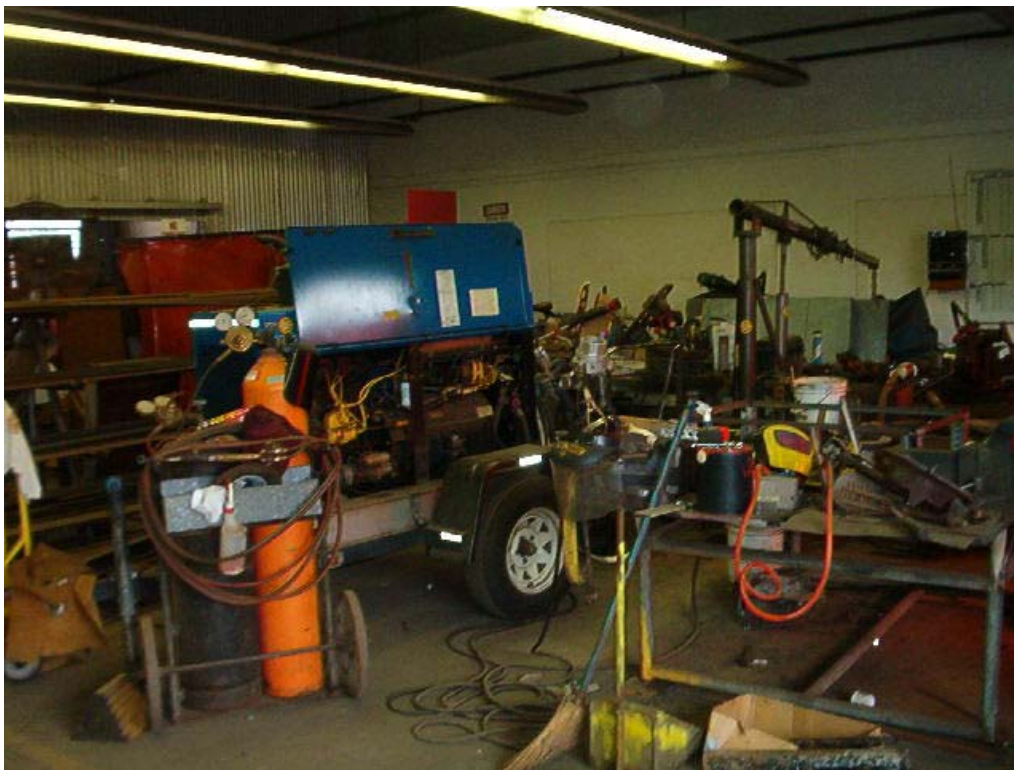
<b>Clayton Project Number</b>  85-06123.00	<b>Description</b>	Mechanic's Shop inside Office/Shop building at DWWM facility	<b>Photo 5</b>
	<b>Site Name</b>	Site 1, Unit 2, Kaka'ako Waterfront Redevelopment, Honolulu, Hawaii	<b>Photo Date</b>
	<b>Client</b>	Alexander & Baldwin, Inc.	11/1/2005

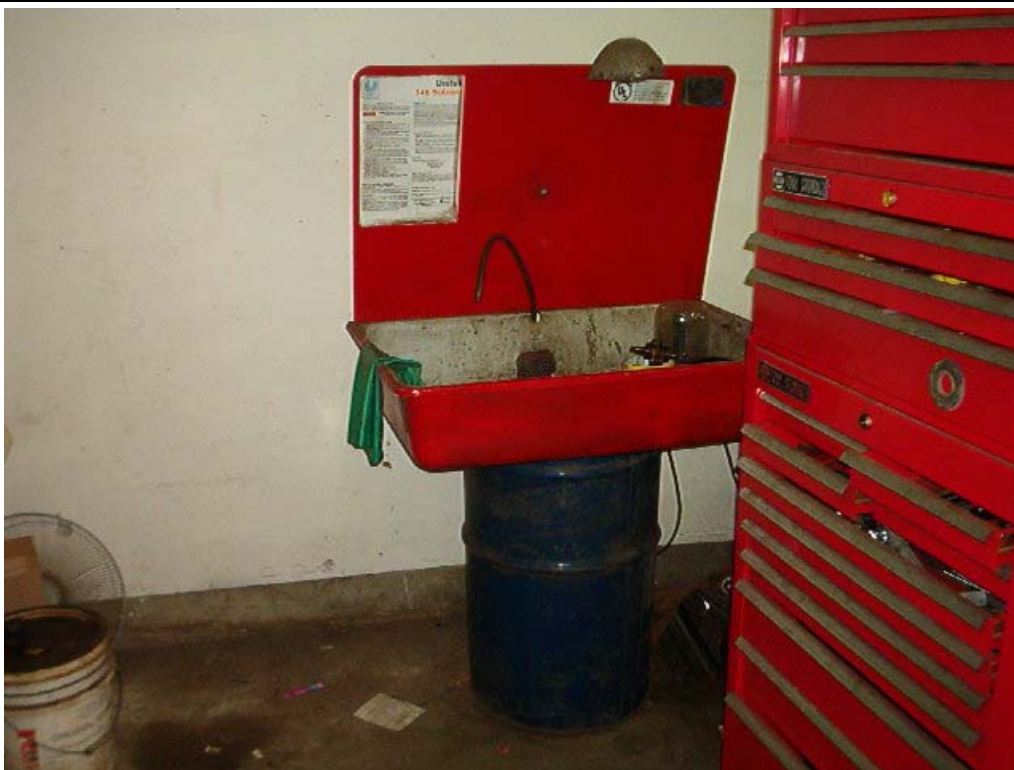
<b>Clayton Project Number</b>  85-06123.00	<b>Description</b>	Solvent parts washer in Mechanic's Shop	<b>Photo 6</b>
	<b>Site Name</b>	Site 1, Unit 2, Kaka'ako Waterfront Redevelopment, Honolulu, Hawaii	<b>Photo Date</b>
	<b>Client</b>	Alexander & Baldwin, Inc.	11/1/2005

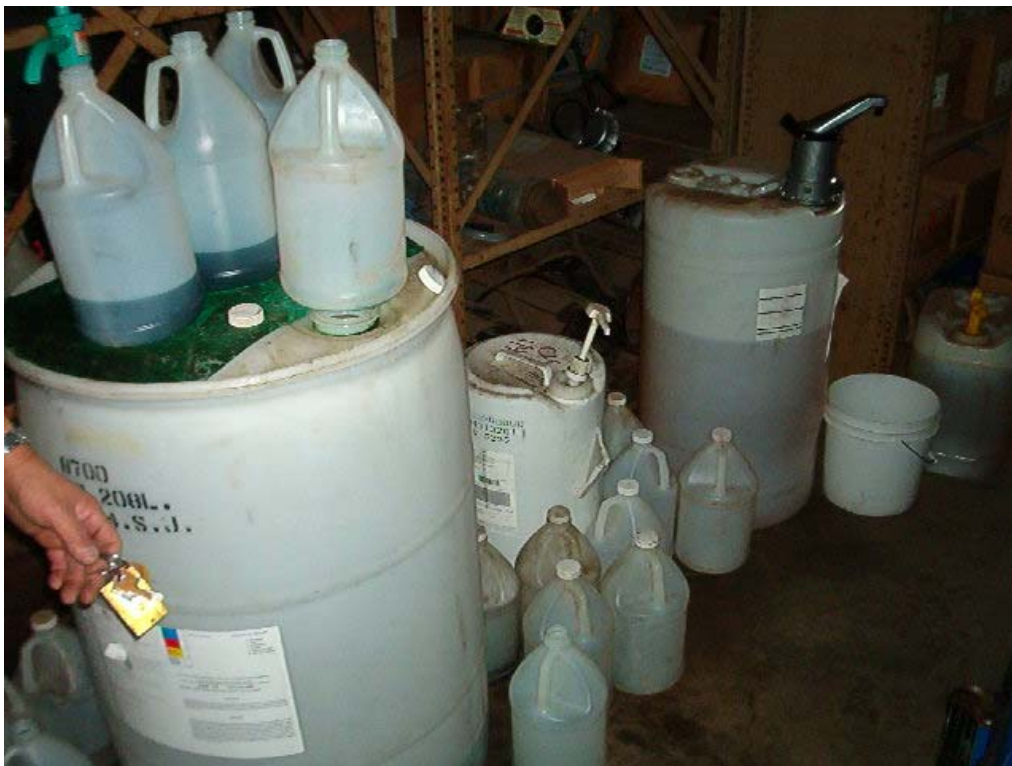
<b>Clayton Project Number</b>  85-06123.00	<b>Description</b>	Chemical containers in storage room of Office/Shop building	<b>Photo 7</b>
	<b>Site Name</b>	Site 1, Unit 2, Kaka'ako Waterfront Redevelopment, Honolulu, Hawaii	<b>Photo Date</b>
	<b>Client</b>	Alexander & Baldwin, Inc.	11/1/2005

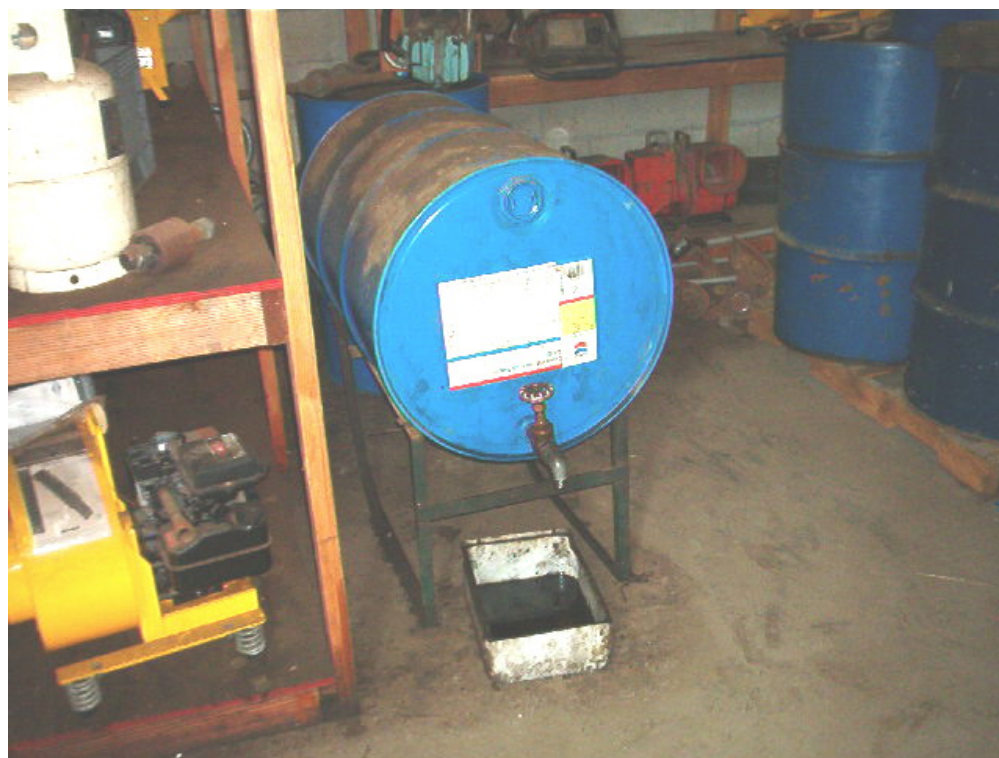
<b>Clayton Project Number</b>  85-06123.00	<b>Description</b>	55-gallon oil drum (in use) in Garage 1 at DWW facility	<b>Photo 8</b>
	<b>Site Name</b>	Site 1, Unit 2, Kaka'ako Waterfront Redevelopment, Honolulu, Hawaii	<b>Photo Date</b>
	<b>Client</b>	Alexander & Baldwin, Inc.	11/1/2005

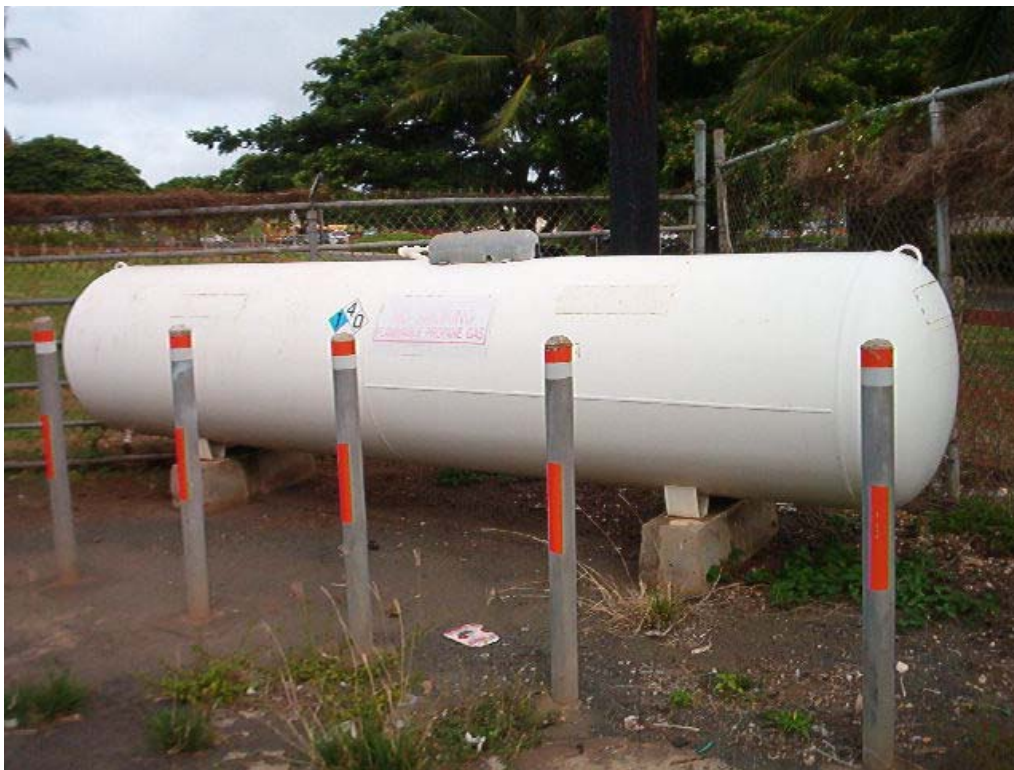
<b>Clayton Project Number</b>  85-06123.00	<b>Description</b>	Liquid propane gas AST at north corner of DWW facility	<b>Photo 9</b>
	<b>Site Name</b>	Site 1, Unit 2, Kaka'ako Waterfront Redevelopment, Honolulu, Hawaii	<b>Photo Date</b>
	<b>Client</b>	Alexander & Baldwin, Inc.	11/1/2005

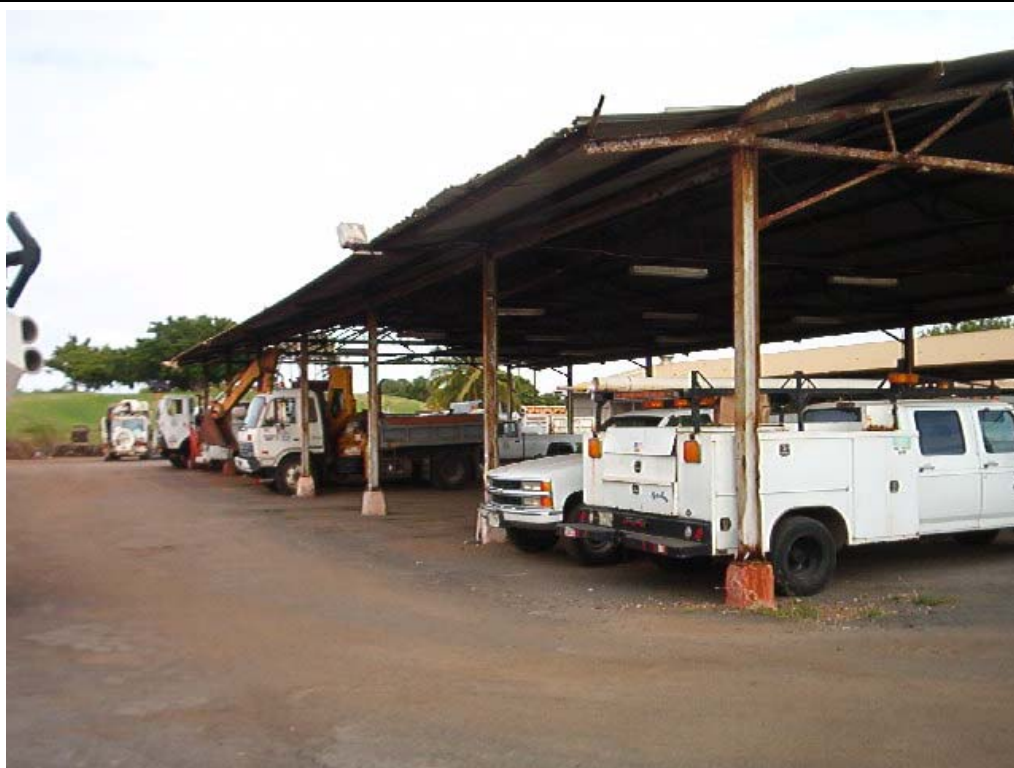
<b>Clayton Project Number</b>  85-06123.00	<b>Description</b>	View of Garage 2 structure at DWW facility	<b>Photo 10</b>
	<b>Site Name</b>	Site 1, Unit 2, Kaka'ako Waterfront Redevelopment, Honolulu, Hawaii	<b>Photo Date</b>
	<b>Client</b>	Alexander & Baldwin, Inc.	11/1/2005

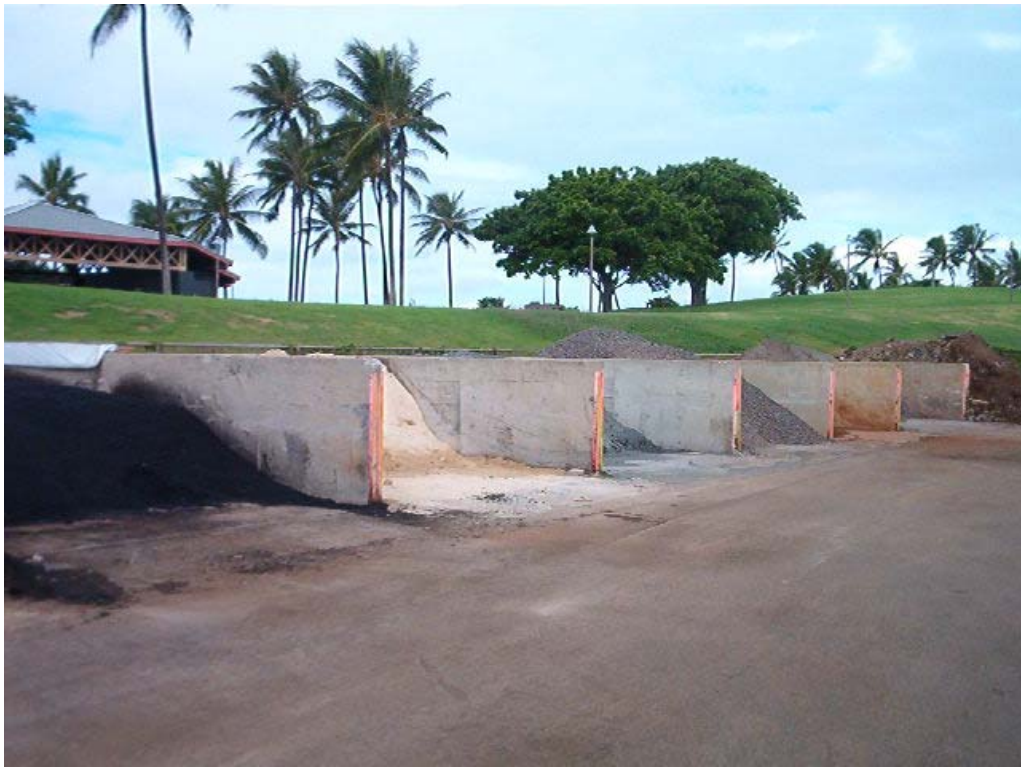
<b>Clayton Project Number</b>  85-06123.00	<b>Description</b>	Storage area for asphalt, sand, gravel, and soil at west corner of DWWM facility	<b>Photo 11</b>
	<b>Site Name</b>	Site 1, Unit 2, Kaka'ako Waterfront Redevelopment, Honolulu, Hawaii	<b>Photo Date</b>
	<b>Client</b>	Alexander & Baldwin, Inc.	11/1/2005

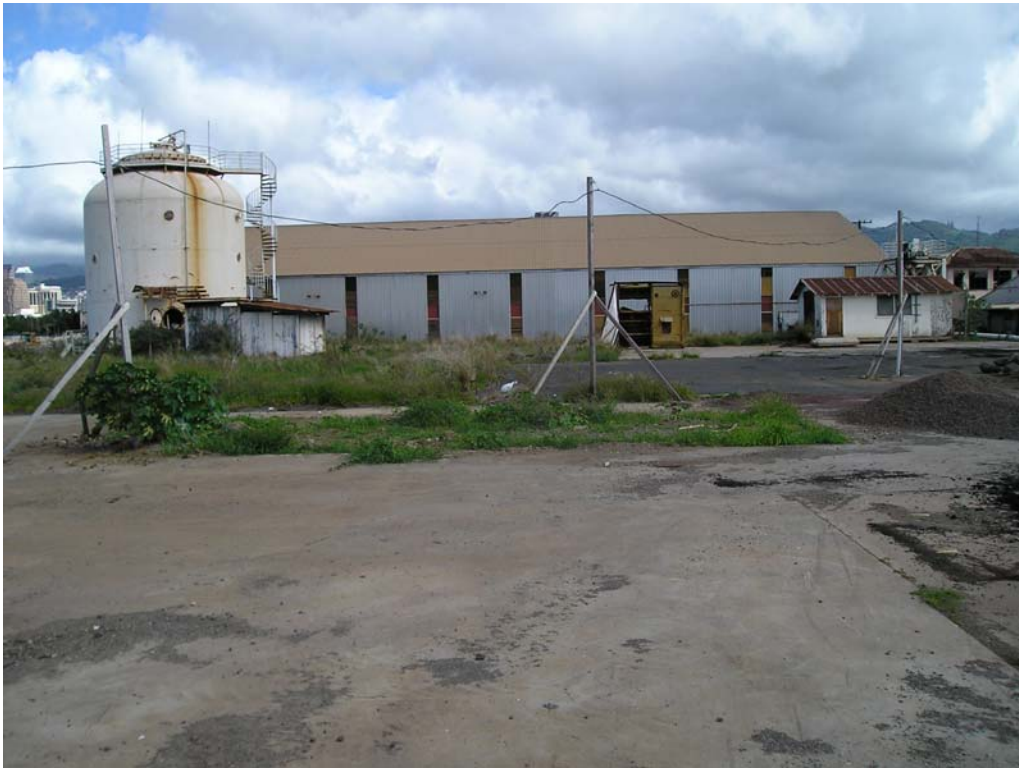
<b>Clayton Project Number</b>  85-06123.00	<b>Description</b>	Overview of Look Laboratory and hyperbaric chamber with adjoining yard area in foreground, looking northeast	<b>Photo 13</b>
	<b>Site Name</b>	Site 1, Unit 4, Kaka'ako Waterfront Redevelopment, Honolulu, Hawaii	<b>Photo Date</b>
	<b>Client</b>	Alexander & Baldwin, Inc.	11/1/2005
A closer view of the white hyperbaric chamber, showing its cylindrical shape and the metal platform at the top. It is situated next to a smaller, attached structure with a brown roof. The foreground is filled with tall, green grass. The sky is blue with white clouds.			
<b>Clayton Project Number</b>  85-06123.00	<b>Description</b>	View of hyperbaric chamber and attached compressor shed	<b>Photo 14</b>
	<b>Site Name</b>	Site 1, Unit 4, Kaka'ako Waterfront Redevelopment, Honolulu, Hawaii	<b>Photo Date</b>
	<b>Client</b>	Alexander & Baldwin, Inc.	11/1/2005

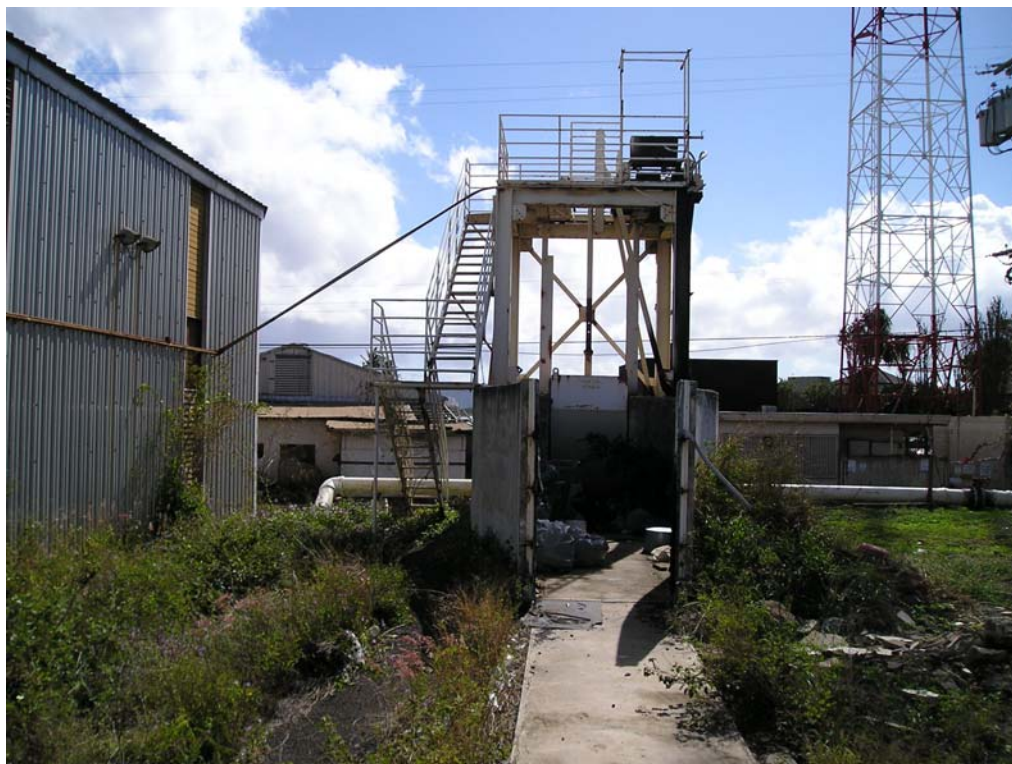
<b>Clayton Project Number</b>  85-06123.00	<b>Description</b>	3-sided concrete structure at east corner of Look Lab yard area	<b>Photo 16</b>
	<b>Site Name</b>	Site 1, Unit 4, Kaka'ako Waterfront Redevelopment, Honolulu, Hawaii	<b>Photo Date</b>
	<b>Client</b>	Alexander & Baldwin, Inc.	11/1/2005

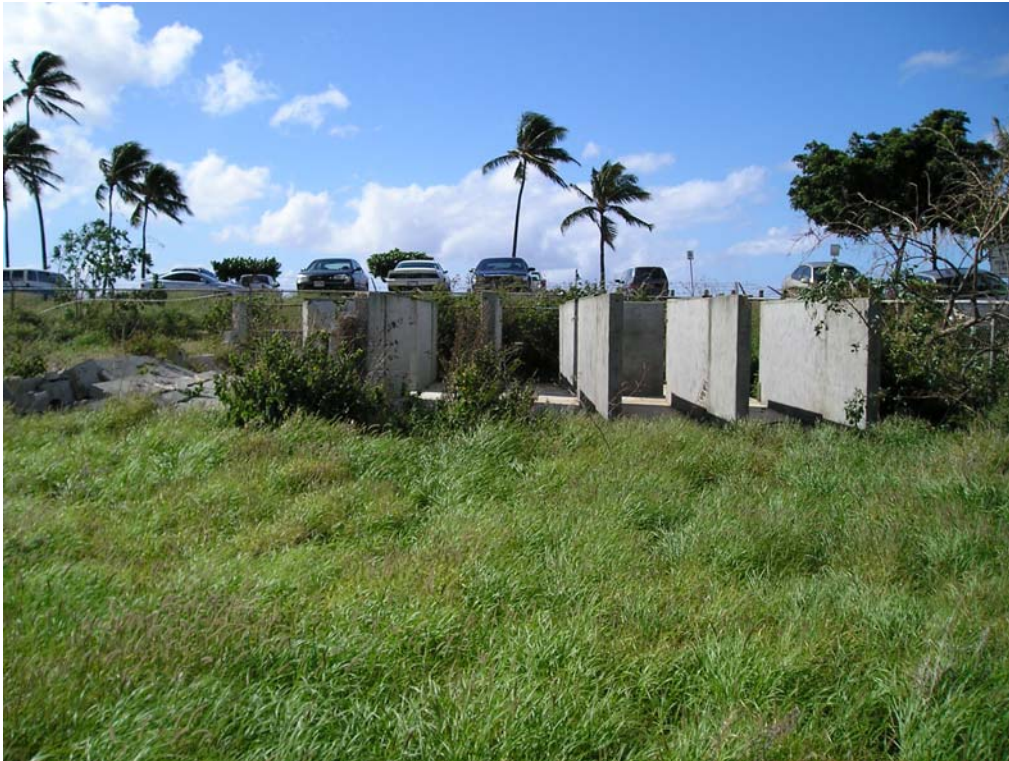
<b>Clayton Project Number</b>  85-06123.00	<b>Description</b>	Former dog kennel structure at west corner of Look Lab yard area	<b>Photo 17</b>
	<b>Site Name</b>	Site 1, Unit 4, Kaka'ako Waterfront Redevelopment, Honolulu, Hawaii	<b>Photo Date</b>
	<b>Client</b>	Alexander & Baldwin, Inc.	11/1/2005

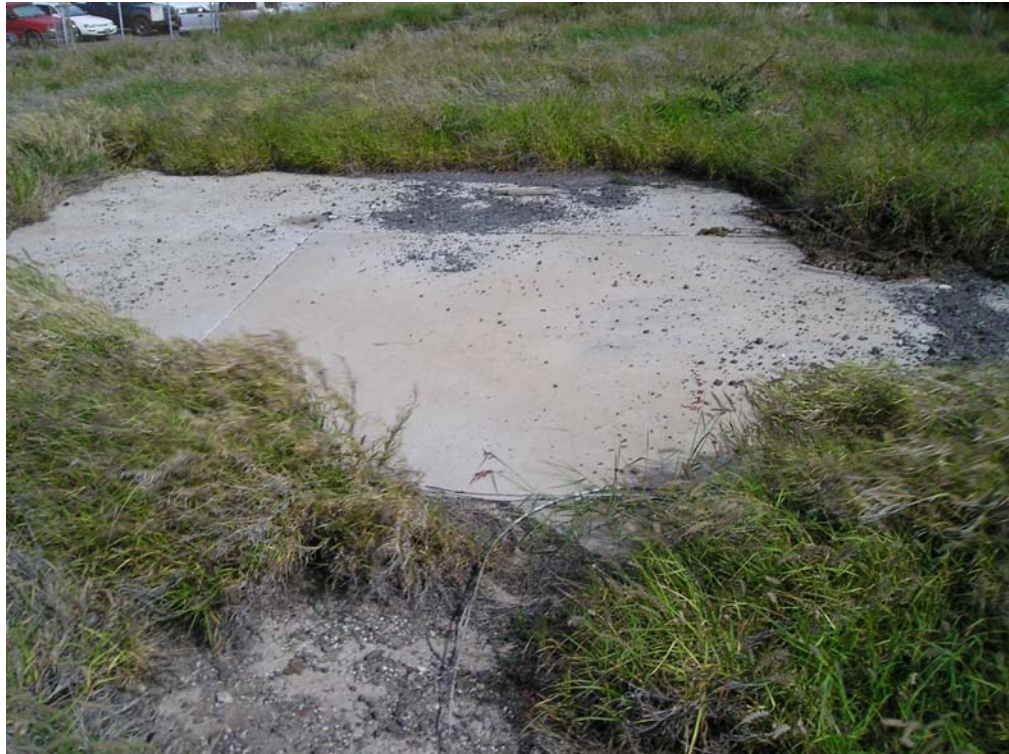
<b>Clayton Project Number</b>  85-06123.00	<b>Description</b>	Concrete slab remnant of former structure on northwest portion of Look Lab yard area	<b>Photo 18</b>
	<b>Site Name</b>	Site 1, Unit 4, Kaka'ako Waterfront Redevelopment, Honolulu, Hawaii	<b>Photo Date</b>
	<b>Client</b>	Alexander & Baldwin, Inc.	11/1/2005

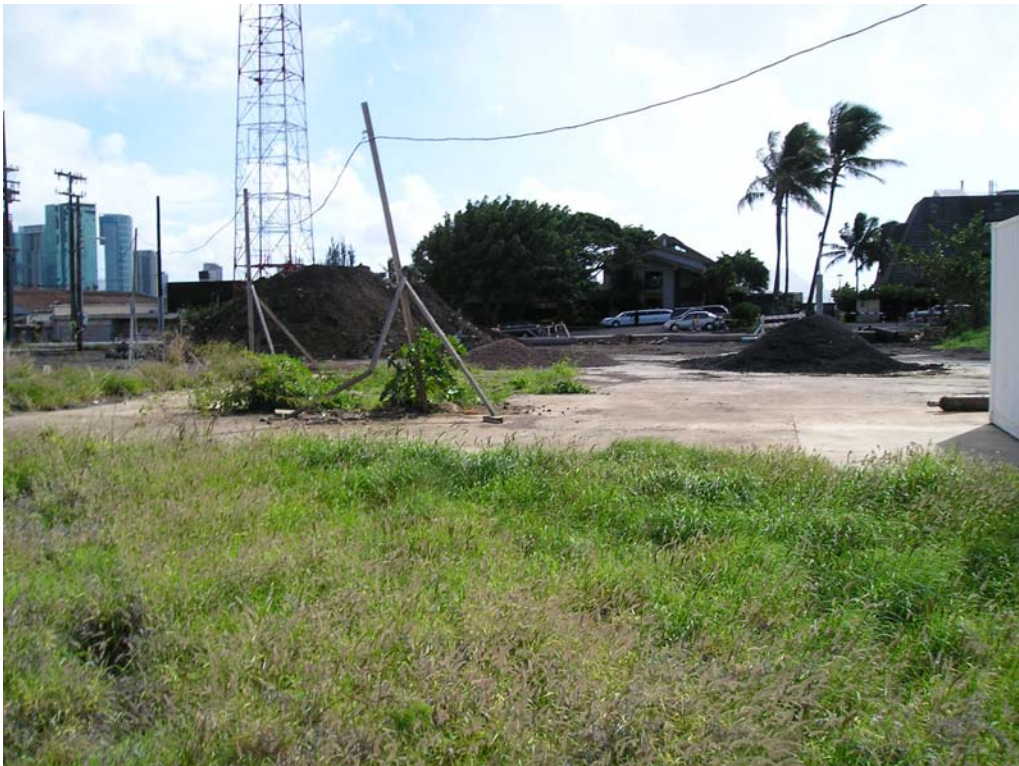
<b>Clayton Project Number</b>  85-06123.00	<b>Description</b>	Piles of soil, rock, and asphalt on southern portion of Look Lab yard area	<b>Photo 19</b>
	<b>Site Name</b>	Site 1, Unit 4, Kaka'ako Waterfront Redevelopment, Honolulu, Hawaii	<b>Photo Date</b>
	<b>Client</b>	Alexander & Baldwin, Inc.	11/1/2005

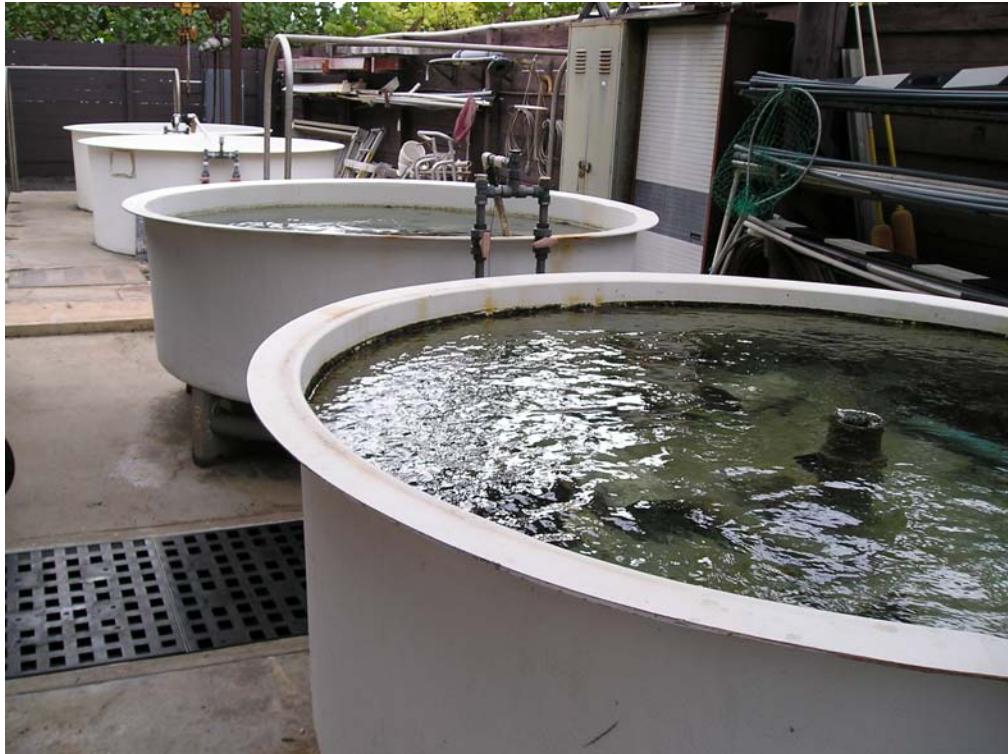
<b>Clayton Project Number</b>  85-06123.00	<b>Description</b>	Saltwater fish tanks in fenced-in area fronting PBRC building	<b>Photo 22</b>
	<b>Site Name</b>	Site 1, Unit 4, Kaka'ako Waterfront Redevelopment, Honolulu, Hawaii	<b>Photo Date</b>
	<b>Client</b>	Alexander & Baldwin, Inc.	11/1/2005

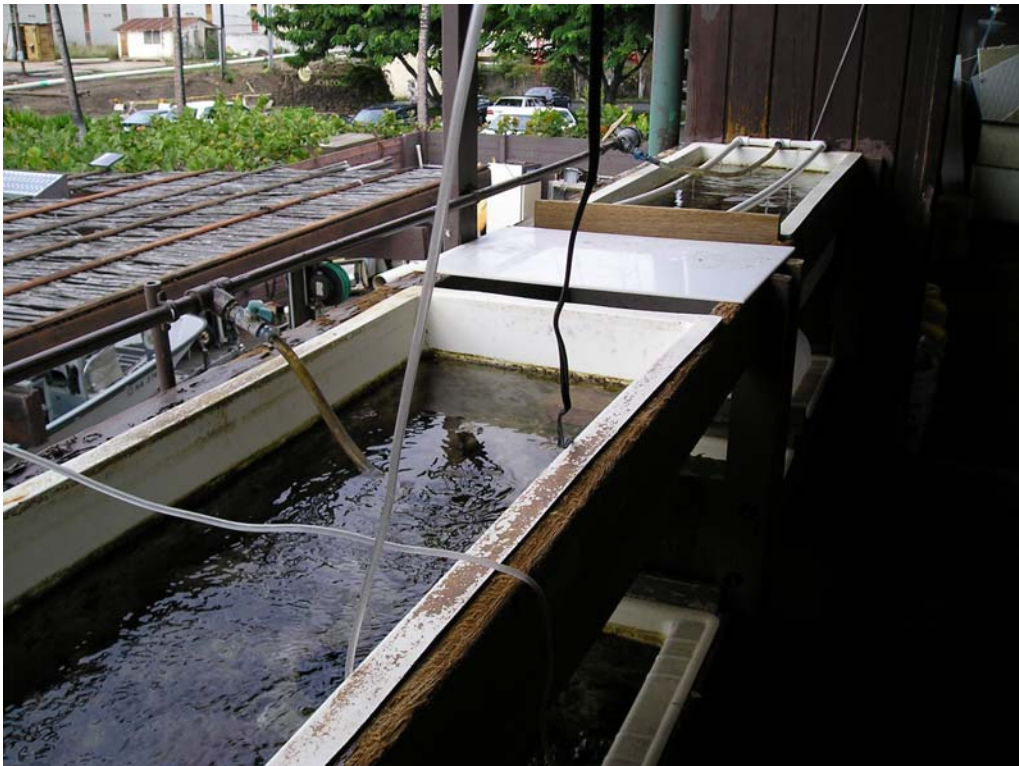
<b>Clayton Project Number</b>  85-06123.00	<b>Description</b>	Research tanks on third floor lanai of PBRC building	<b>Photo 23</b>
	<b>Site Name</b>	Site 1, Unit 4, Kaka'ako Waterfront Redevelopment, Honolulu, Hawaii	<b>Photo Date</b>
	<b>Client</b>	Alexander & Baldwin, Inc.	11/1/2005

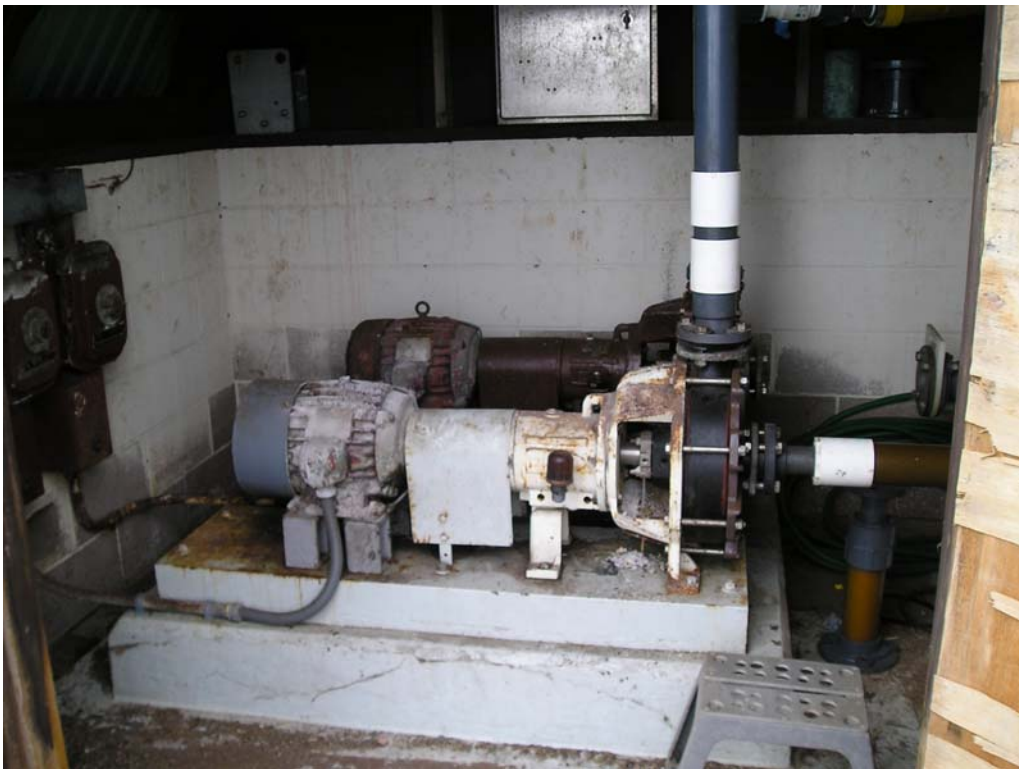
<b>Clayton Project Number</b>  85-06123.00	<b>Description</b>	Interior of pump house/saltwater well near east corner of PBRC facility	<b>Photo 24</b>
	<b>Site Name</b>	Site 1, Unit 4, Kaka'ako Waterfront Redevelopment, Honolulu, Hawaii	<b>Photo Date</b>
	<b>Client</b>	Alexander & Baldwin, Inc.	11/1/2005

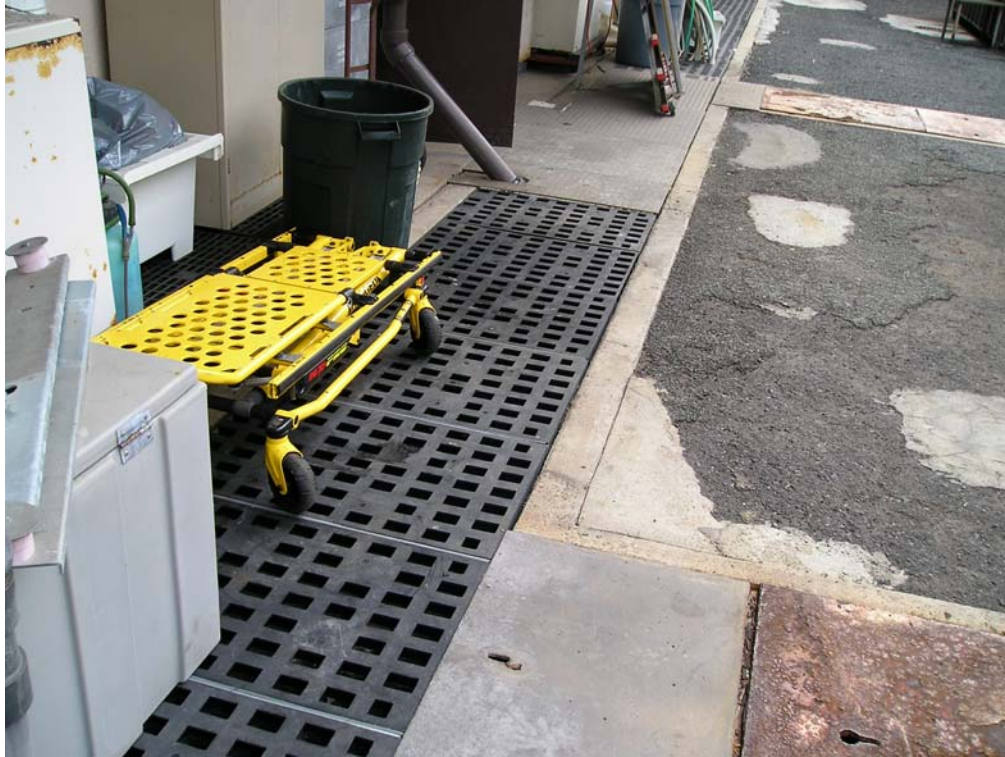
<b>Clayton Project Number</b>  85-06123.00	<b>Description</b>	Saltwater discharge trench along northeast side of PBRC building	<b>Photo 25</b>
	<b>Site Name</b>	Site 1, Unit 4, Kaka'ako Waterfront Redevelopment, Honolulu, Hawaii	<b>Photo Date</b>
	<b>Client</b>	Alexander & Baldwin, Inc.	11/1/2005

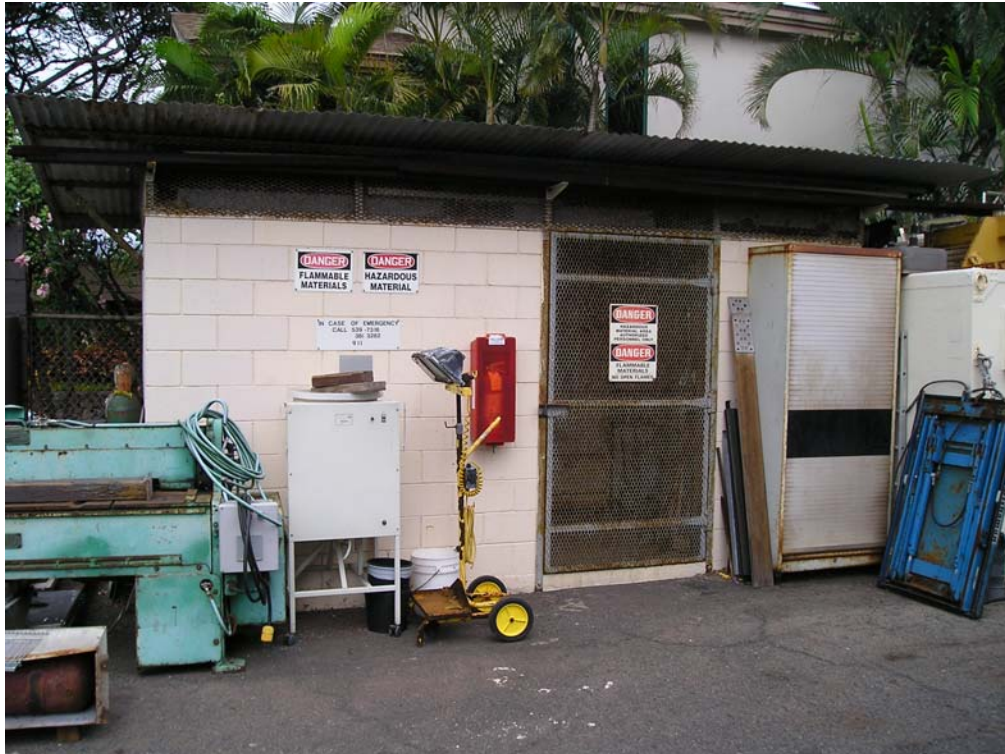
<b>Clayton Project Number</b>  85-06123.00	<b>Description</b>	Hazardous materials/flammable storage shed on northeast portion of PBRC facility	<b>Photo 26</b>
	<b>Site Name</b>	Site 1, Unit 4, Kaka'ako Waterfront Redevelopment, Honolulu, Hawaii	<b>Photo Date</b>
	<b>Client</b>	Alexander & Baldwin, Inc.	11/1/2005

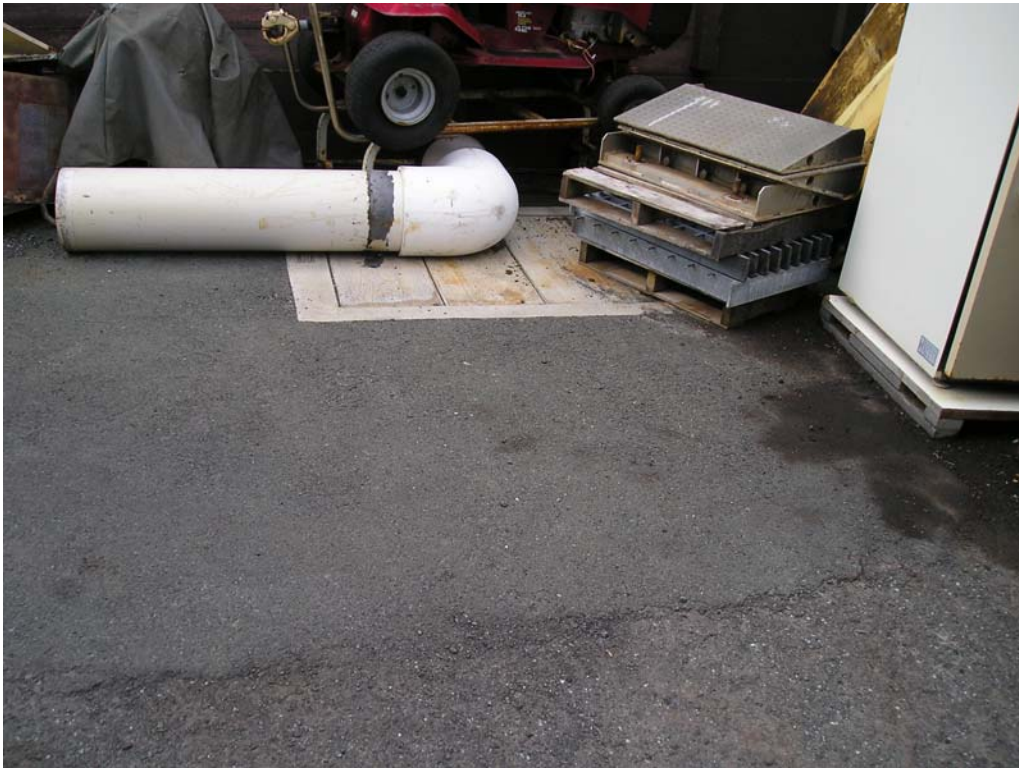
- A former Hawaiian Electric Company (HECO) transformer site was identified at the PBRC facility, located on Site 1 on Unit 4. According to a previous Phase I ESA report, this transformer leaked PCB-containing dielectric fluid and HECO removed the transformer and contaminated soils. Full cleanup documentation was not available for this report. However, a memorandum indicated that soil samples had non-detectable to 4.7 mg/kg concentration of PCBs which is above the current DOH Environmental Action Level of 1.1 mg/kg.

This finding is considered a REC because there is evidence that the reported PCB release was not fully cleaned up to current DOH Action Levels. Clayton recommends an assessment of the PCB impacts in the area surrounding the spill.

<b>Clayton Project Number</b>  85-06123.00	<b>Description</b>	Area of former HECO transformer/PCB release (cleaned up) on north portion of PBRC facility	<b>Photo 27</b>
	<b>Site Name</b>	Site 1, Unit 4, Kaka'ako Waterfront Redevelopment, Honolulu, Hawaii	<b>Photo Date</b>
	<b>Client</b>	Alexander & Baldwin, Inc.	11/1/2005

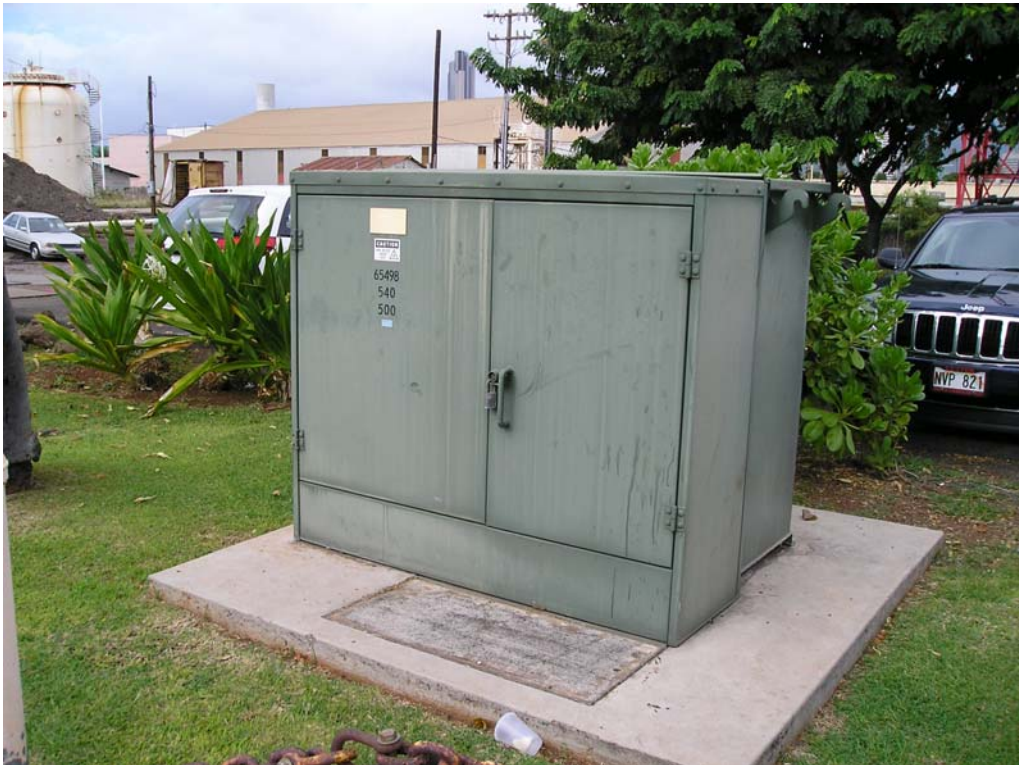
<b>Clayton Project Number</b>  85-06123.00	<b>Description</b>	Pad-mounted HECO transformer (no PCBs) on north portion of PBRC facility	<b>Photo 28</b>
	<b>Site Name</b>	Site 1, Unit 4, Kaka'ako Waterfront Redevelopment, Honolulu, Hawaii	<b>Photo Date</b>
	<b>Client</b>	Alexander & Baldwin, Inc.	11/1/2005

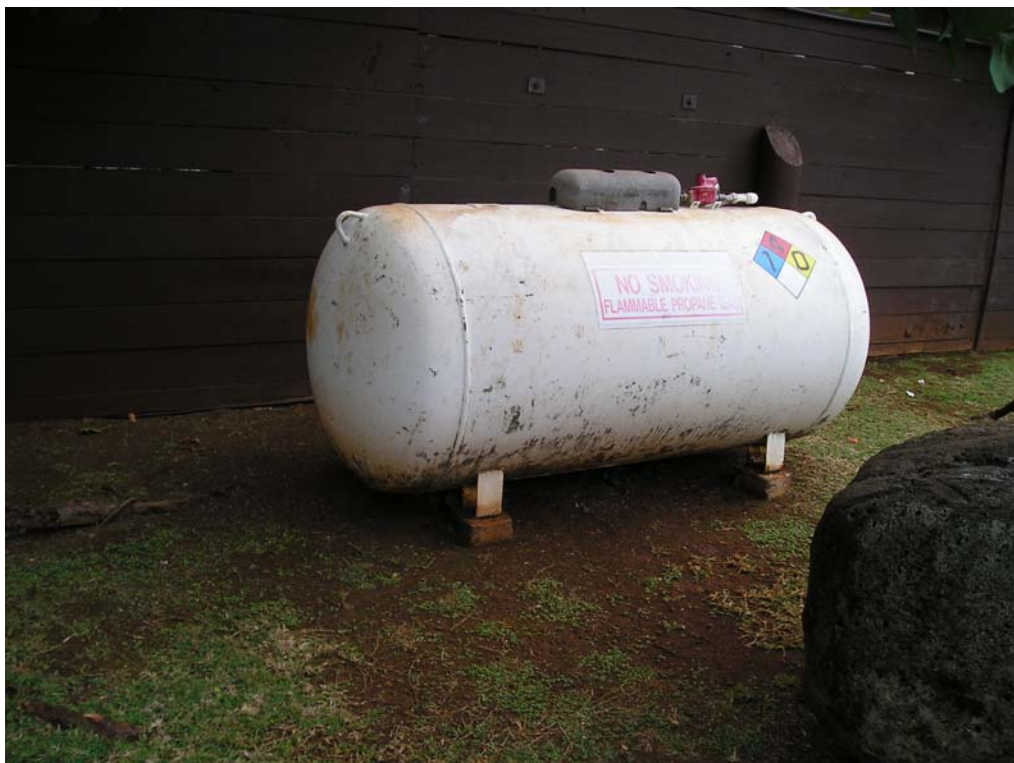
<b>Clayton Project Number</b>  85-06123.00	<b>Description</b>	Liquid propane gas AST on northwest portion of PBRC facility	<b>Photo 29</b>
	<b>Site Name</b>	Site 1, Unit 4, Kaka'ako Waterfront Redevelopment, Honolulu, Hawaii	<b>Photo Date</b>
	<b>Client</b>	Alexander & Baldwin, Inc.	11/1/2005

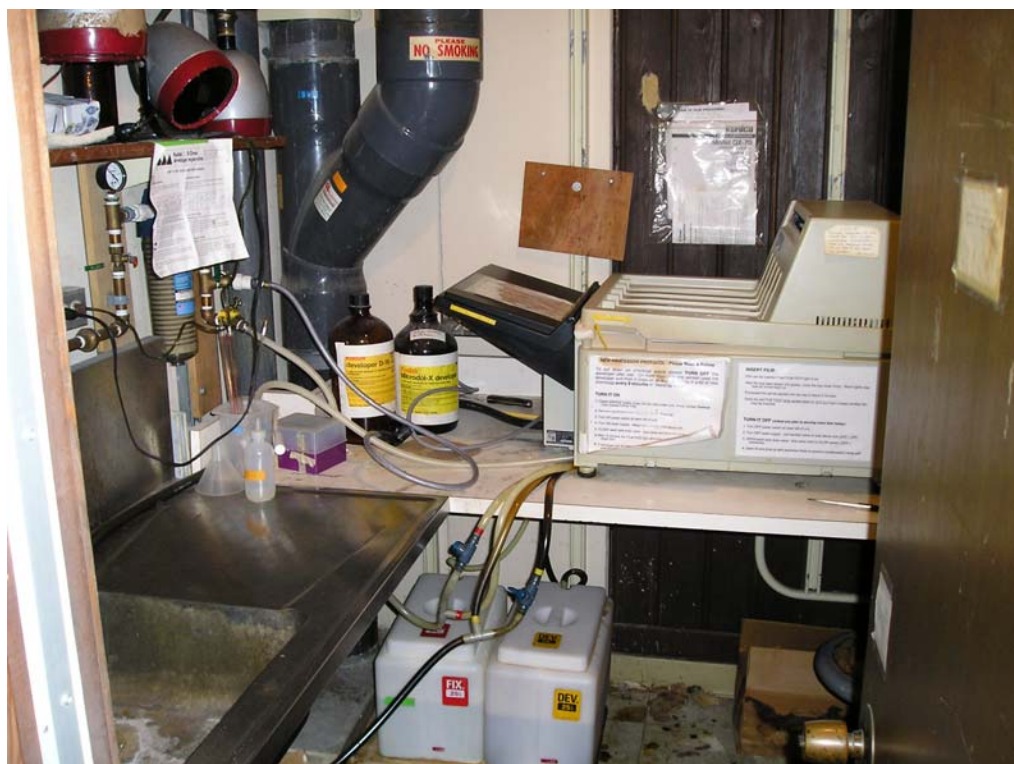
<b>Clayton Project Number</b>  85-06123.00	<b>Description</b>	X-ray developing room on second floor of PBRC building	<b>Photo 30</b>
	<b>Site Name</b>	Site 1, Unit 4, Kaka'ako Waterfront Redevelopment, Honolulu, Hawaii	<b>Photo Date</b>
	<b>Client</b>	Alexander & Baldwin, Inc.	11/1/2005

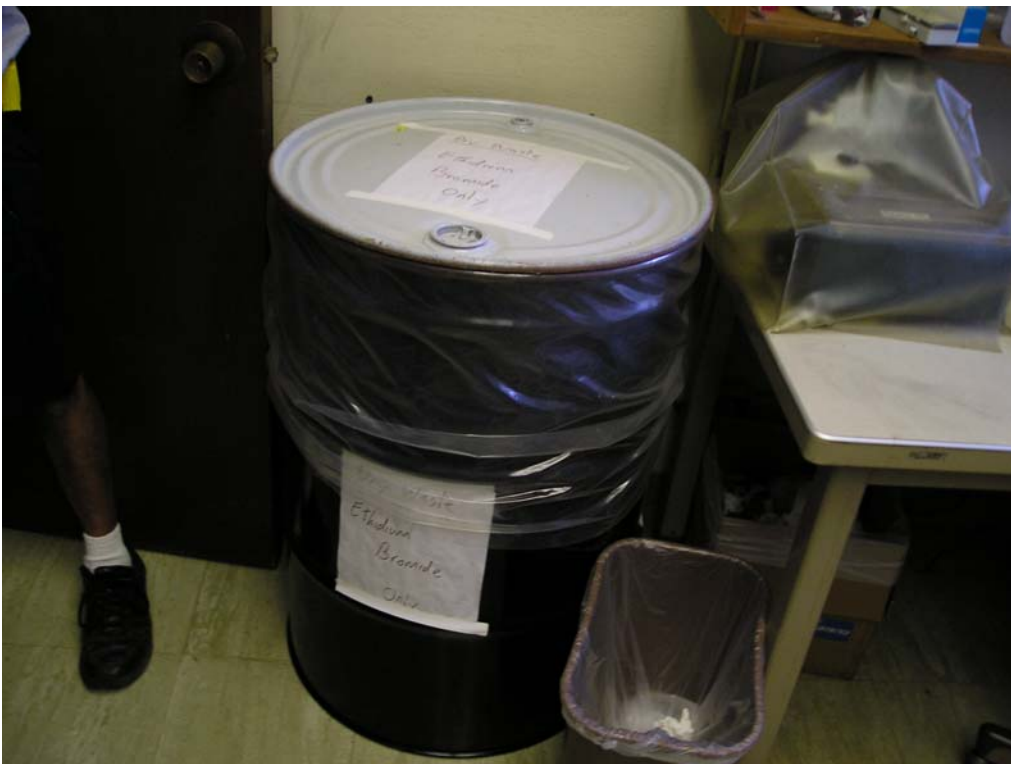
<b>Clayton Project Number</b>  85-06123.00	<b>Description</b>	55-gallon drum of ethidium bromide dry waste in third floor laboratory of PBRC building	<b>Photo 32</b>
	<b>Site Name</b>	Site 1, Unit 4, Kaka'ako Waterfront Redevelopment, Honolulu, Hawaii	<b>Photo Date</b>
	<b>Client</b>	Alexander & Baldwin, Inc.	11/1/2005
