# ***Phase I Environmental Site Assessment***

## **Kaka'ako Waterfront Redevelopment Property Honolulu, Oahu, Hawaii**

January 23, 2006  
Clayton Project No. 85-06123.00

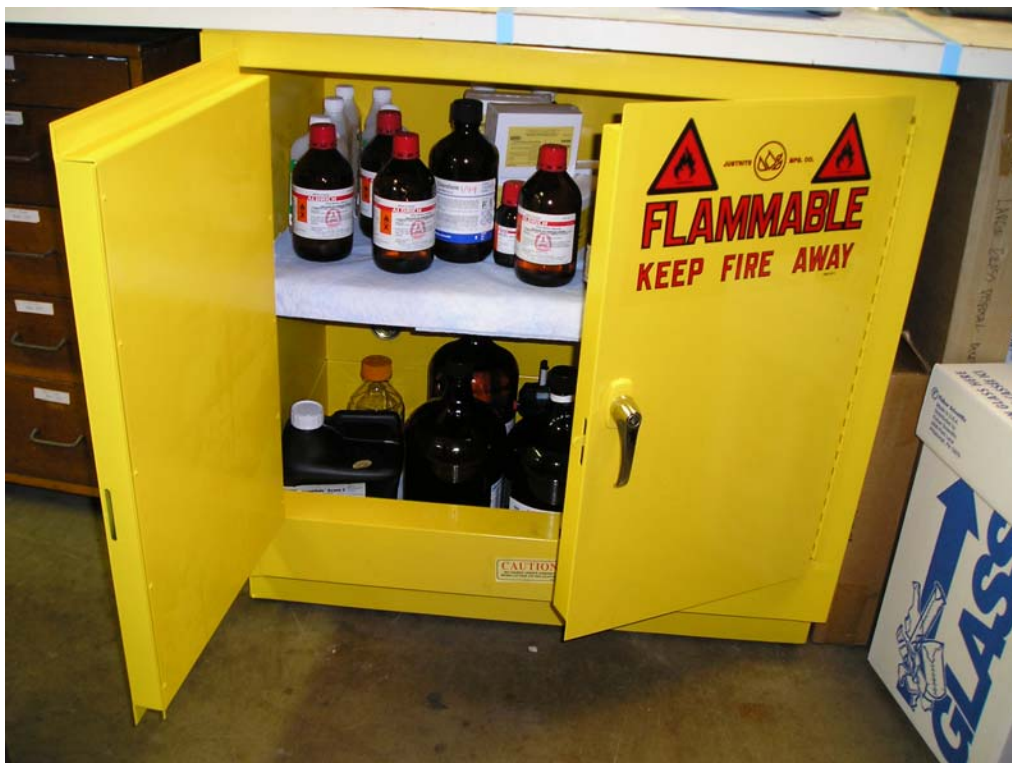
<b>Clayton Project Number</b>  85-06123.00	<b>Description</b>	Chemicals stored in flammable storage cabinet in first floor laboratory of PBRC building	<b>Photo 33</b>
	<b>Site Name</b>	Site 1, Unit 4, Kaka'ako Waterfront Redevelopment, Honolulu, Hawaii	<b>Photo Date</b>
	<b>Client</b>	Alexander & Baldwin, Inc.	11/1/2005

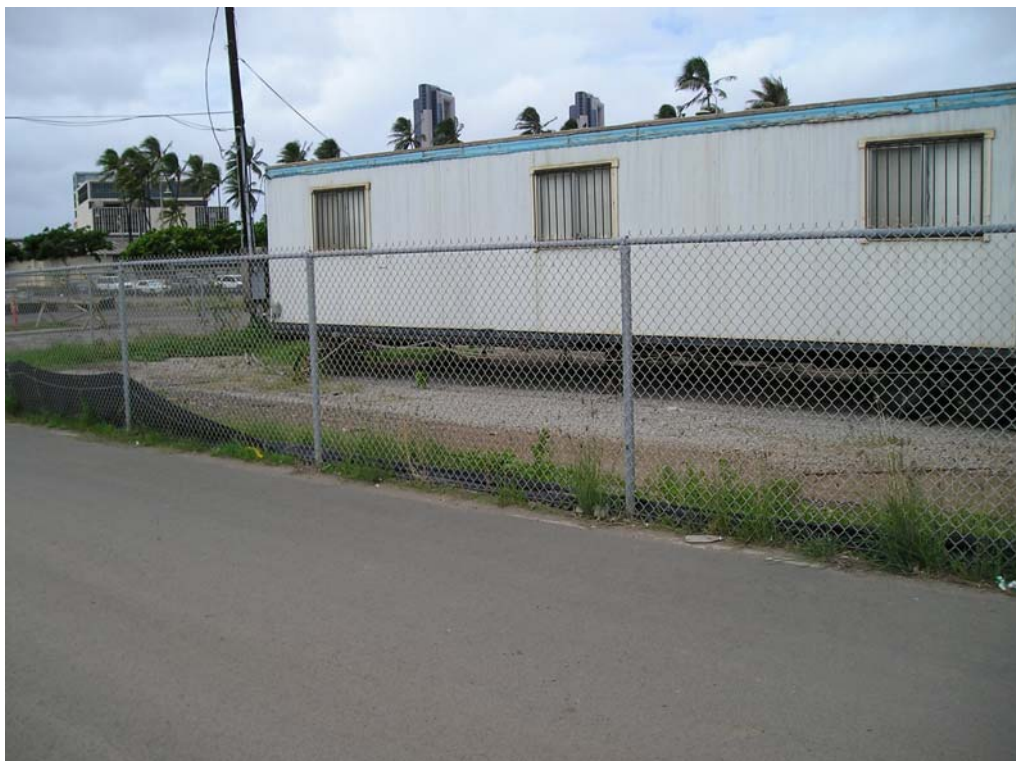
<b>Clayton Project Number</b>  85-06123.00	<b>Description</b>	Area of former LUST site (under office trailer), near west corner of Unit 6	<b>Photo 38</b>
	<b>Site Name</b>	Site 2, Unit 6, Kaka'ako Waterfront Redevelopment, Honolulu, Hawaii	<b>Photo Date</b>
	<b>Client</b>	Alexander & Baldwin, Inc.	11/1/2005

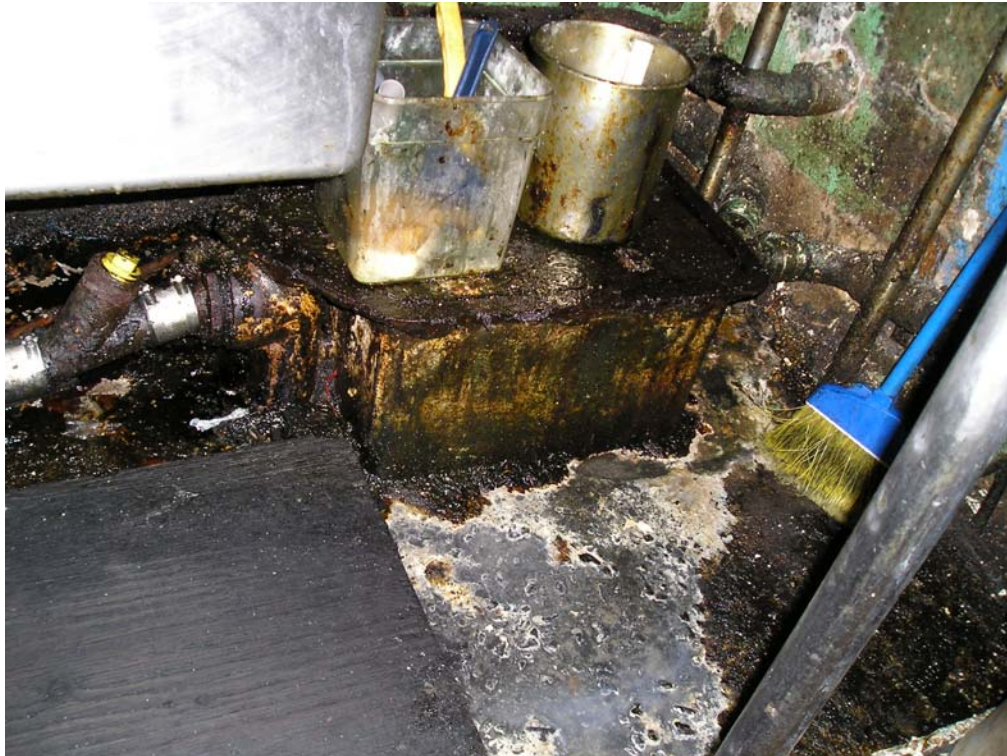
<b>Clayton Project Number</b>  85-06123.00	<b>Description</b>	Grease trap in kitchen of Fisherman's Wharf Restaurant	<b>Photo 42</b>
	<b>Site Name</b>	Site 2, Unit 6, Kaka'ako Waterfront Redevelopment, Honolulu, Hawaii	<b>Photo Date</b>
	<b>Client</b>	Alexander & Baldwin, Inc.	11/1/2005

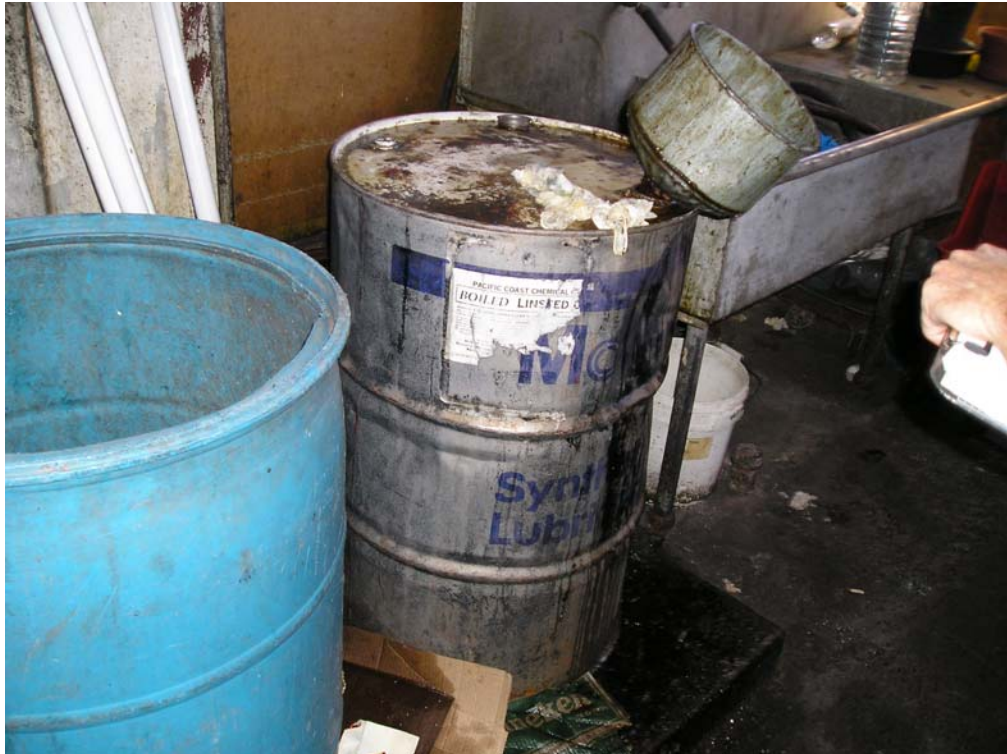
<b>Clayton Project Number</b>  85-06123.00	<b>Description</b>	Drum of food grease outside kitchen of Fisherman's Wharf Restaurant	<b>Photo 44</b>
	<b>Site Name</b>	Site 2, Unit 6, Kaka'ako Waterfront Redevelopment, Honolulu, Hawaii	<b>Photo Date</b>
	<b>Client</b>	Alexander & Baldwin, Inc.	11/1/2005

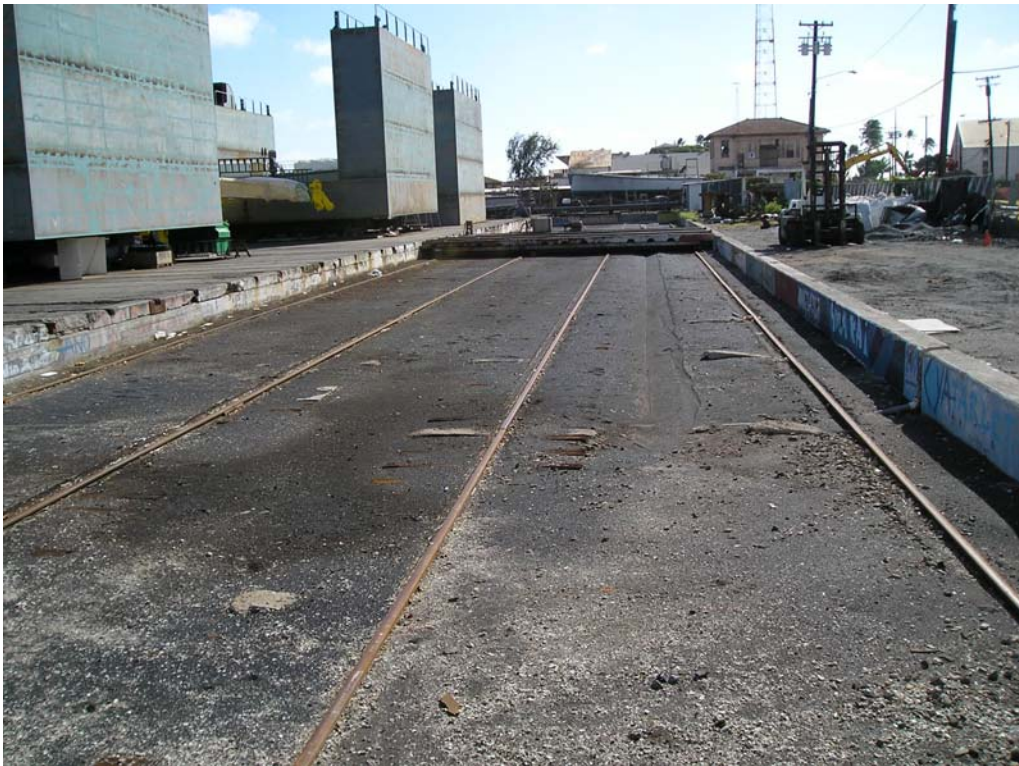
This finding is considered a REC because there is evidence that metals and other regulated substances may be included in the sandblast grit. Therefore, Clayton recommends the collection and analysis of samples to determine if the sandblast grit is acceptable for disposal and to assess whether any regulated substances have leached into the underlying soil.

<b>Clayton Project Number</b>  85-06123.00	<b>Description</b>	Transfer rail area covered with sandblast grit, located on northwest portion of Kewalo Shipyard facility, looking southwest	<b>Photo 47</b>
	<b>Site Name</b>	Site 2, Unit 7, Kaka'ako Waterfront Redevelopment, Honolulu, Hawaii	<b>Photo Date</b>
	<b>Client</b>	Alexander & Baldwin, Inc.	11/1/2005

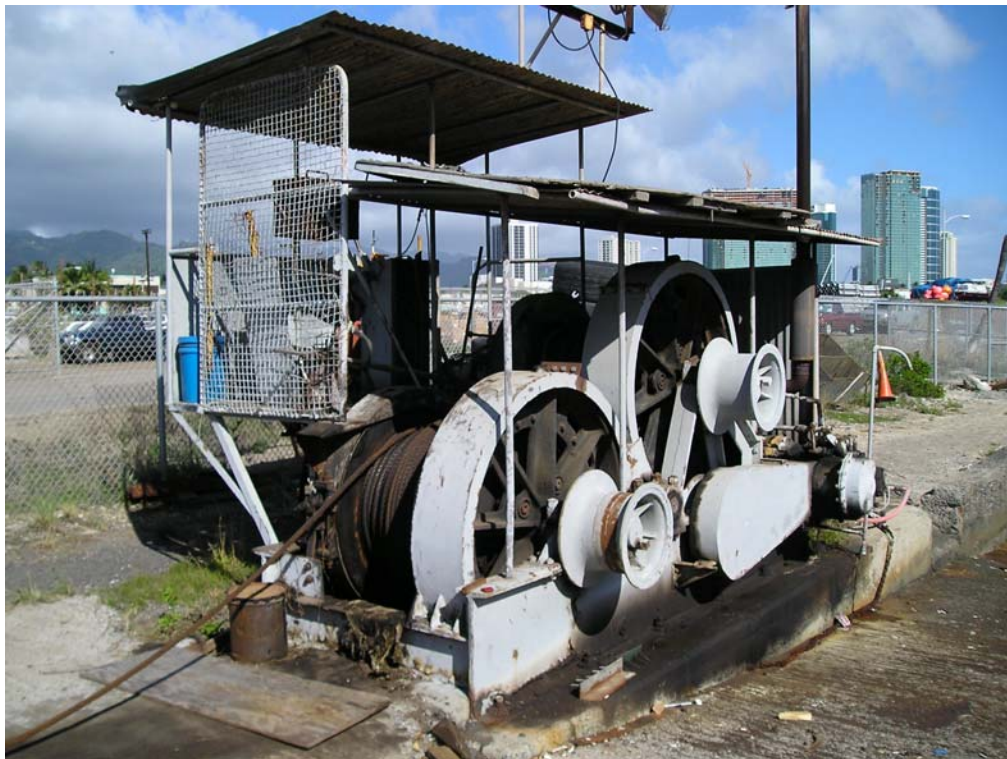
<b>Clayton Project Number</b>  85-06123.00	<b>Description</b>	Diesel-powered boat winch (note stained concrete) by boat ramp at Kewalo Shipyard facility	<b>Photo 48</b>
	<b>Site Name</b>	Site 2, Unit 7, Kaka'ako Waterfront Redevelopment, Honolulu, Hawaii	<b>Photo Date</b>
	<b>Client</b>	Alexander & Baldwin, Inc.	11/1/2005

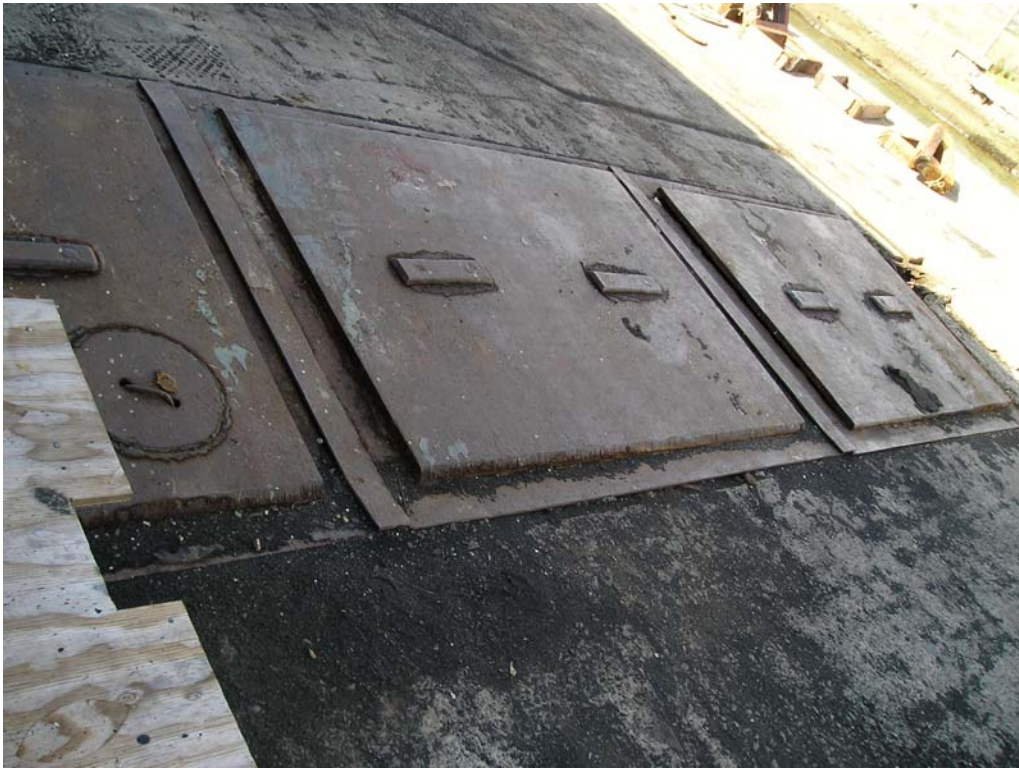
- Storm drains were observed throughout the subject property in proximity to current and former industrial facilities. These storm drains reportedly discharge to the Pacific Ocean and/or Kewalo Basin. Based on a previous limited environmental investigation, contaminants were identified in a portion of the storm drain sediments sampled. These contaminants include metals, pesticides, and petroleum hydrocarbons. In addition, the Kewalo Shipyard facility ( Site 2, Unit 7), includes two subsurface “catch basins” located adjacent to Kewalo Boat Harbor. These structures reportedly contain sediments and may contain petroleum constituents and metals associated with shipyard activities.

This finding is considered a REC because there is evidence of impacts to the sediment within the storm drains and catch basins on the subject property. These impacts include metals, pesticides, and petroleum hydrocarbons. Clayton recommends a comprehensive investigation of the sediments in the storm drain system throughout the property and the catch basins at the Kewalo Shipyard facility. Sediments with elevated contaminant levels should be properly removed and disposed prior to redevelopment of the subject property. In addition, should redevelopment plans include activities that would disturb sediments within Kewalo Basin in areas of storm drain discharges, Clayton recommends conducting an investigation of the sediments to assess the potential impacts by metals, pesticides, and petroleum hydrocarbons.

<b>Clayton Project Number</b>  85-06123.00	<b>Description</b>	Large oil/sediment catch basin near east corner of Kewalo Shipyard facility (not accessed)	<b>Photo 49</b>
	<b>Site Name</b>	Site 2, Unit 7, Kaka'ako Waterfront Redevelopment, Honolulu, Hawaii	<b>Photo Date</b>
	<b>Client</b>	Alexander & Baldwin, Inc.	11/1/2005

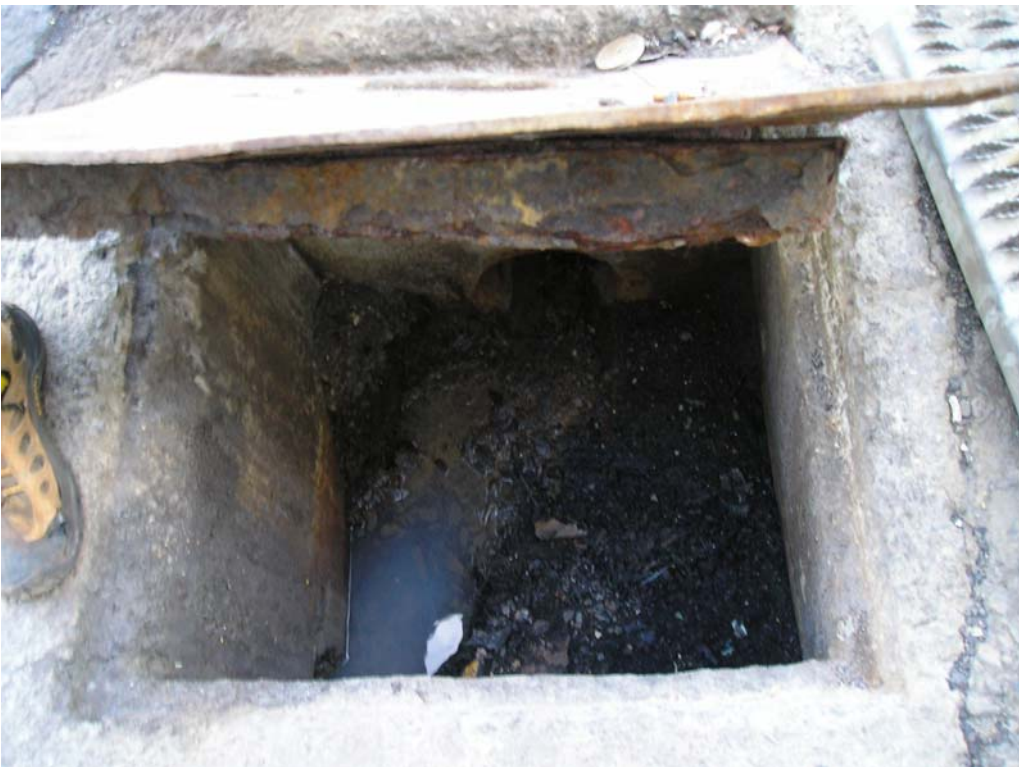
<b>Clayton Project Number</b>  85-06123.00	<b>Description</b>	Small oil/sediment catch basin on southeast side of Kewalo Shipyard facility	<b>Photo 50</b>
	<b>Site Name</b>	Site 2, Unit 7, Kaka'ako Waterfront Redevelopment, Honolulu, Hawaii	<b>Photo Date</b>
	<b>Client</b>	Alexander & Baldwin, Inc.	11/1/2005

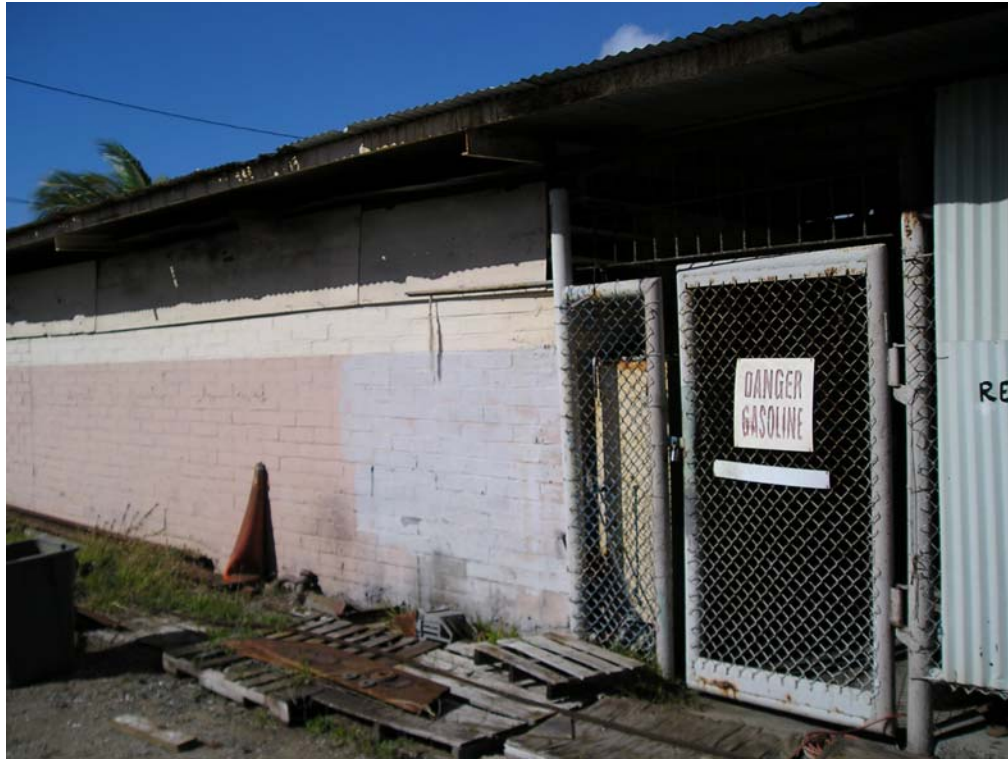
<b>Clayton Project Number</b>  85-06123.00	<b>Description</b>	Storage building (formerly flammable storage) on north portion of Kewalo Shipyard facility	<b>Photo 51</b>
	<b>Site Name</b>	Site 2, Unit 7, Kaka'ako Waterfront Redevelopment, Honolulu, Hawaii	<b>Photo Date</b>
	<b>Client</b>	Alexander & Baldwin, Inc.	11/1/2005

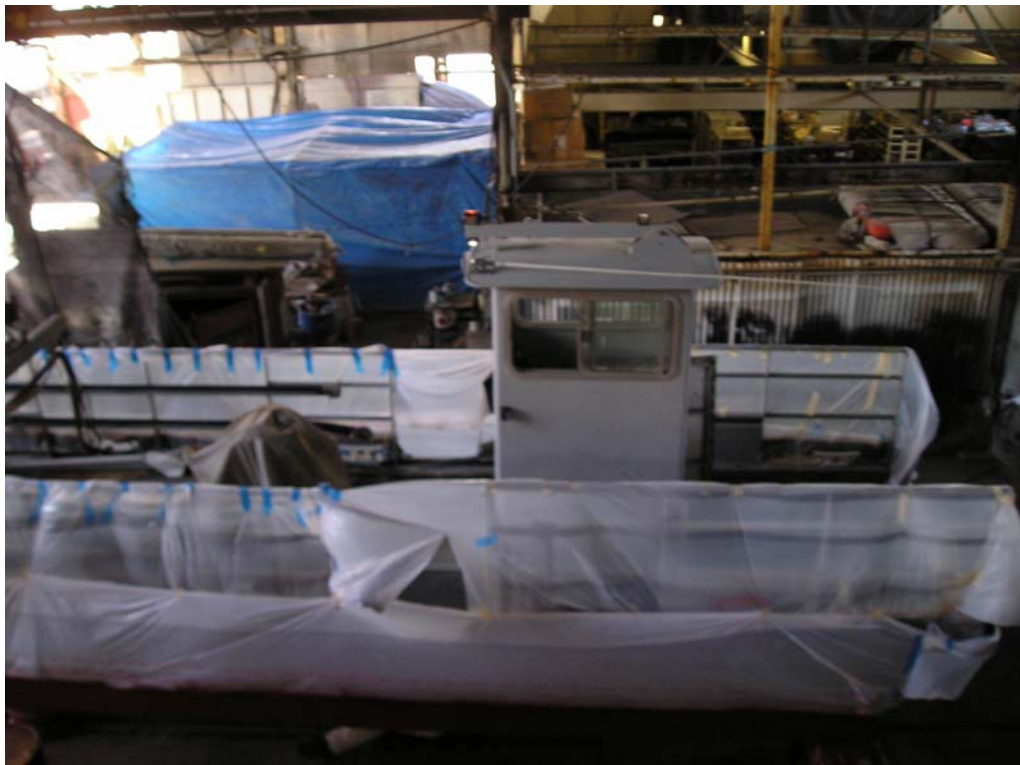
<b>Clayton Project Number</b>  85-06123.00	<b>Description</b>	Boat repair area inside main Kewalo Shipyard building	<b>Photo 52</b>
	<b>Site Name</b>	Site 2, Unit 7, Kaka'ako Waterfront Redevelopment, Honolulu, Hawaii	<b>Photo Date</b>
	<b>Client</b>	Alexander & Baldwin, Inc.	11/1/2005

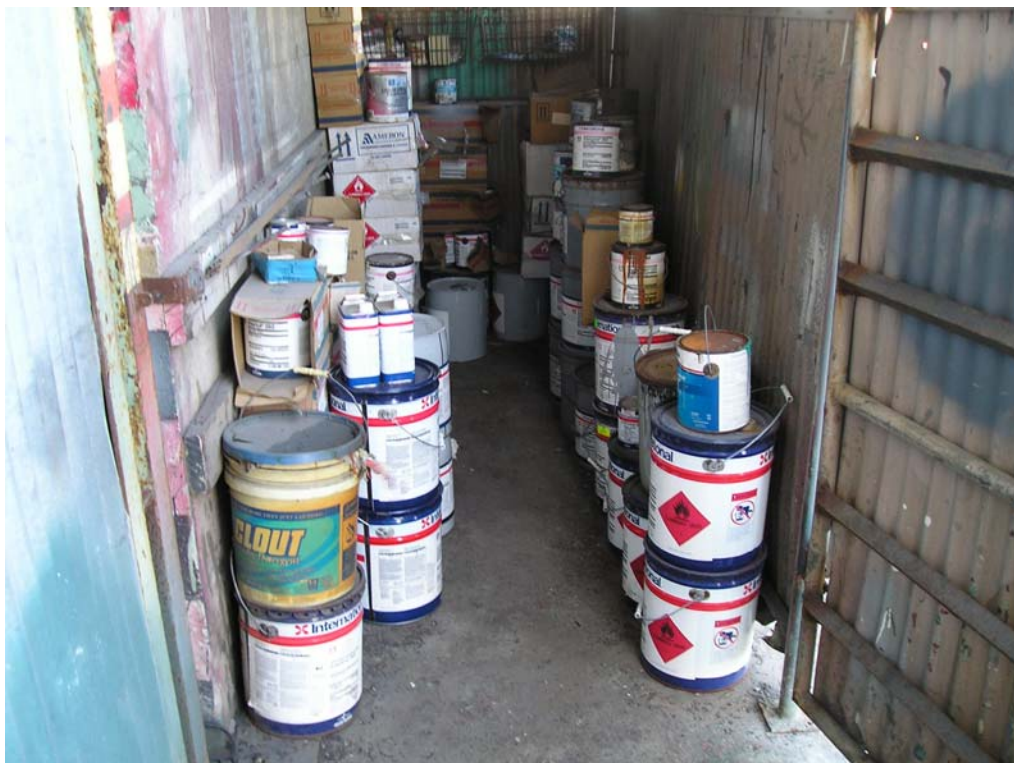
<b>Clayton Project Number</b>  85-06123.00	<b>Description</b>	Paints and thinners in storage shed on southeast side of Kewalo Shipyard facility	<b>Photo 53</b>
	<b>Site Name</b>	Site 2, Unit 7, Kaka'ako Waterfront Redevelopment, Honolulu, Hawaii	<b>Photo Date</b>
	<b>Client</b>	Alexander & Baldwin, Inc.	11/1/2005

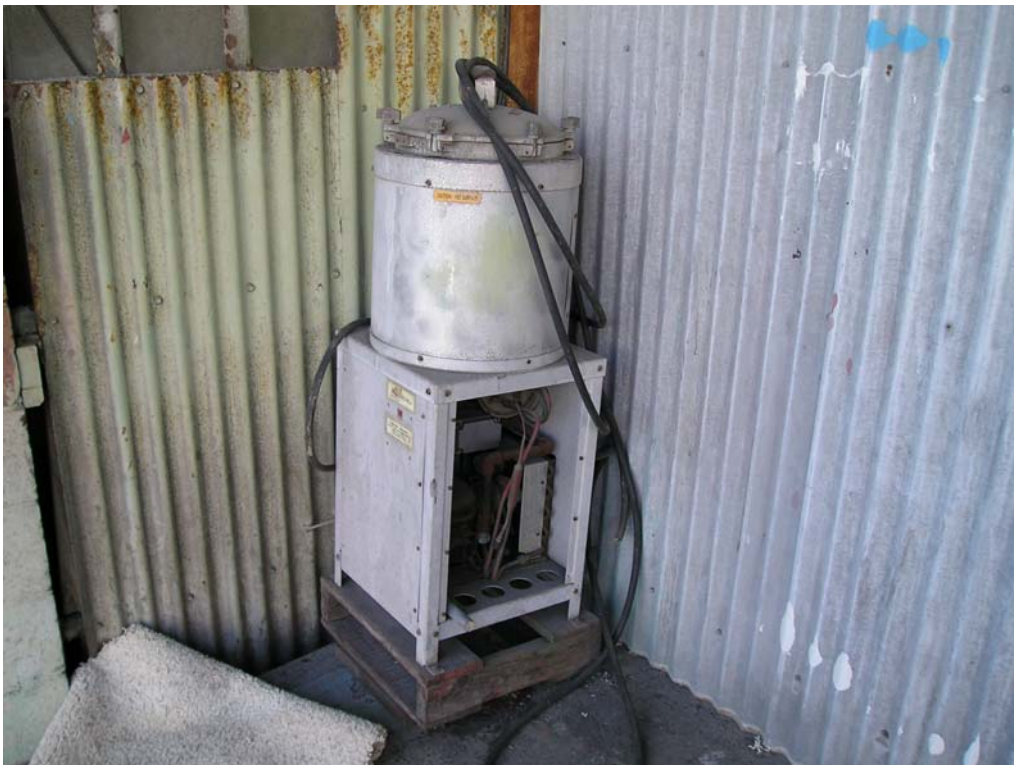
<b>Clayton Project Number</b>  85-06123.00	<b>Description</b>	Paint thinner recycling machine on southeast side of Kewalo Shipyard facility	<b>Photo 54</b>
	<b>Site Name</b>	Site 2, Unit 7, Kaka'ako Waterfront Redevelopment, Honolulu, Hawaii	<b>Photo Date</b>
	<b>Client</b>	Alexander & Baldwin, Inc.	11/1/2005

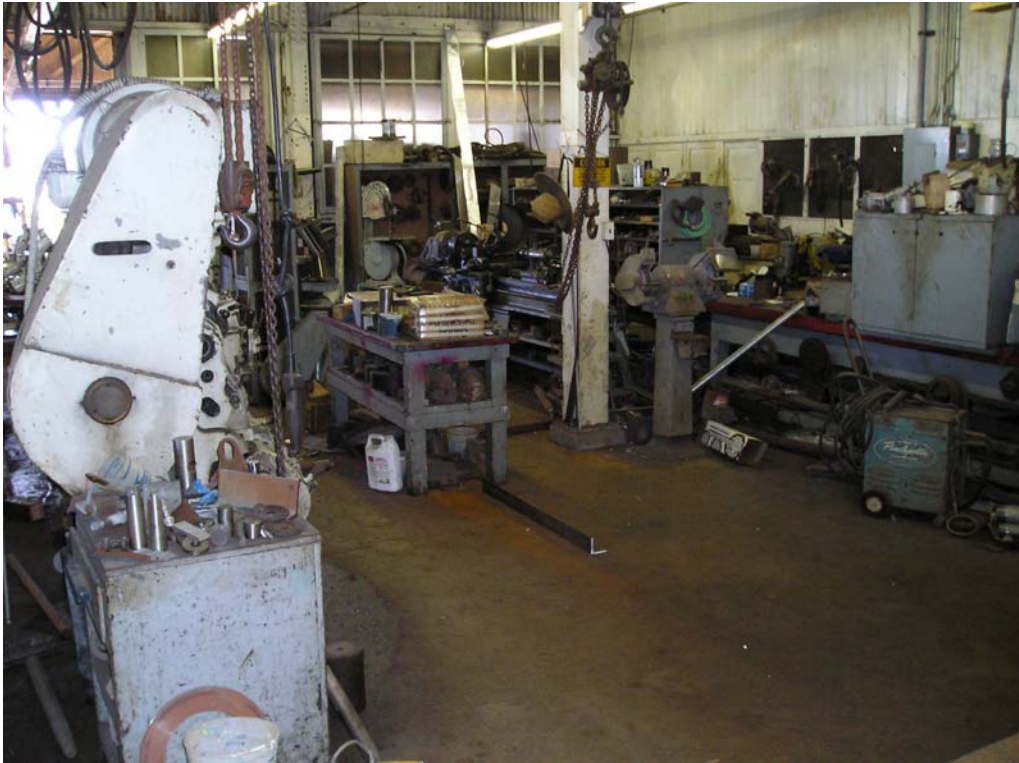
<b>Clayton Project Number</b>  85-06123.00	<b>Description</b>	Machine shop inside main Kewalo Shipyard building	<b>Photo 55</b>
	<b>Site Name</b>	Site 2, Unit 7, Kaka'ako Waterfront Redevelopment, Honolulu, Hawaii	<b>Photo Date</b>
	<b>Client</b>	Alexander & Baldwin, Inc.	11/1/2005

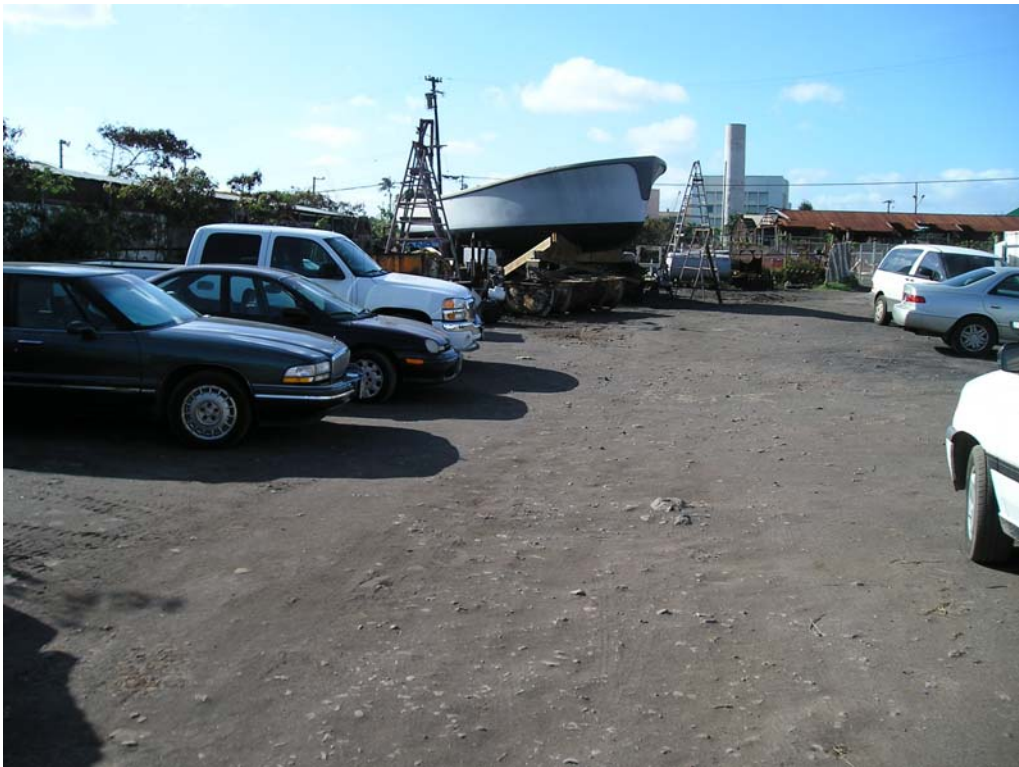
<b>Clayton Project Number</b>  85-06123.00	<b>Description</b>	Parking/storage area (covered with sandblast grit) located on southwest portion of Kewalo Shipyard facility, looking northwest	<b>Photo 58</b>
	<b>Site Name</b>	Site 2, Unit 7, Kaka'ako Waterfront Redevelopment, Honolulu, Hawaii	<b>Photo Date</b>
	<b>Client</b>	Alexander & Baldwin, Inc.	11/1/2005

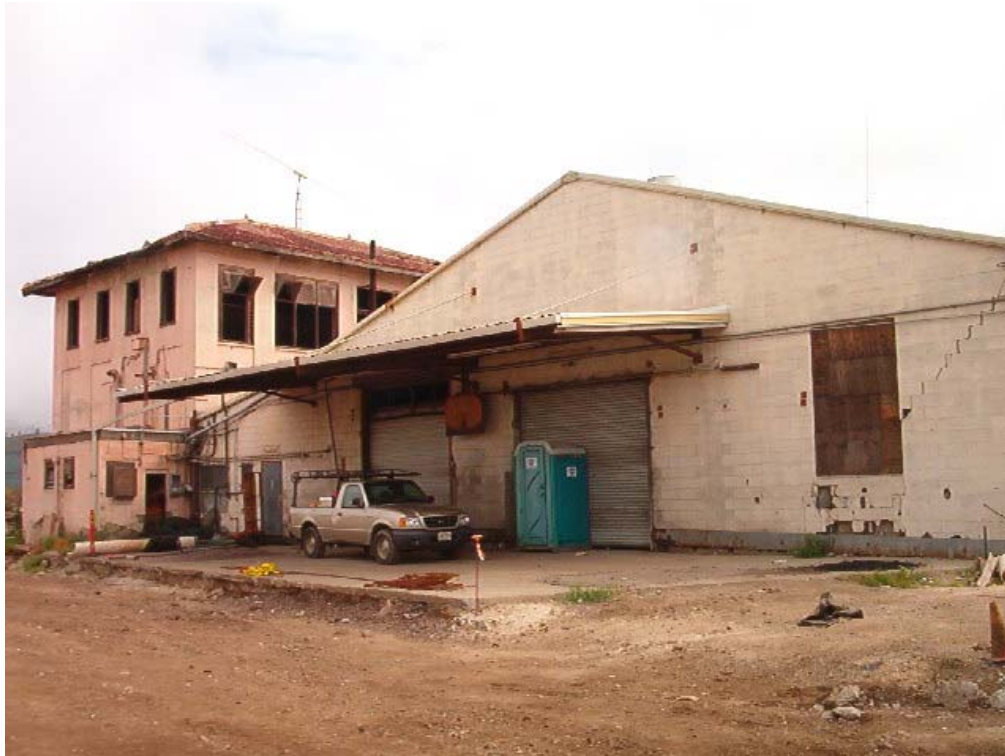
<b>Clayton Project Number</b>  85-06123.00	<b>Description</b>	Former fish auction house with attached icehouse on northeast portion of former GRG facility	<b>Photo 59</b>
	<b>Site Name</b>	Site 2, Unit 8, Kaka'ako Waterfront Redevelopment, Honolulu, Hawaii	<b>Photo Date</b>
	<b>Client</b>	Alexander & Baldwin, Inc.	11/1/2005

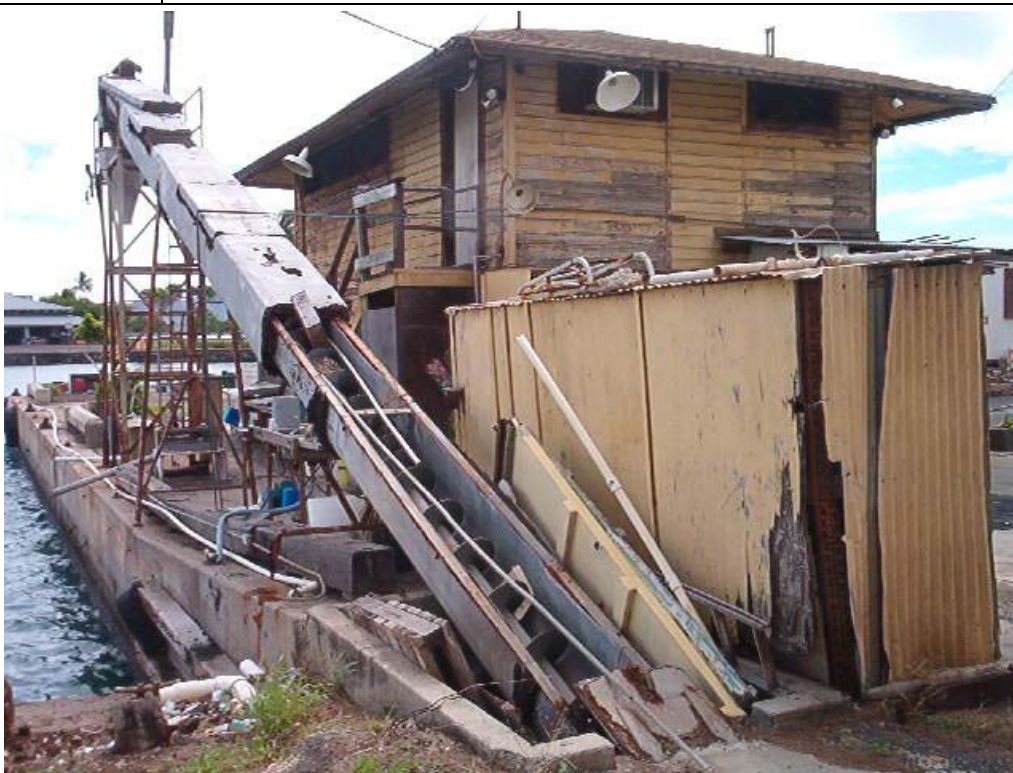
<b>Clayton Project Number</b>  85-06123.00	<b>Description</b>	Two-story office building and old ice conveyor (on left), located on southeast portion of former GRG facility	<b>Photo 60</b>
	<b>Site Name</b>	Site 2, Unit 8, Kaka'ako Waterfront Redevelopment, Honolulu, Hawaii	<b>Photo Date</b>
	<b>Client</b>	Alexander & Baldwin, Inc.	11/1/2005

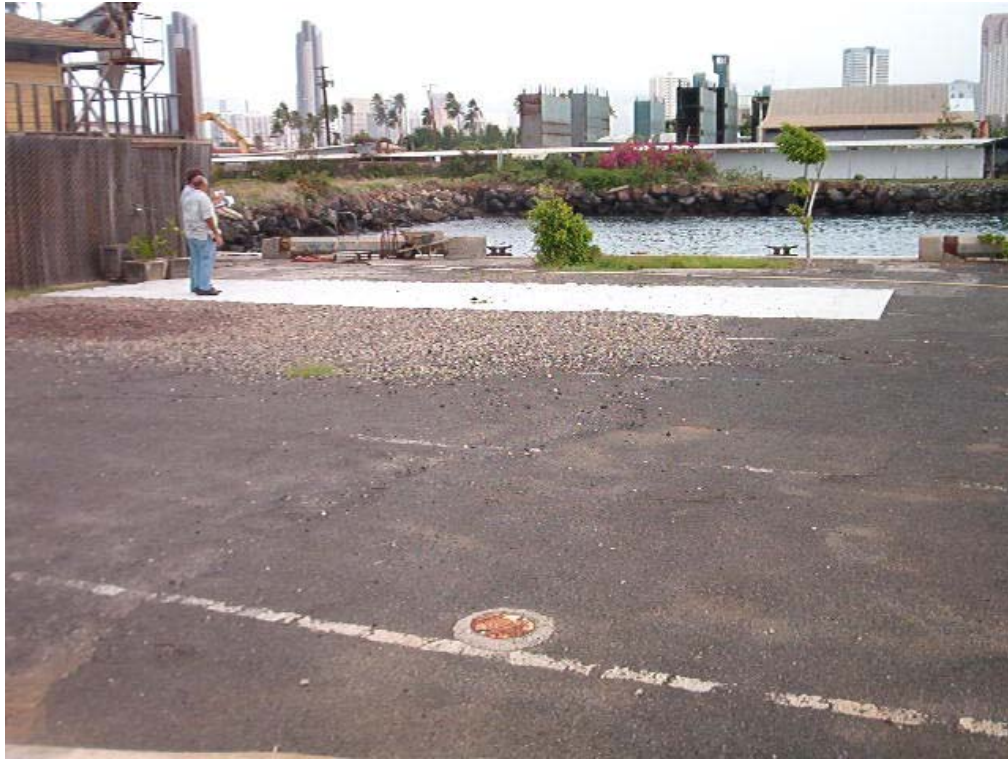
Clayton Project Number  85-06123.00	<b>Description</b>	Former LUST site on southeast portion of former GRG facility (note groundwater monitoring well in foreground)	<b>Photo 61</b>
	<b>Site Name</b>	Site 2, Unit 8, Kaka'ako Waterfront Redevelopment, Honolulu, Hawaii	<b>Photo Date</b>
	<b>Client</b>	Alexander & Baldwin, Inc.	11/1/2005

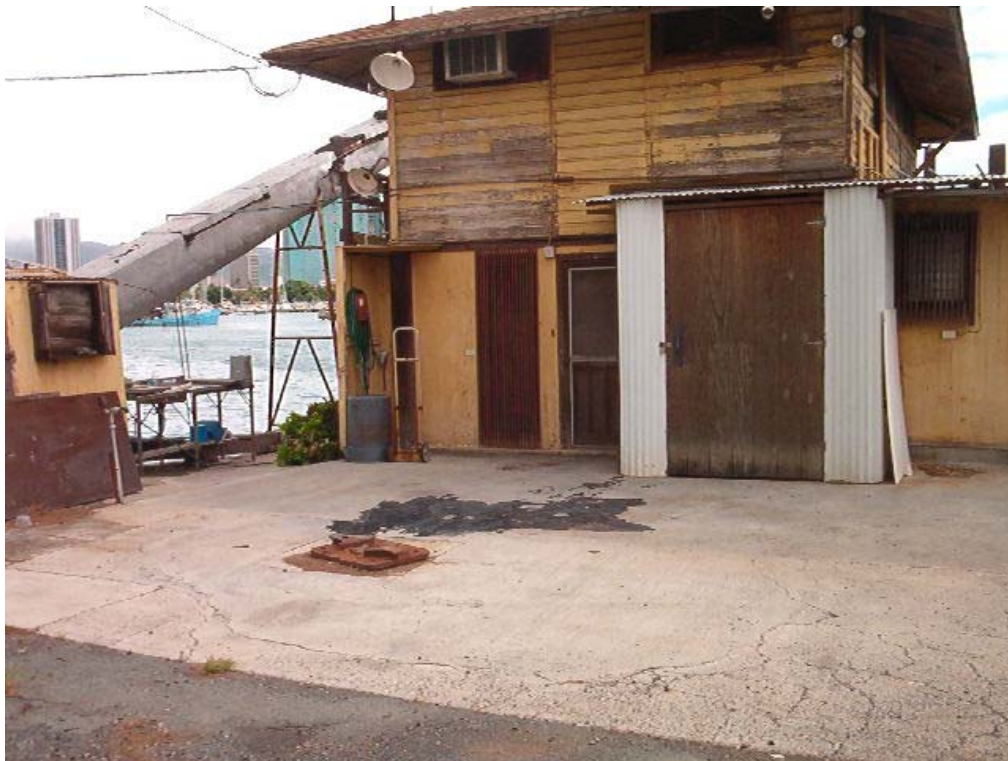
- The former GRG facility at the southwest end of Site 2 on Unit 8 includes a below-grade hydraulic lift, which is located at the center of a concrete slab on the northwest side of the two-story office building. During the onsite inspection, Clayton observed a small, rusted steel plate at the center of the concrete slab, which was the only aboveground portion of the lift that remained. No pertinent information regarding this hydraulic lift was available during Clayton's assessment.

This finding is considered a REC because there is a potential for past releases of hydraulic fluid from this lift. Clayton recommends removing the lift and conducting soil/groundwater sampling with laboratory analyses for polychlorinated biphenyls (PCBs) and petroleum hydrocarbons.

Clayton Project Number  85-06123.00	<b>Description</b>	Below-grade hydraulic lift (rusted steel plate) on concrete slab, located on northwest side of two-story office building at former GRG facility	<b>Photo 62</b>
	<b>Site Name</b>	Site 2, Unit 8, Kaka'ako Waterfront Redevelopment, Honolulu, Hawaii	<b>Photo Date</b>
	<b>Client</b>	Alexander & Baldwin, Inc.	11/1/2005

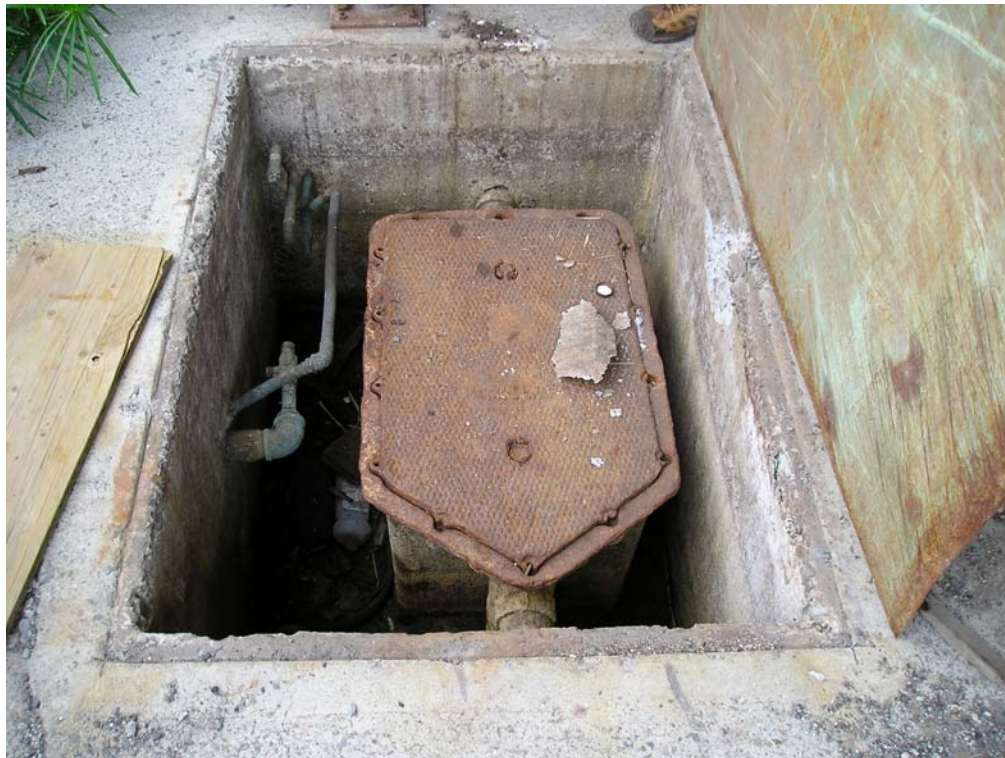
<b>Clayton Project Number</b>  85-06123.00	<b>Description</b>	Below-grade food grease interceptor on northwest side of former Kane's Fish Market building at former GRG facility	<b>Photo 63</b>
	<b>Site Name</b>	Site 2, Unit 8, Kaka'ako Waterfront Redevelopment, Honolulu, Hawaii	<b>Photo Date</b>
	<b>Client</b>	Alexander & Baldwin, Inc.	11/1/2005

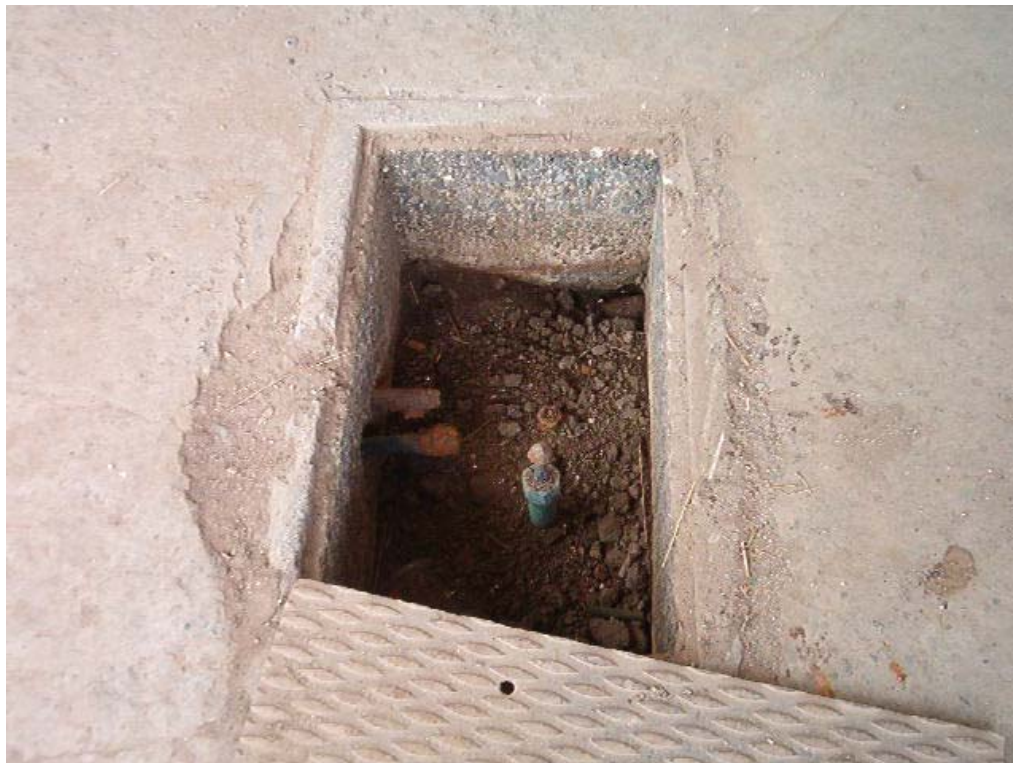
<b>Clayton Project Number</b>  85-06123.00	<b>Description</b>	One of two small utility vaults in concrete slab on northwest side of former icehouse at former GRG facility	<b>Photo 64</b>
	<b>Site Name</b>	Site 2, Unit 8, Kaka'ako Waterfront Redevelopment, Honolulu, Hawaii	<b>Photo Date</b>
	<b>Client</b>	Alexander & Baldwin, Inc.	11/1/2005

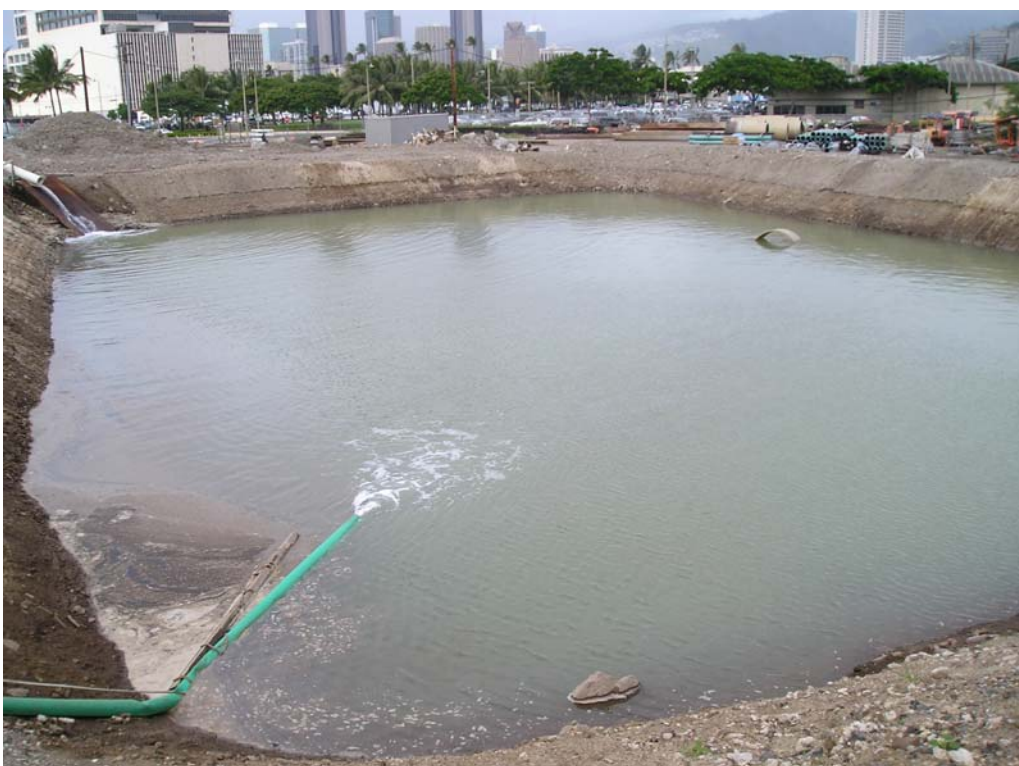
<b>Clayton Project Number</b>  85-06123.00	<b>Description</b>	Temporary reservoir (for dewatering purposes) on southeast-central portion of Unit 1, looking north	<b>Photo 74</b>
	<b>Site Name</b>	Site 3, Unit 1, Kaka'ako Waterfront Redevelopment, Honolulu, Hawaii	<b>Photo Date</b>
	<b>Client</b>	Alexander & Baldwin, Inc.	11/1/2005

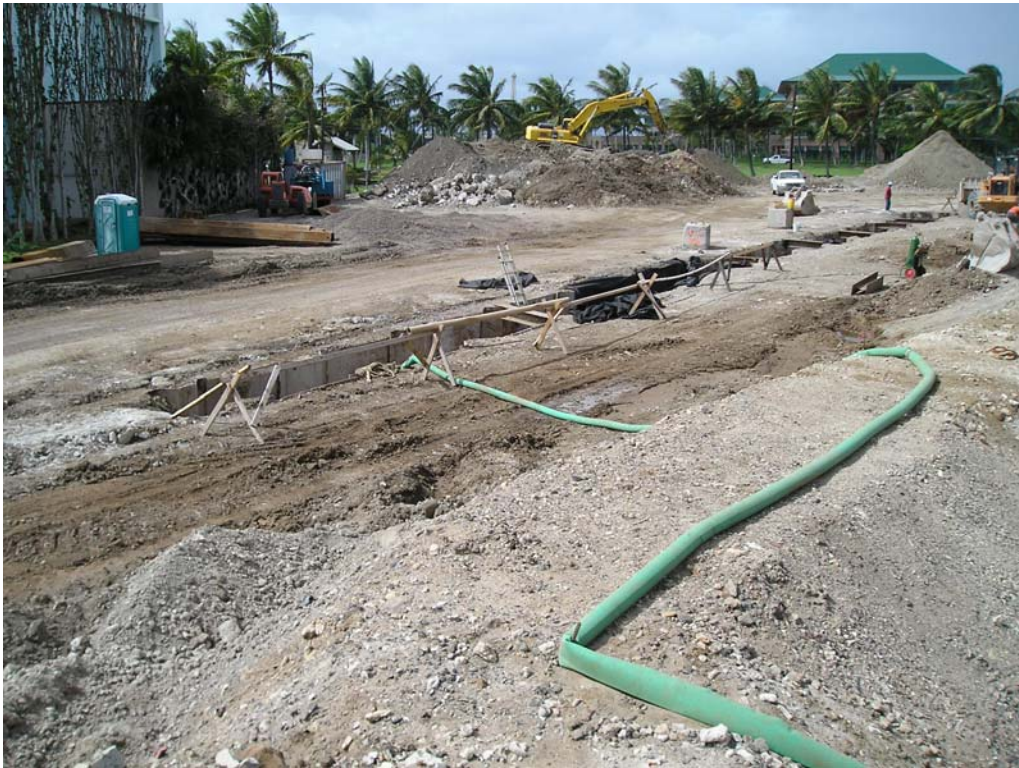
<b>Clayton Project Number</b>  85-06123.00	<b>Description</b>	Trenching activities for the installation of utilities on west-central portion of Unit 1, looking west	<b>Photo 75</b>
	<b>Site Name</b>	Site 3, Unit 1, Kaka'ako Waterfront Redevelopment, Honolulu, Hawaii	<b>Photo Date</b>
	<b>Client</b>	Alexander & Baldwin, Inc.	11/1/2005

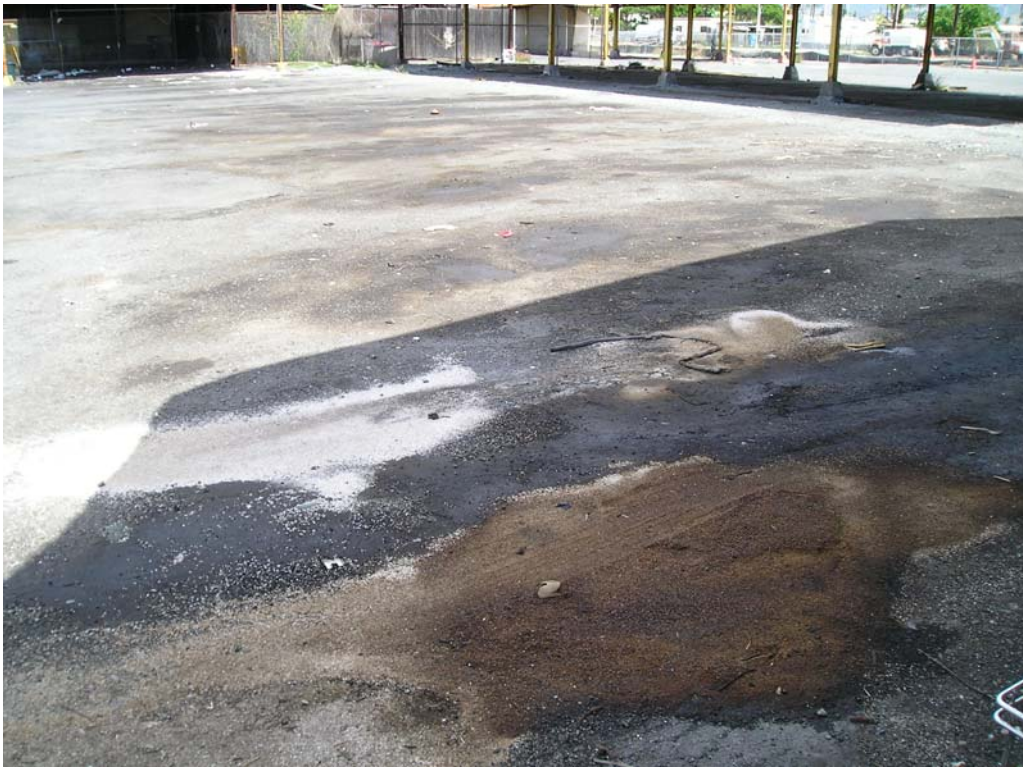
<b>Clayton Project Number</b>  85-06123.00	<b>Description</b>	Oil-stained asphalt pavement on central portion of Unit 3	<b>Photo 81</b>
	<b>Site Name</b>	Site 3, Unit 3, Kaka'ako Waterfront Redevelopment, Honolulu, Hawaii	<b>Photo Date</b>
	<b>Client</b>	Alexander & Baldwin, Inc.	11/1/2005

Stained Pavement	Heavy surface staining, primarily on asphalt-paved areas along the northwest side and central area of the former Corporation Yard.	<p>Recommend proper removal and disposal of the stained pavement. Following the removal of the stained pavement, perform an assessment of potential impacts to the underlying soil.</p> <p><u>Reference:</u></p> <p>Clayton Phase I ESA (January 2006)</p>
Existing Cesspool	Suspected cesspool associated with former building on Unit 3.	<p>Recommend sampling and analysis of the contents of the cesspool, followed by proper closure.</p> <p><u>Reference:</u></p> <p>Clayton Phase I ESA (January 2006)</p>
<b>Site 4 –Unit 9</b>		
N/A	N/A	N/A

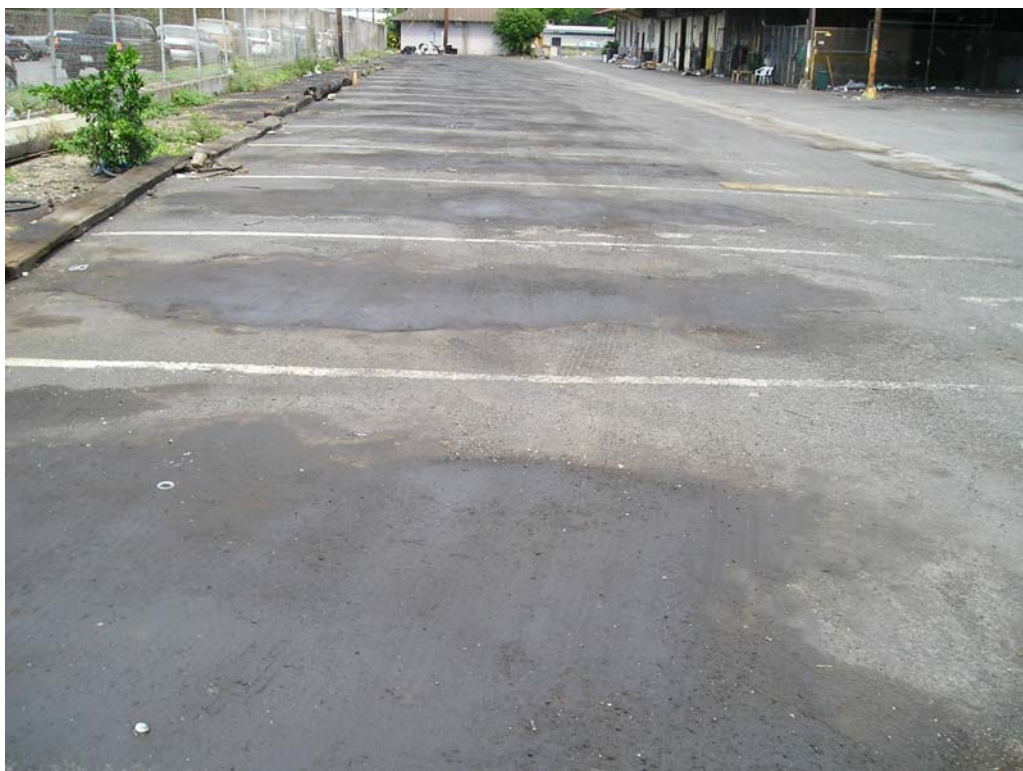
<b>Clayton Project Number</b>  85-06123.00	<b>Description</b>	Oil-stained asphalt pavement on northwest portion of Unit 3	<b>Photo 82</b>
	<b>Site Name</b>	Site 3, Unit 3, Kaka'ako Waterfront Redevelopment, Honolulu, Hawaii	<b>Photo Date</b>
	<b>Client</b>	Alexander & Baldwin, Inc.	11/1/2005

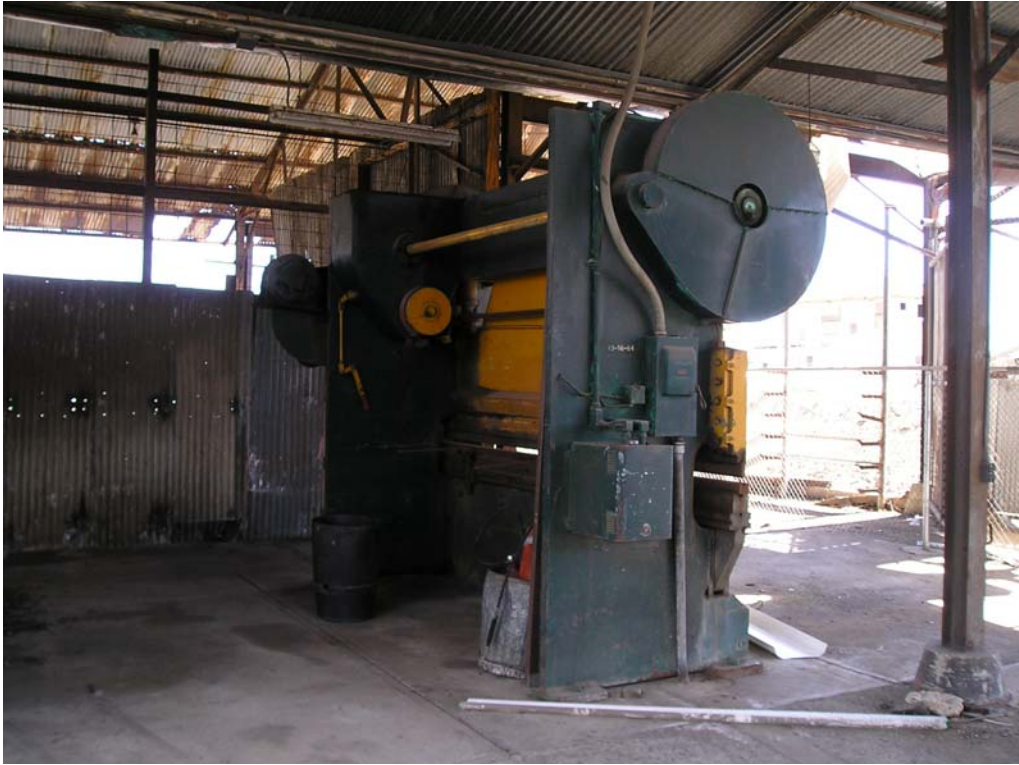
<b>Clayton Project Number</b>  85-06123.00	<b>Description</b>	Metal shearing machine in open-sided structure, located on southwest-central portion of Unit 3	<b>Photo 83</b>
	<b>Site Name</b>	Site 3, Unit 3, Kaka'ako Waterfront Redevelopment, Honolulu, Hawaii	<b>Photo Date</b>
	<b>Client</b>	Alexander & Baldwin, Inc.	11/1/2005
