# ***Phase I Environmental Site Assessment***

## **Kaka'ako Waterfront Redevelopment Property Honolulu, Oahu, Hawaii**

January 23, 2006  
Clayton Project No. 85-06123.00

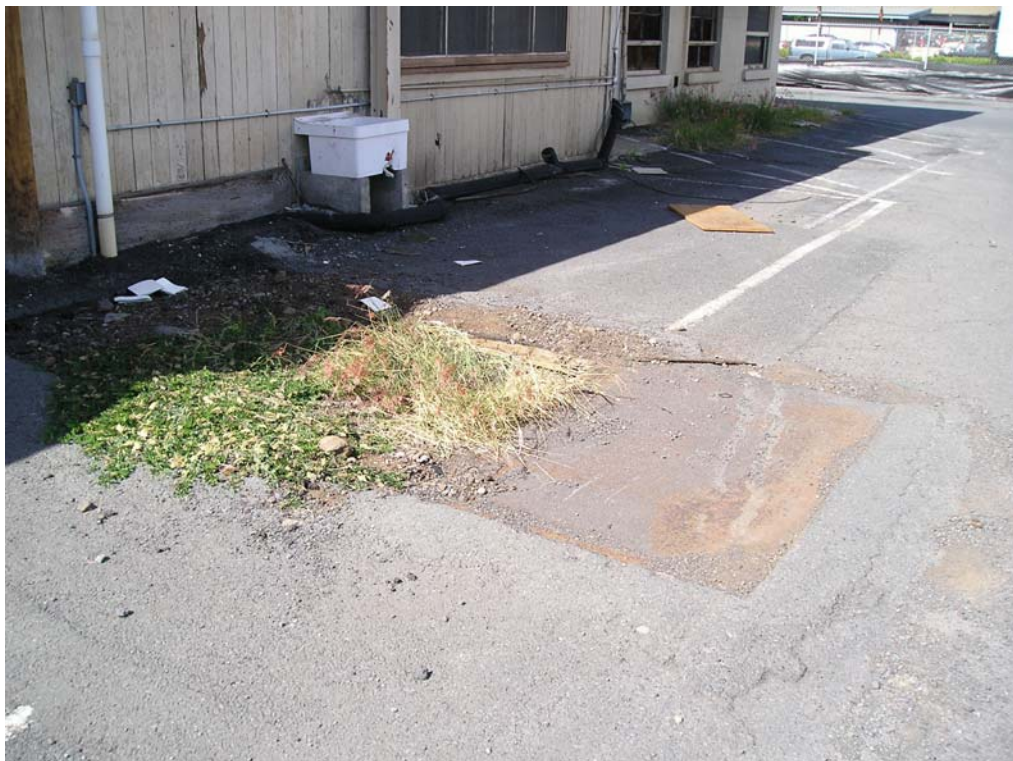
<b>Clayton Project Number</b>  85-06123.00	<b>Description</b>	Suspect cesspool site on southeast side of east-southeast building on Unit 3	<b>Photo 86</b>
	<b>Site Name</b>	Site 3, Unit 3, Kaka'ako Waterfront Redevelopment, Honolulu, Hawaii	<b>Photo Date</b>
	<b>Client</b>	Alexander & Baldwin, Inc.	11/1/2005

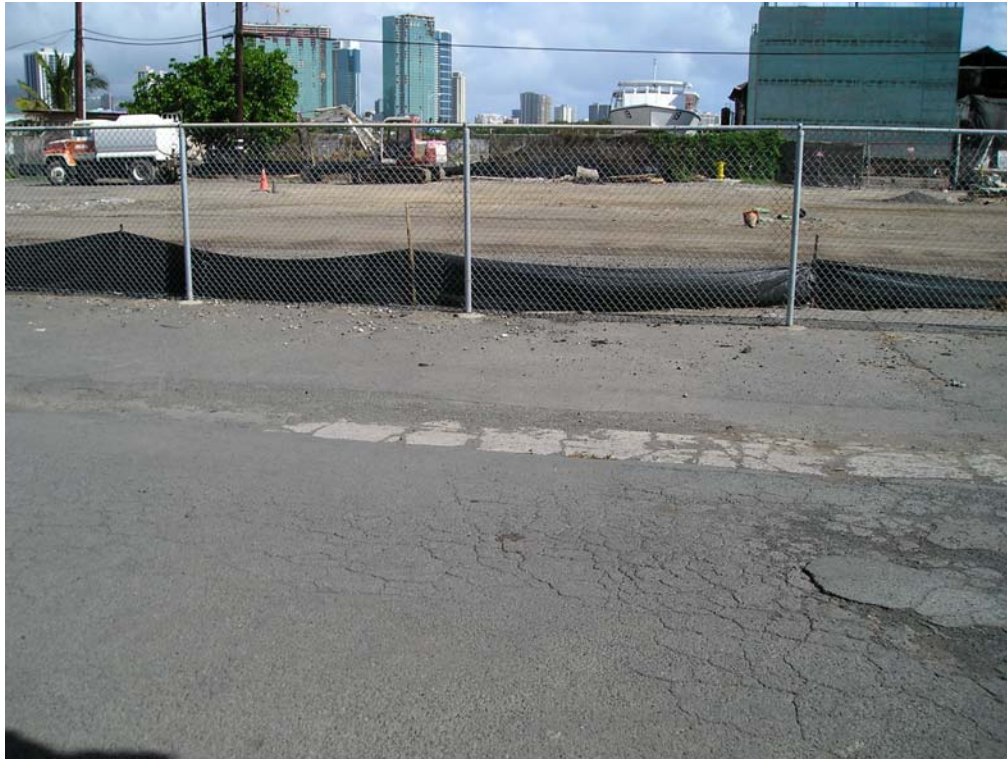
<b>Clayton Project Number</b>  85-06123.00	<b>Description</b>	Former UST site (with 3 USTs) on southeast portion of Unit 3	<b>Photo 87</b>
	<b>Site Name</b>	Site 3, Unit 3, Kaka'ako Waterfront Redevelopment, Honolulu, Hawaii	<b>Photo Date</b>
	<b>Client</b>	Alexander & Baldwin, Inc.	11/1/2005

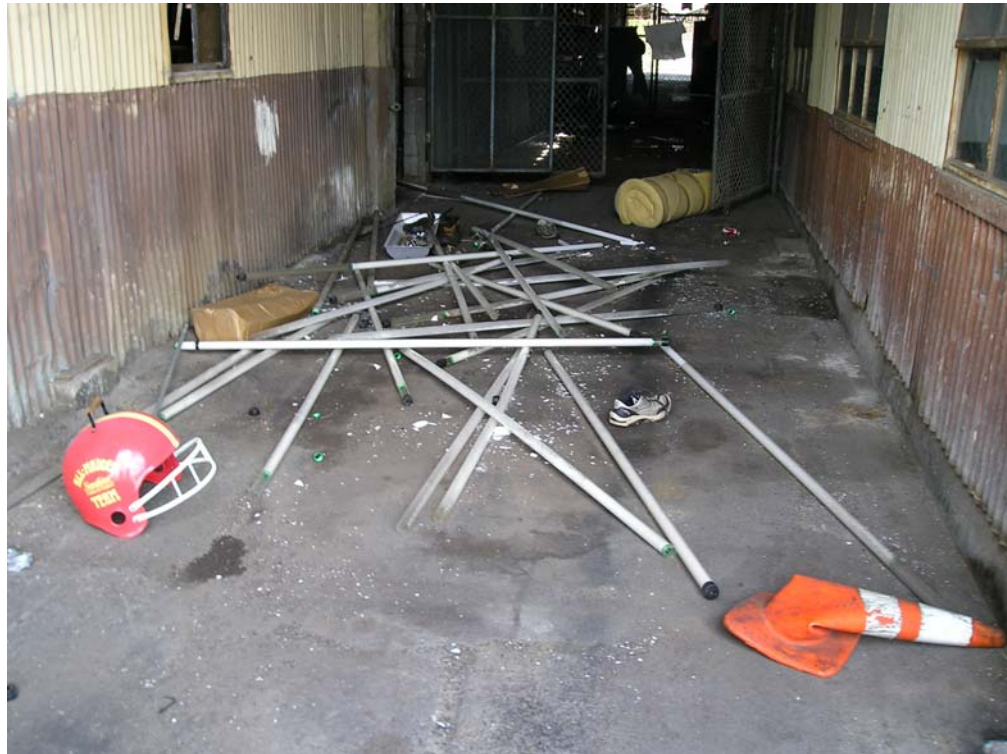
<b>Clayton Project Number</b>  85-06123.00	<b>Description</b>	Former LUST site between warehouse buildings on northeast-central portion of Unit 3	<b>Photo 88</b>
	<b>Site Name</b>	Site 3, Unit 3, Kaka'ako Waterfront Redevelopment, Honolulu, Hawaii	<b>Photo Date</b>
	<b>Client</b>	Alexander & Baldwin, Inc.	11/1/2005

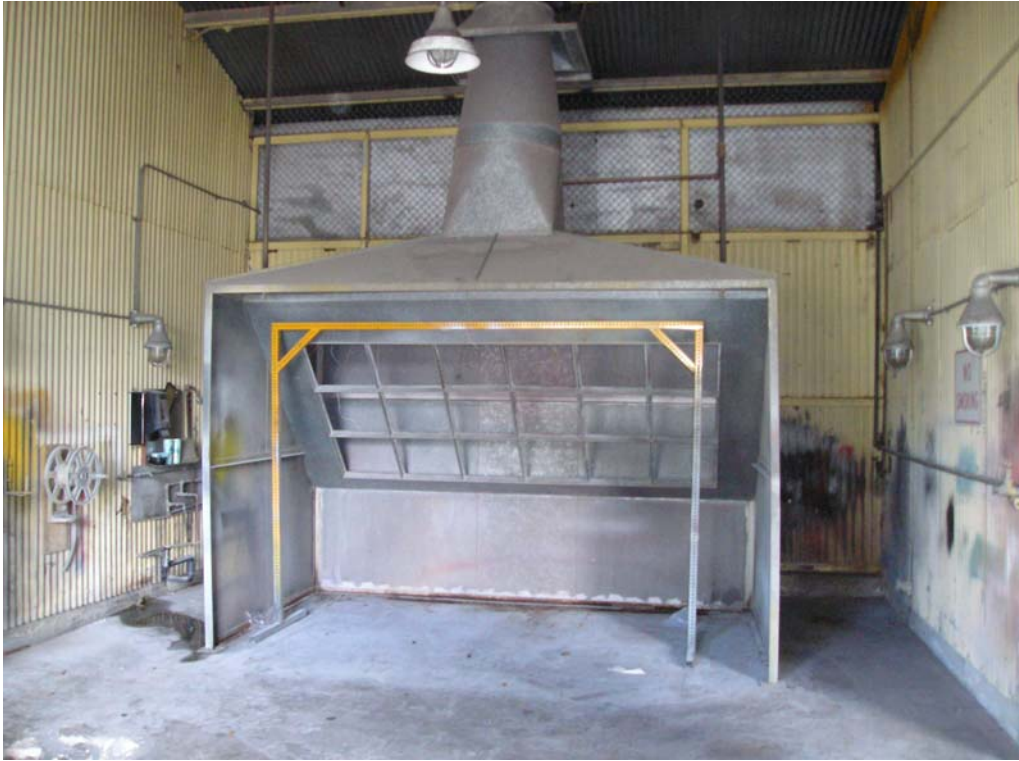
<b>Clayton Project Number</b>  85-06123.00	<b>Description</b>	Former paint booth in northeast-central warehouse-type building on Unit 3	<b>Photo 89</b>
	<b>Site Name</b>	Site 3, Unit 3, Kaka'ako Waterfront Redevelopment, Honolulu, Hawaii	<b>Photo Date</b>
	<b>Client</b>	Alexander & Baldwin, Inc.	11/1/2005

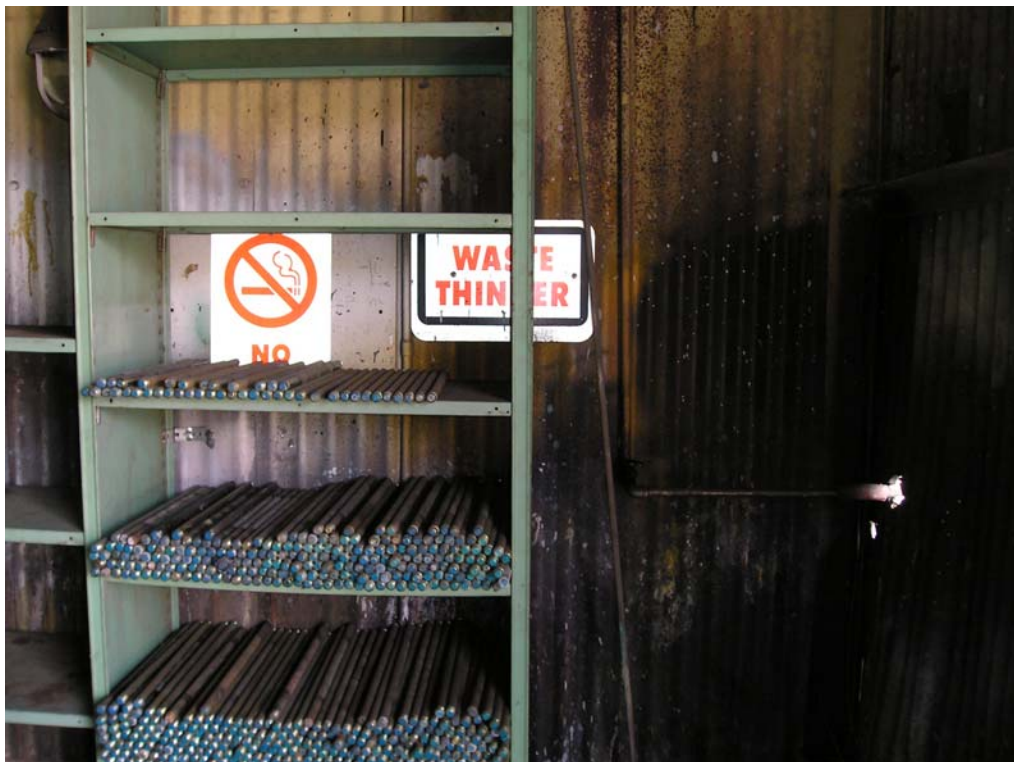
<b>Clayton Project Number</b>  85-06123.00	<b>Description</b>	Former waste thinner storage area inside northeast-central warehouse-type building on Unit 3	<b>Photo 90</b>
	<b>Site Name</b>	Site 3, Unit 3, Kaka'ako Waterfront Redevelopment, Honolulu, Hawaii	<b>Photo Date</b>
	<b>Client</b>	Alexander & Baldwin, Inc.	11/1/2005

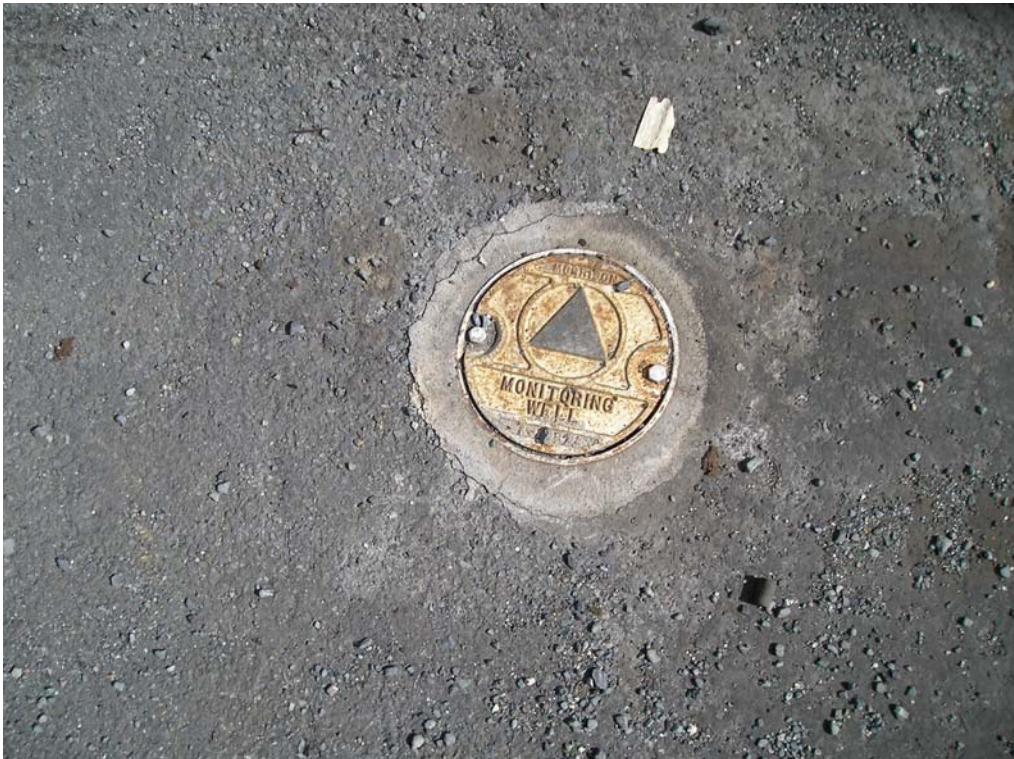
<b>Clayton Project Number</b>  85-06123.00	<b>Description</b>	Groundwater monitoring well near west corner of Unit 3	<b>Photo 92</b>
	<b>Site Name</b>	Site 3, Unit 3, Kaka'ako Waterfront Redevelopment, Honolulu, Hawaii	<b>Photo Date</b>
	<b>Client</b>	Alexander & Baldwin, Inc.	11/1/2005

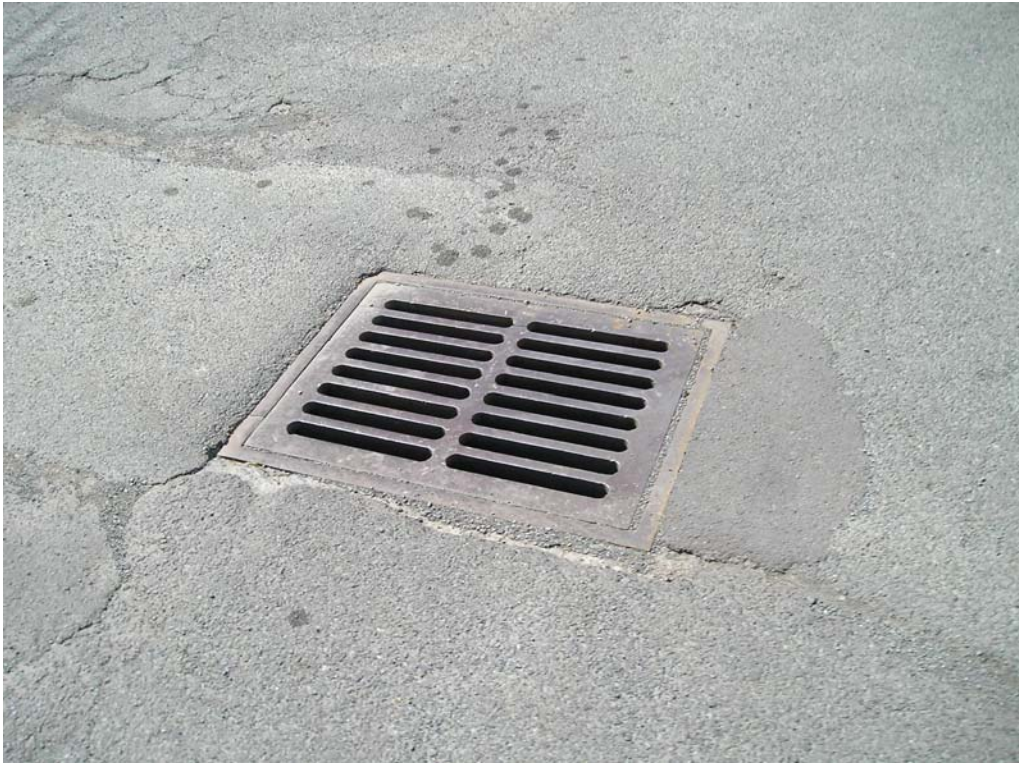
<b>Clayton Project Number</b>  85-06123.00	<b>Description</b>	Typical storm drain opening on Unit 3	<b>Photo 93</b>
	<b>Site Name</b>	Site 3, Unit 3, Kaka'ako Waterfront Redevelopment, Honolulu, Hawaii	<b>Photo Date</b>
	<b>Client</b>	Alexander & Baldwin, Inc.	11/1/2005

Storm Drain Sediments Catch Basin Sediments	Storm drains and catch basins observed throughout the subject property in proximity to current and former industrial facilities. Possible environmental impacts include metals, pesticides, and petroleum hydrocarbons of sediments within storm drain system.	<p>Perform assessment of storm drains and catch basins. Dispose of sediments according to assessment results. Document sampling, cleanup, and disposal activities.</p> <p><u>Reference:</u> Edward K. Noda (July 1999)</p>

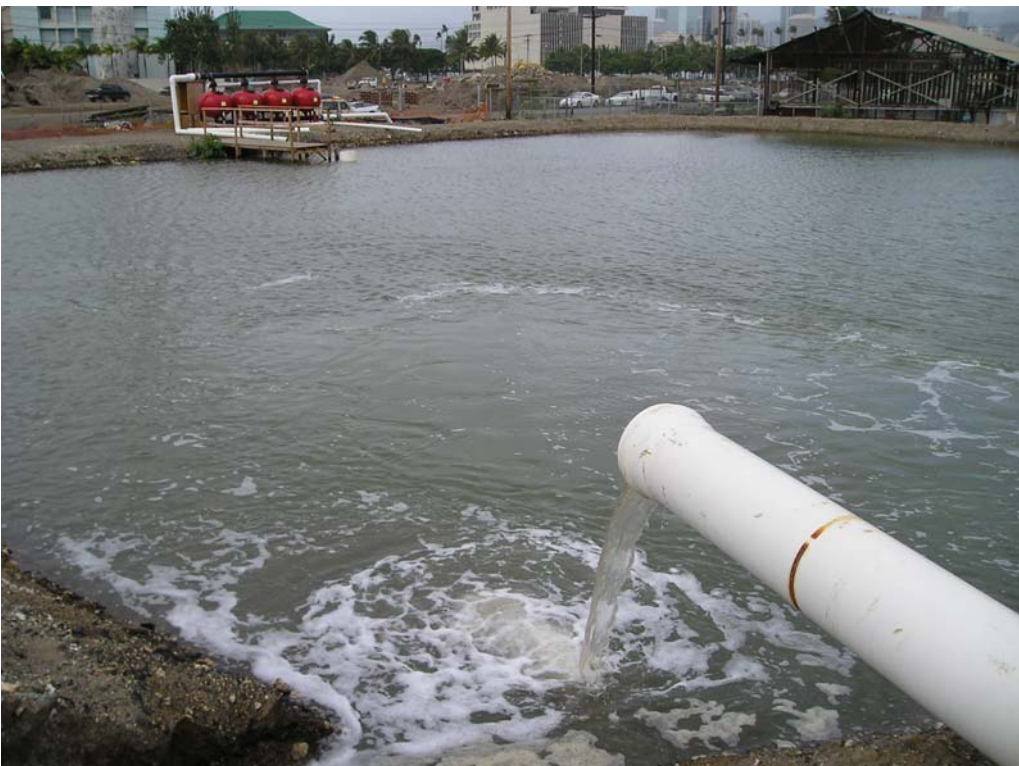
<b>Clayton Project Number</b>  85-06123.00	<b>Description</b>	Temporary reservoir (for dewatering purposes) on southeast portion of Unit 3, looking north	<b>Photo 94</b>
	<b>Site Name</b>	Site 3, Unit 3, Kaka'ako Waterfront Redevelopment, Honolulu, Hawaii	<b>Photo Date</b>
	<b>Client</b>	Alexander & Baldwin, Inc.	11/1/2005

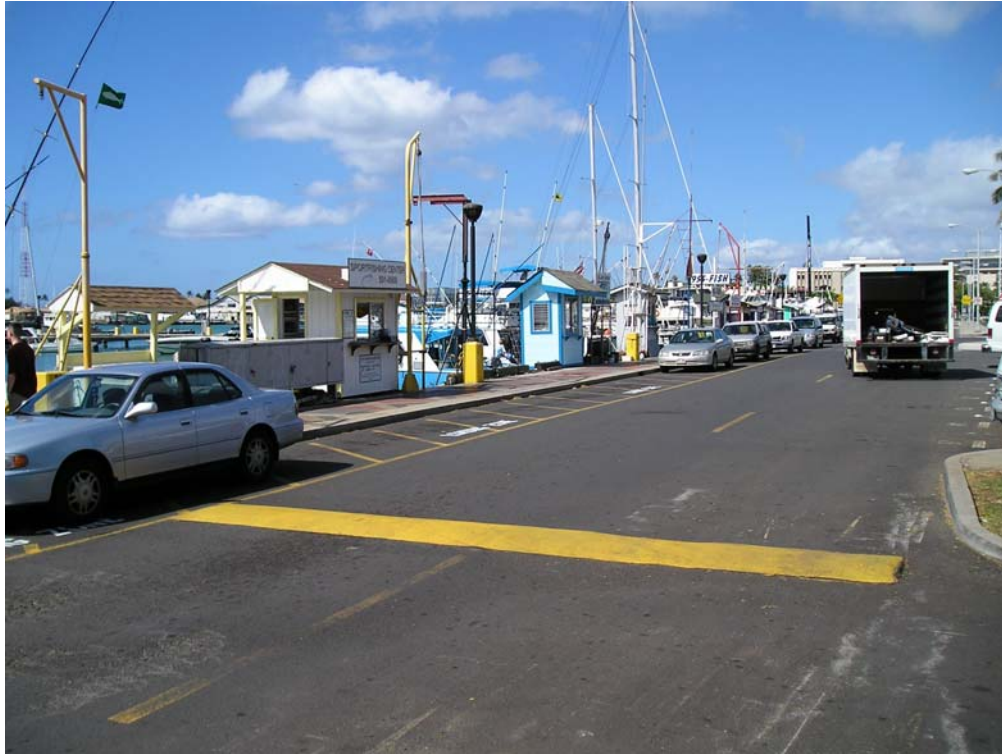
<b>Clayton Project Number</b>  85-06123.00	<b>Description</b>	View of sport fishing boat ticket booths along northeast side of Kewalo Basin on Site 4, looking west	<b>Photo 97</b>
	<b>Site Name</b>	Site 4, Kaka'ako Waterfront Redevelopment, Honolulu, Hawaii	<b>Photo Date</b>
	<b>Client</b>	Alexander & Baldwin, Inc.	11/1/2005

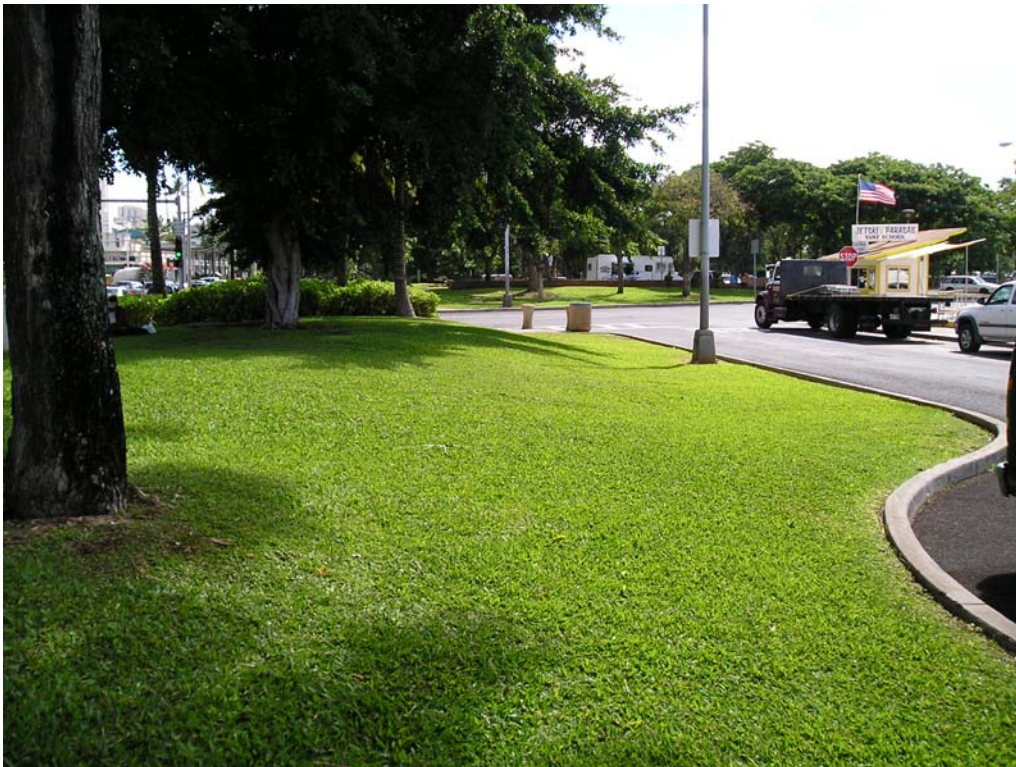
<b>Clayton Project Number</b>  85-06123.00	<b>Description</b>	East portion of Site 4 (location of former McWayne Marine Supply facility), looking southeast	<b>Photo 98</b>
	<b>Site Name</b>	Site 4, Kaka'ako Waterfront Redevelopment, Honolulu, Hawaii	<b>Photo Date</b>
	<b>Client</b>	Alexander & Baldwin, Inc.	11/1/2005

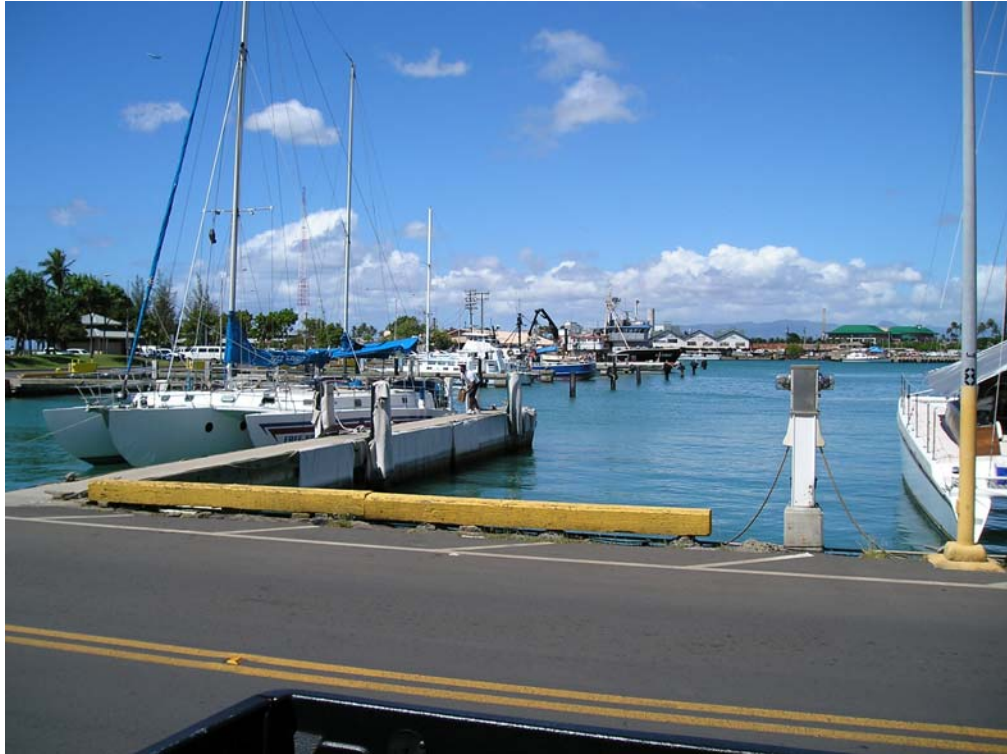
<b>Clayton Project Number</b>  85-06123.00	<b>Description</b>	View of Kewalo Basin boat harbor (submerged lands) adjacent to Site 4, looking northwest	<b>Photo 99</b>
	<b>Site Name</b>	Site 4, Kaka'ako Waterfront Redevelopment, Honolulu, Hawaii	<b>Photo Date</b>
	<b>Client</b>	Alexander & Baldwin, Inc.	11/1/2005

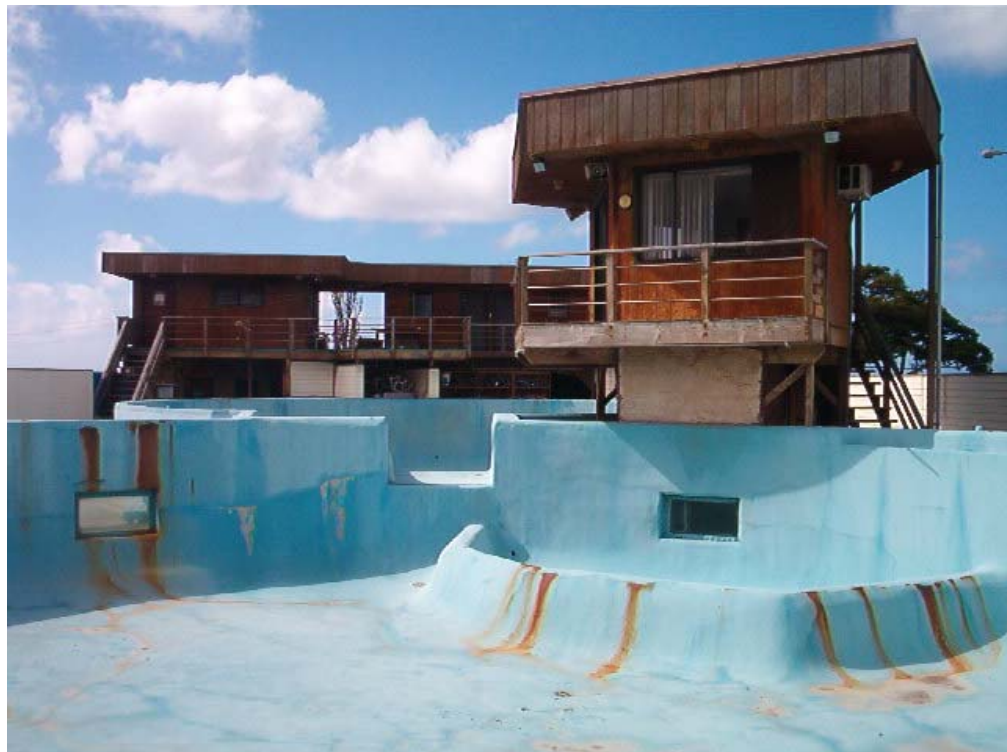
<b>Clayton Project Number</b>  85-06123.00	<b>Description</b>	Dolphin pools with observation deck at Mammal Lab facility on southeast portion of Site 4 (Unit 10)	<b>Photo 100</b>
	<b>Site Name</b>	Site 4, Kaka'ako Waterfront Redevelopment, Honolulu, Hawaii	<b>Photo Date</b>
	<b>Client</b>	Alexander & Baldwin, Inc.	11/1/2005

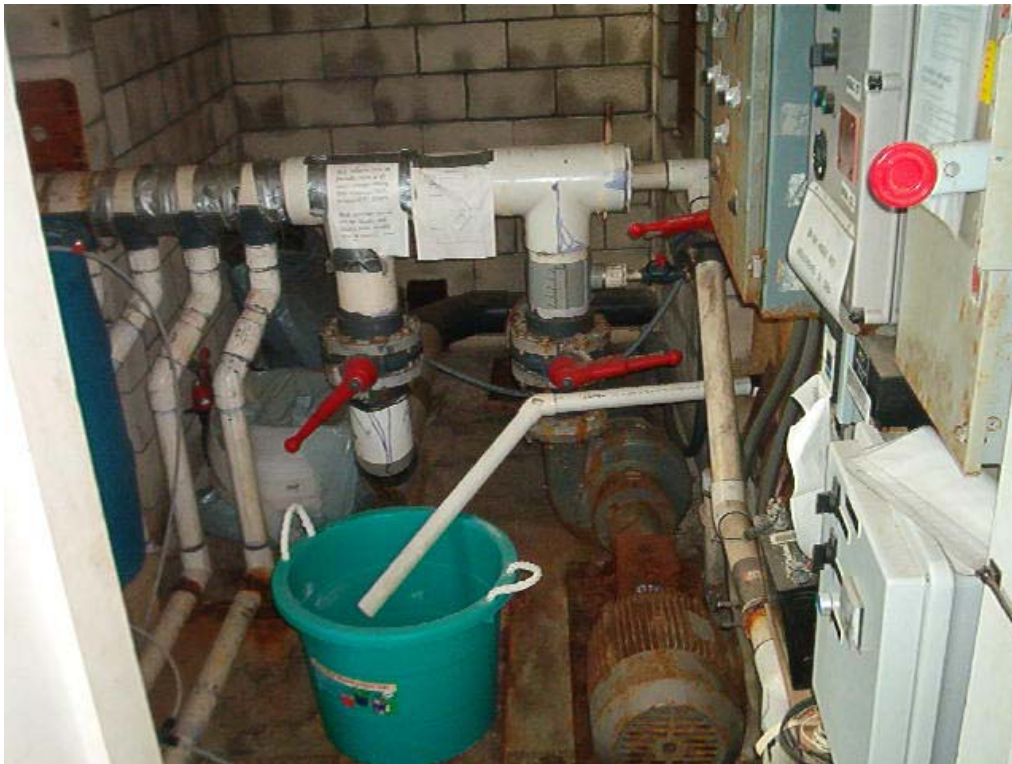
<b>Clayton Project Number</b>  85-06123.00	<b>Description</b>	Pool pump room at Mammal Lab facility on southeast portion of Site 4 (Unit 10)	<b>Photo 101</b>
	<b>Site Name</b>	Site 4, Kaka'ako Waterfront Redevelopment, Honolulu, Hawaii	<b>Photo Date</b>
	<b>Client</b>	Alexander & Baldwin, Inc.	11/1/2005

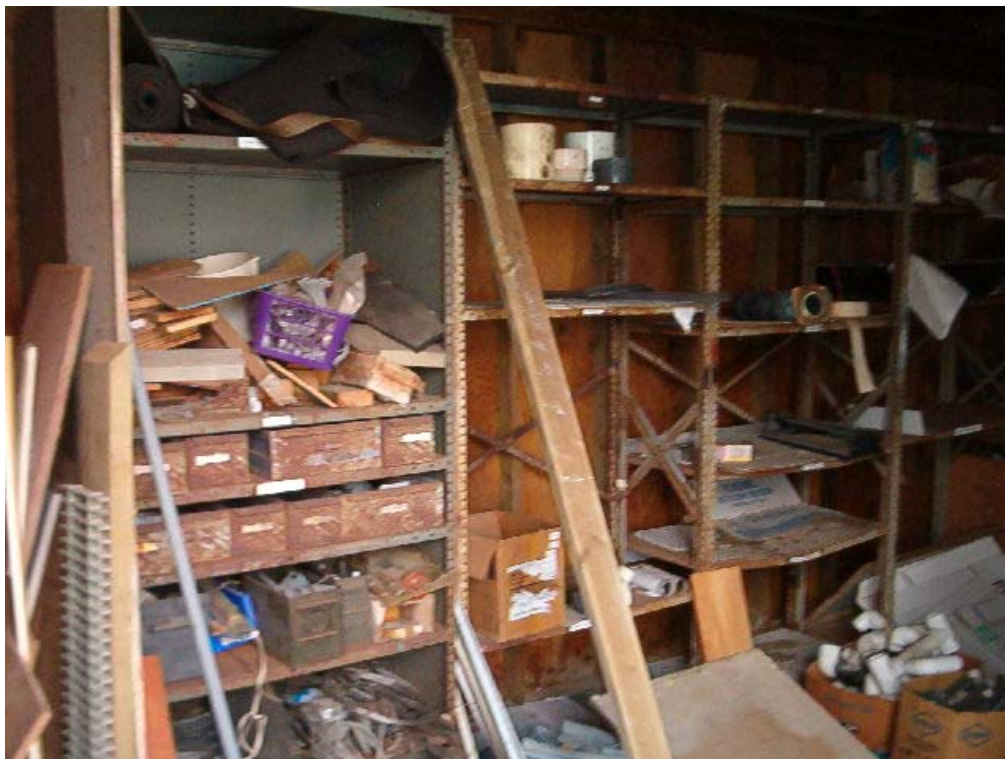
<b>Clayton Project Number</b>  85-06123.00	<b>Description</b>	Tool shed at Mammal Lab facility on southeast portion of Site 4 (Unit 10)	<b>Photo 102</b>
	<b>Site Name</b>	Site 4, Kaka'ako Waterfront Redevelopment, Honolulu, Hawaii	<b>Photo Date</b>
	<b>Client</b>	Alexander & Baldwin, Inc.	11/1/2005

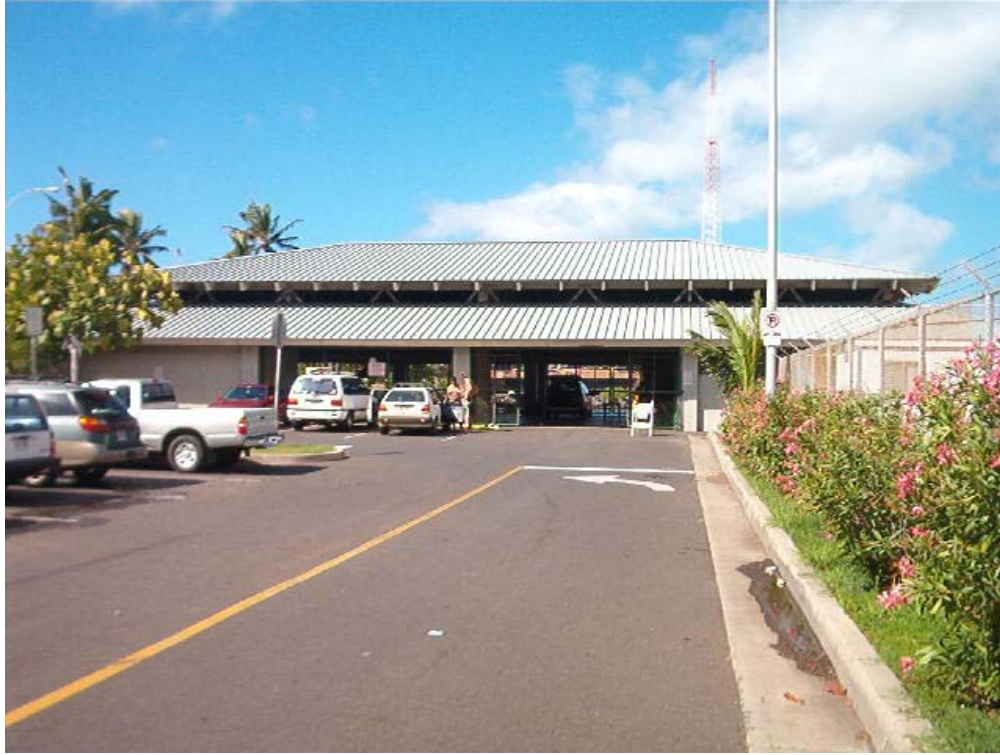
<b>Clayton Project Number</b>  85-06123.00	<b>Description</b>	View of State of Hawaii Net Shed on southwest portion of Site 4	<b>Photo 103</b>
	<b>Site Name</b>	Site 4, Kaka'ako Waterfront Redevelopment, Honolulu, Hawaii	<b>Photo Date</b>
	<b>Client</b>	Alexander & Baldwin, Inc.	11/1/2005

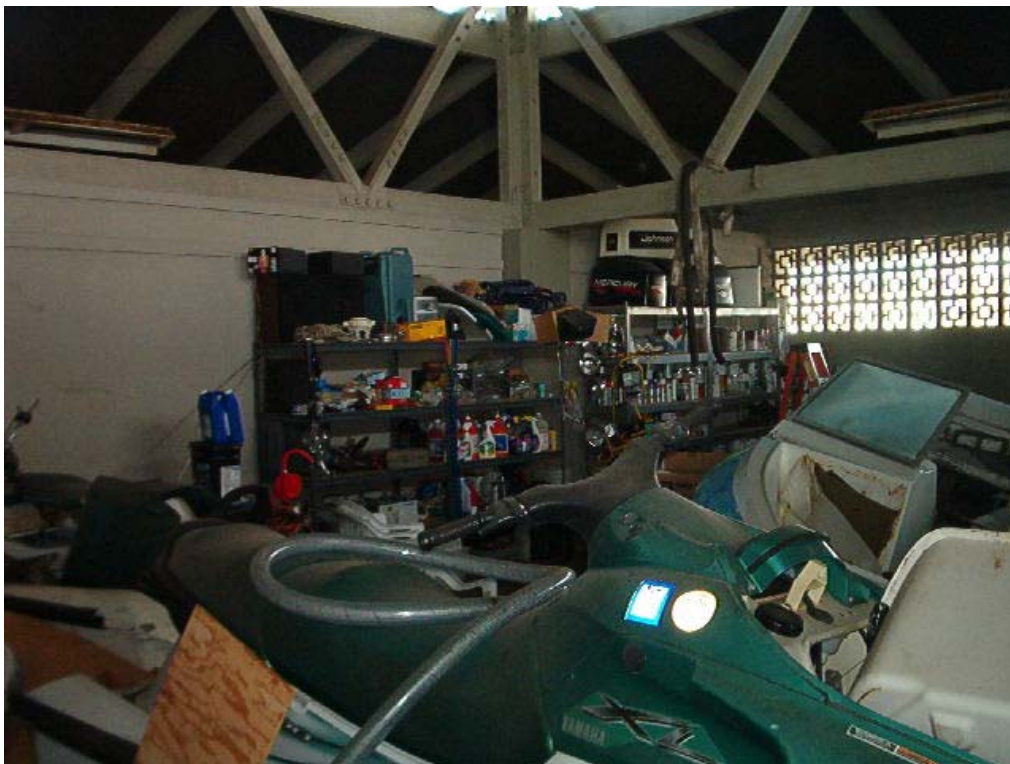
<b>Clayton Project Number</b>  85-06123.00	<b>Description</b>	Fenced-in storage area inside State of Hawaii Net Shed on southwest portion of Site 4	<b>Photo 104</b>
	<b>Site Name</b>	Site 4, Kaka'ako Waterfront Redevelopment, Honolulu, Hawaii	<b>Photo Date</b>
	<b>Client</b>	Alexander & Baldwin, Inc.	11/1/2005

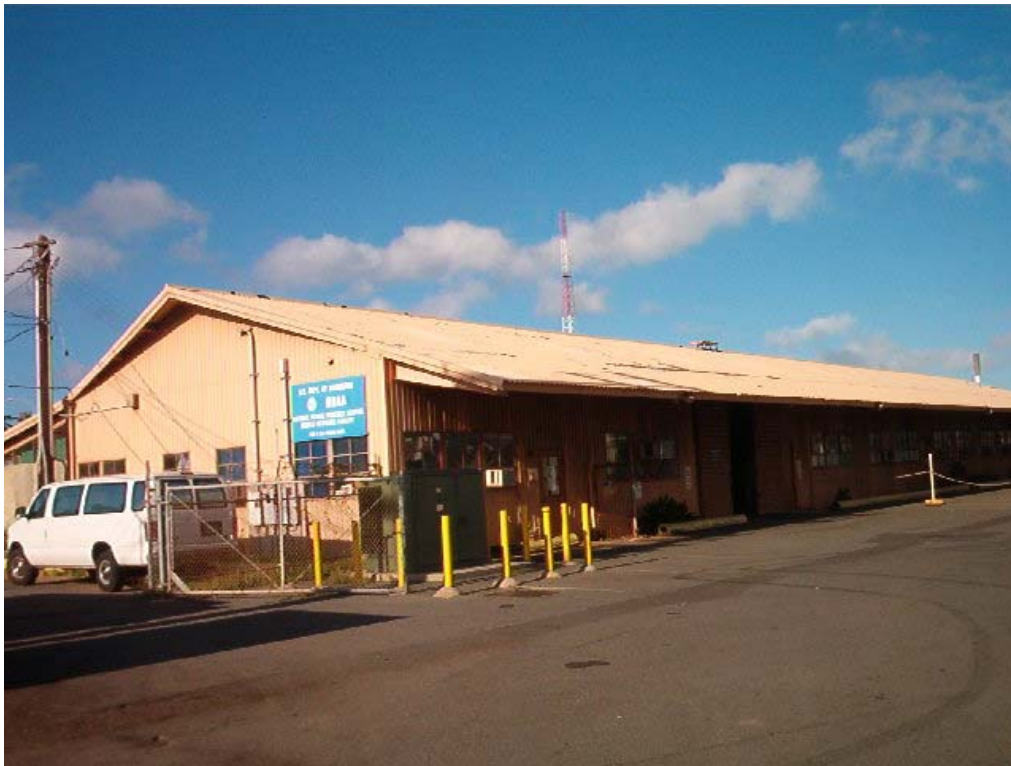
<b>Clayton Project Number</b>  85-06123.00	<b>Description</b>	Main building at NOAA facility on southwest portion of Site 4, looking west	<b>Photo 105</b>
	<b>Site Name</b>	Site 4, Kaka'ako Waterfront Redevelopment, Honolulu, Hawaii	<b>Photo Date</b>
	<b>Client</b>	Alexander & Baldwin, Inc.	11/1/2005

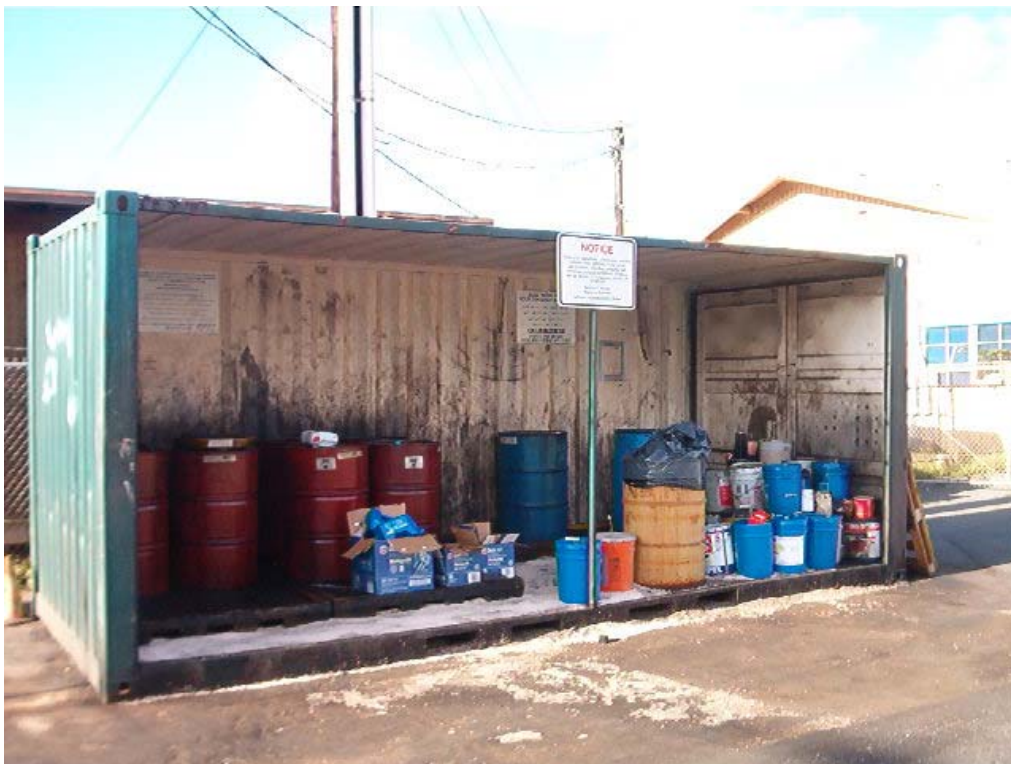
<b>Clayton Project Number</b>  85-06123.00	<b>Description</b>	DOT drum storage container on east portion of NOAA facility	<b>Photo 106</b>
	<b>Site Name</b>	Site 4, Kaka'ako Waterfront Redevelopment, Honolulu, Hawaii	<b>Photo Date</b>
	<b>Client</b>	Alexander & Baldwin, Inc.	11/1/2005

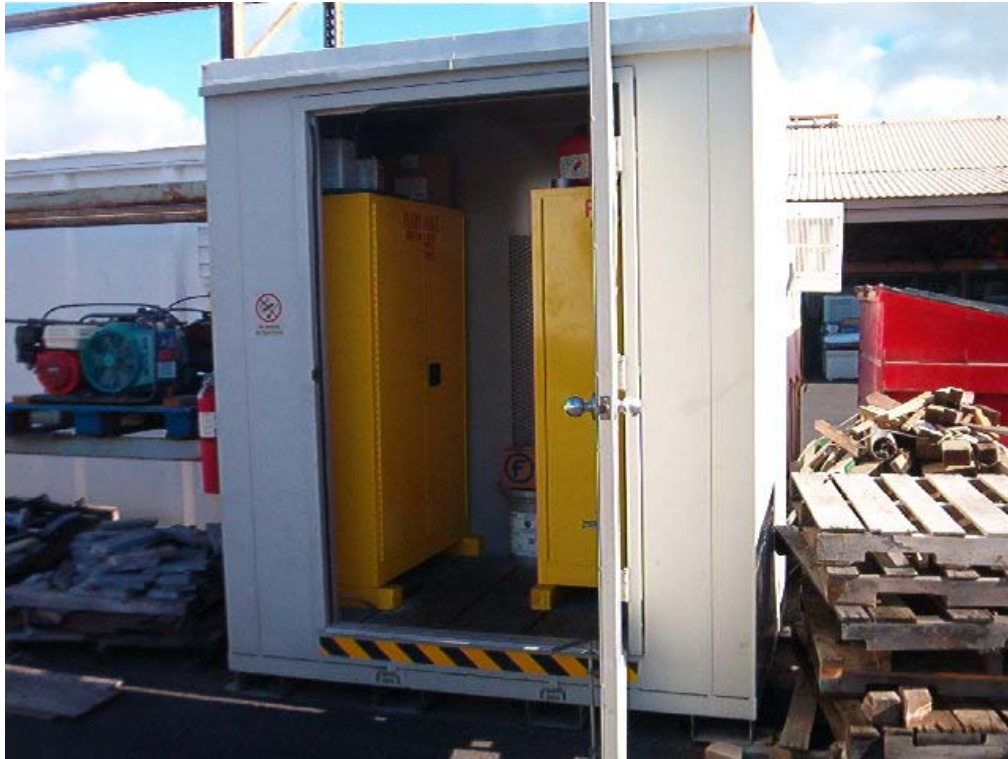
<b>Clayton Project Number</b>  85-06123.00	<b>Description</b>	One of two hazardous materials storage sheds on southwest portion of NOAA facility	<b>Photo 107</b>
	<b>Site Name</b>	Site 4, Kaka'ako Waterfront Redevelopment, Honolulu, Hawaii	<b>Photo Date</b>
	<b>Client</b>	Alexander & Baldwin, Inc.	11/1/2005

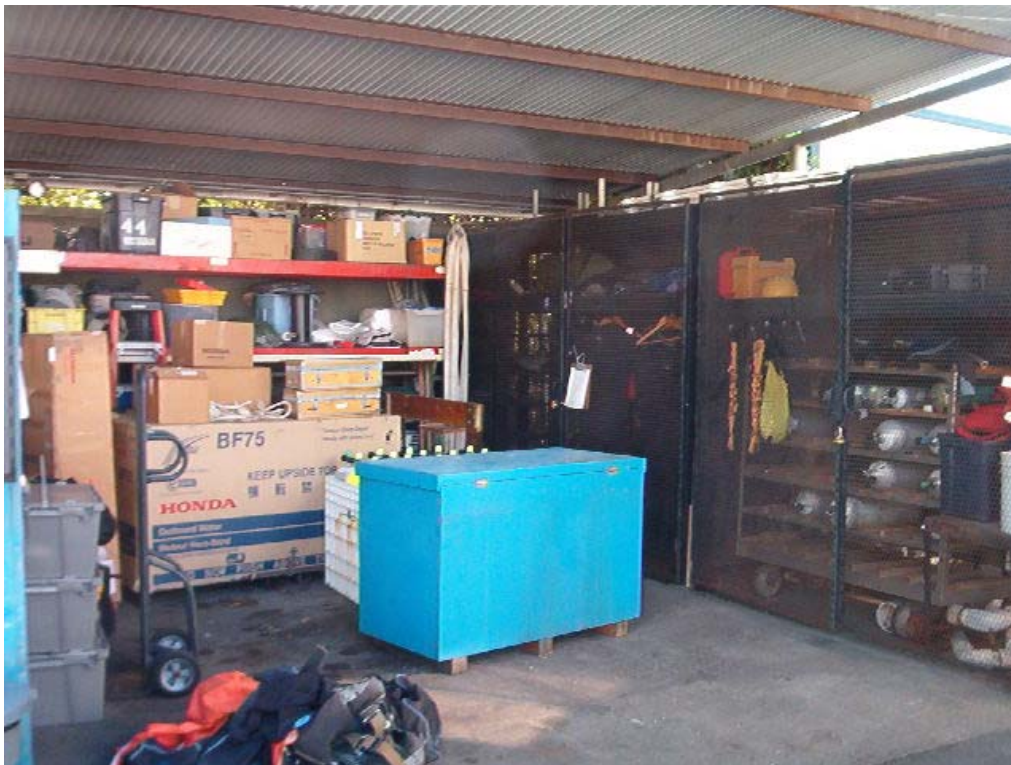
<b>Clayton Project Number</b>  85-06123.00	<b>Description</b>	Open-sided storage shelter on southwest portion of NOAA facility	<b>Photo 108</b>
	<b>Site Name</b>	Site 4, Kaka'ako Waterfront Redevelopment, Honolulu, Hawaii	<b>Photo Date</b>
	<b>Client</b>	Alexander & Baldwin, Inc.	11/1/2005

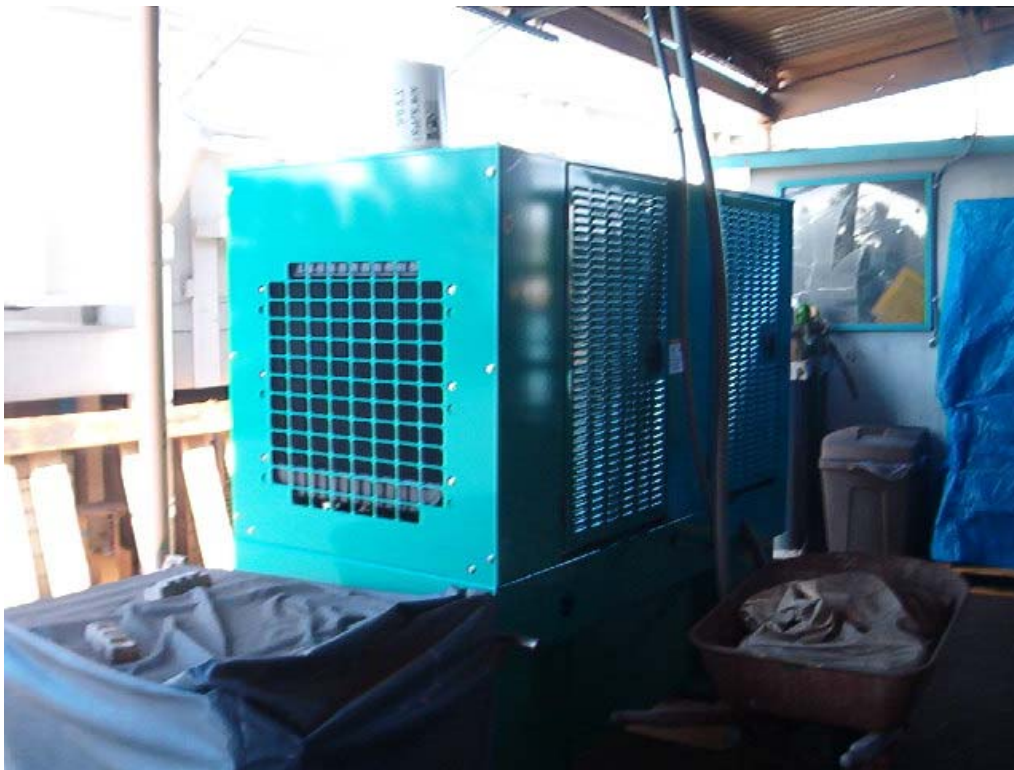
<b>Clayton Project Number</b>  85-06123.00	<b>Description</b>	Emergency generator on southwest side of NOAA building	<b>Photo 109</b>
	<b>Site Name</b>	Site 4, Kaka'ako Waterfront Redevelopment, Honolulu, Hawaii	<b>Photo Date</b>
	<b>Client</b>	Alexander & Baldwin, Inc.	11/1/2005

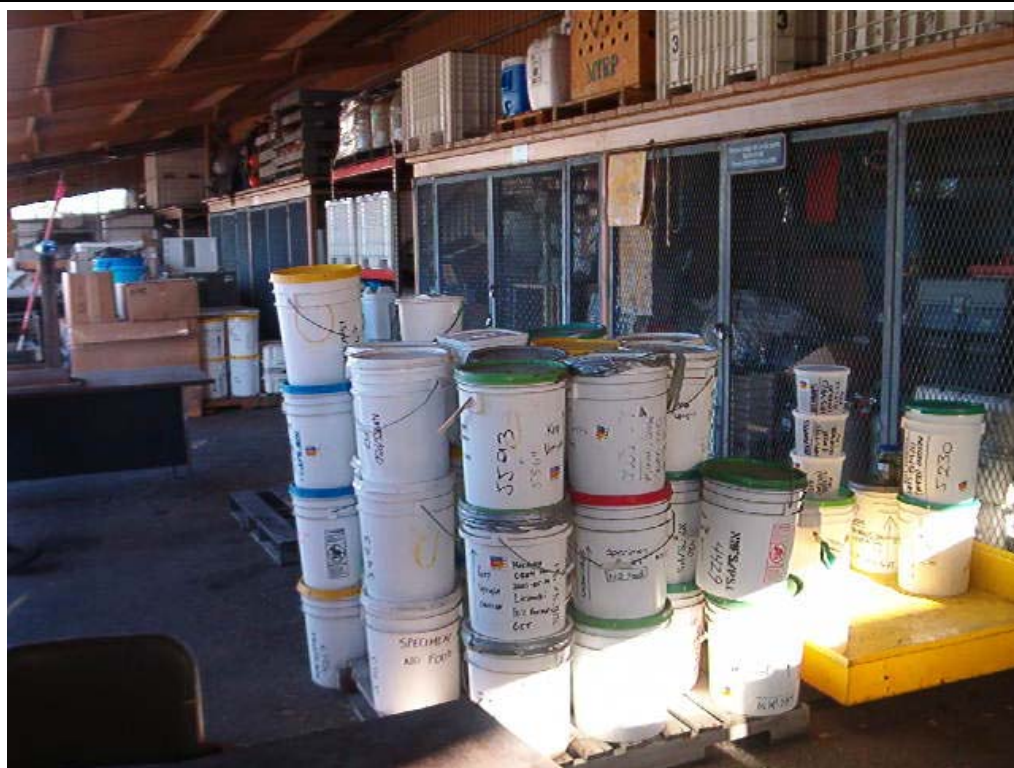
<b>Clayton Project Number</b>  85-06123.00	<b>Description</b>	Buckets of marine animal tissue samples (in formalin) stored on southwest side of NOAA building	<b>Photo 110</b>
	<b>Site Name</b>	Site 4, Kaka'ako Waterfront Redevelopment, Honolulu, Hawaii	<b>Photo Date</b>
	<b>Client</b>	Alexander & Baldwin, Inc.	11/1/2005

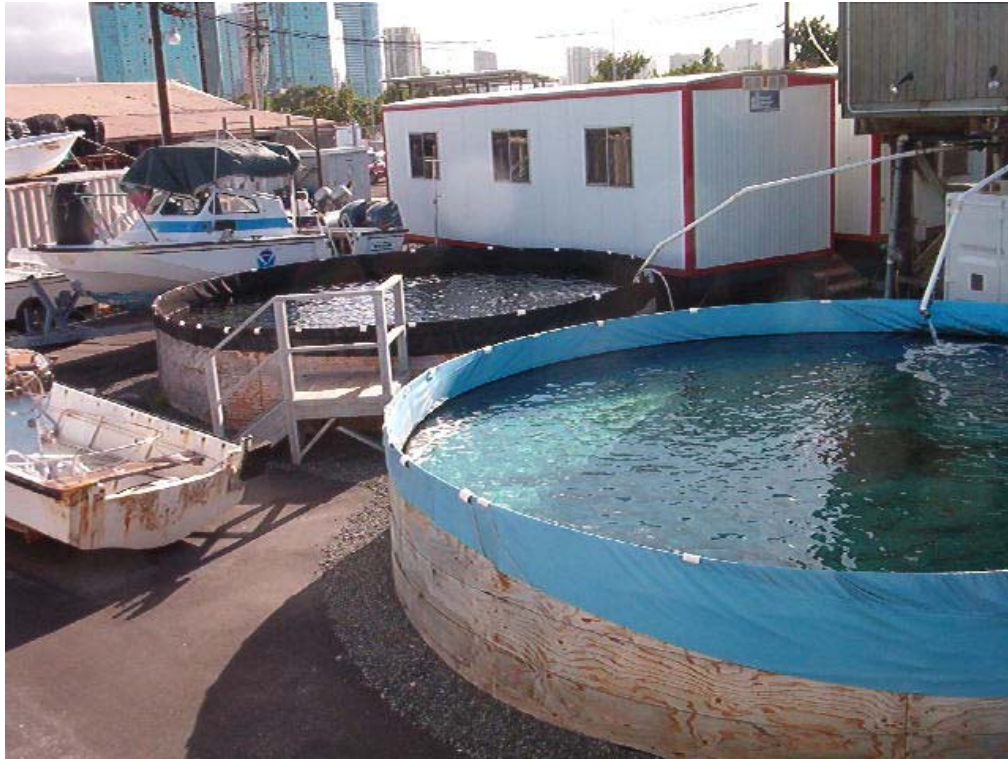
<b>Clayton Project Number</b>  85-06123.00	<b>Description</b>	Marine animal pools and office trailers on southwest portion of NOAA facility	<b>Photo 111</b>
	<b>Site Name</b>	Site 4, Kaka'ako Waterfront Redevelopment, Honolulu, Hawaii	<b>Photo Date</b>
	<b>Client</b>	Alexander & Baldwin, Inc.	11/1/2005

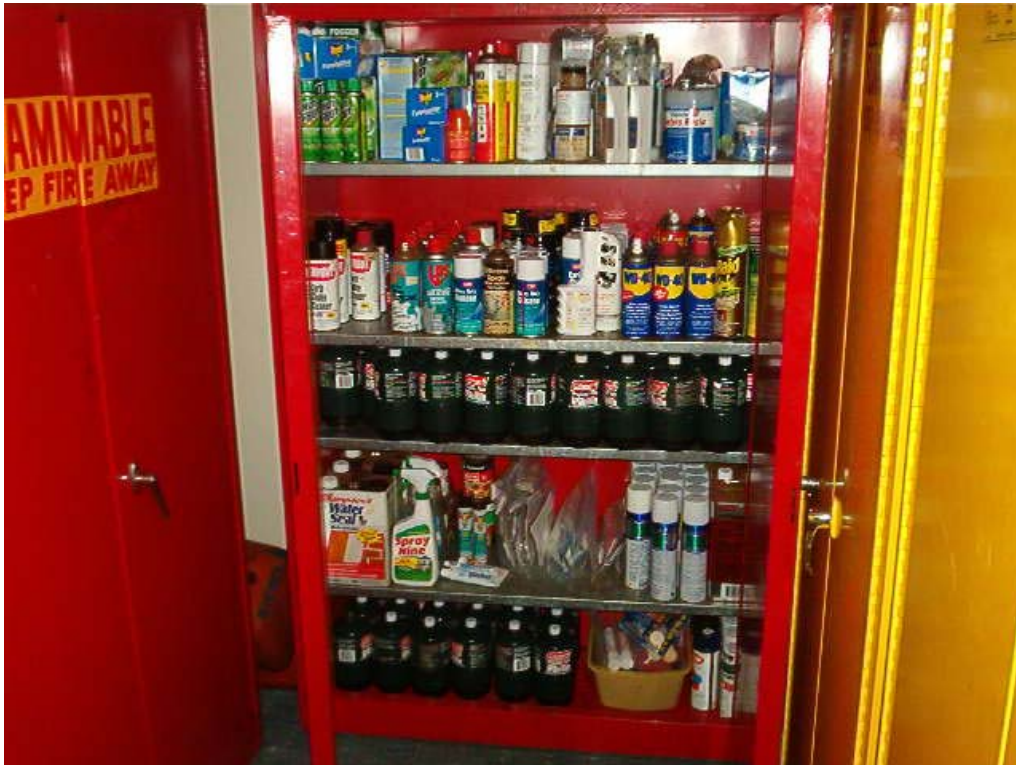
<b>Clayton Project Number</b>  85-06123.00	<b>Description</b>	Flammable storage cabinets inside main NOAA building	<b>Photo 112</b>
	<b>Site Name</b>	Site 4, Kaka'ako Waterfront Redevelopment, Honolulu, Hawaii	<b>Photo Date</b>
	<b>Client</b>	Alexander & Baldwin, Inc.	11/1/2005

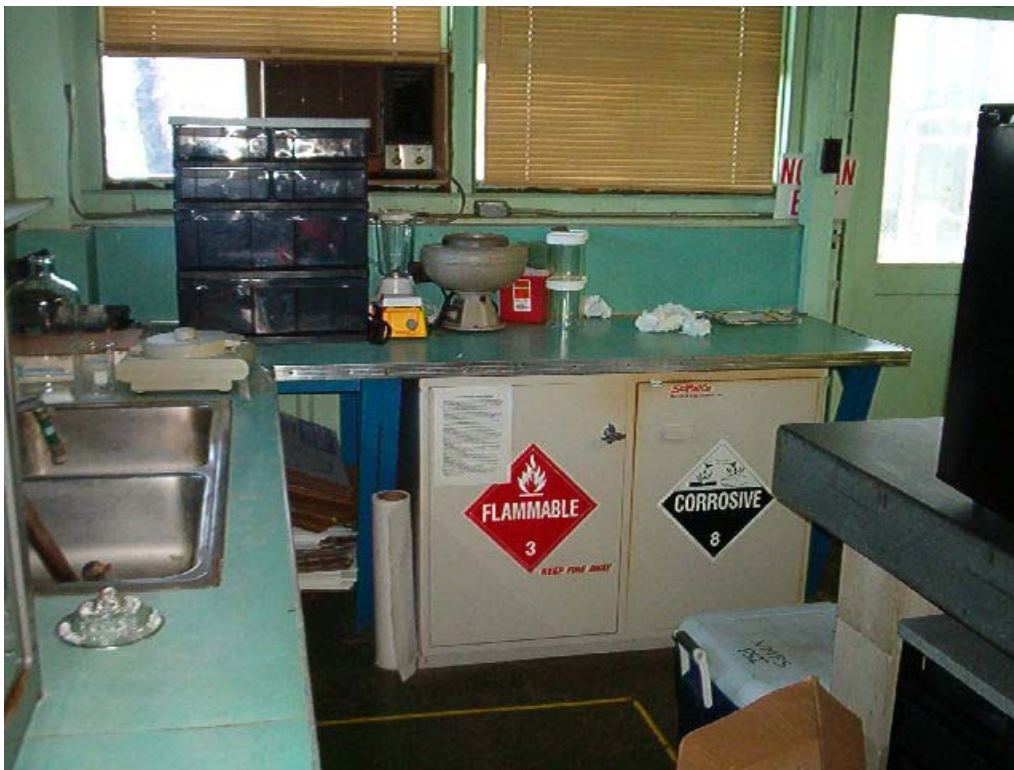
<b>Clayton Project Number</b>  85-06123.00	<b>Description</b>	Laboratory with flammable/corrosive chemical storage cabinets inside main NOAA building	<b>Photo 113</b>
	<b>Site Name</b>	Site 4, Kaka'ako Waterfront Redevelopment, Honolulu, Hawaii	<b>Photo Date</b>
	<b>Client</b>	Alexander & Baldwin, Inc.	11/1/2005

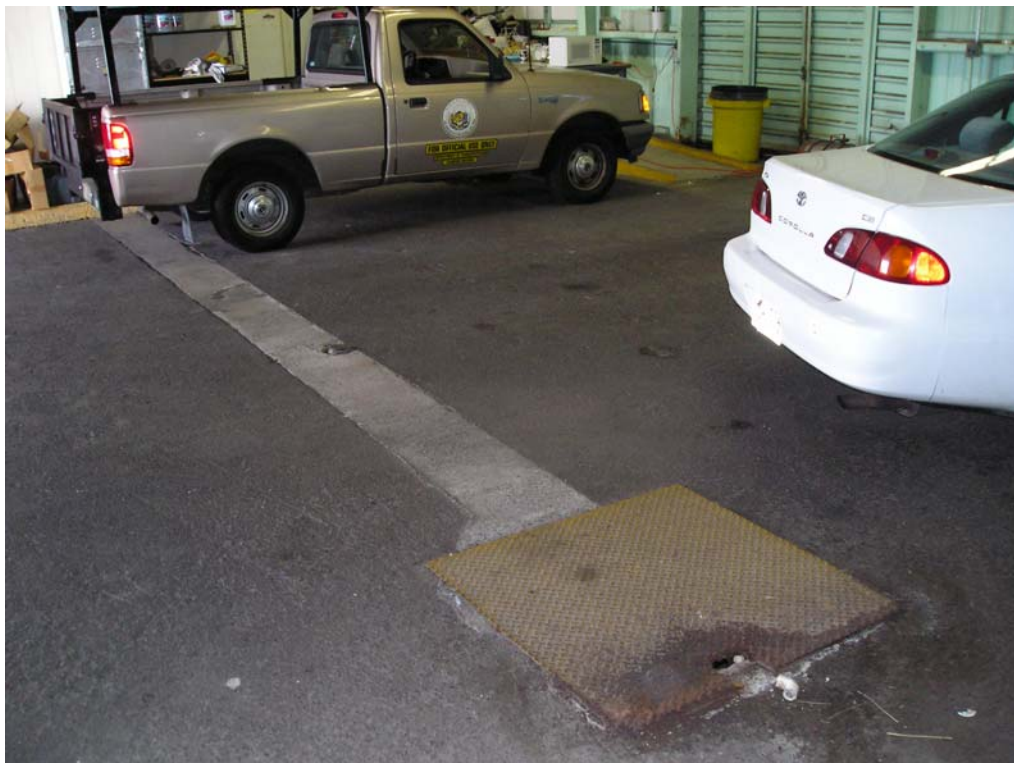
<b>Clayton Project Number</b>  85-06123.00	<b>Description</b>	DOT Harbors space inside main NOAA building, with seawater valve/pipeline in floor	<b>Photo 114</b>
	<b>Site Name</b>	Site 4, Kaka'ako Waterfront Redevelopment, Honolulu, Hawaii	<b>Photo Date</b>
	<b>Client</b>	Alexander & Baldwin, Inc.	11/1/2005
