# ***Phase I Environmental Site Assessment***

## **Kaka'ako Waterfront Redevelopment Property Honolulu, Oahu, Hawaii**

January 23, 2006  
Clayton Project No. 85-06123.00

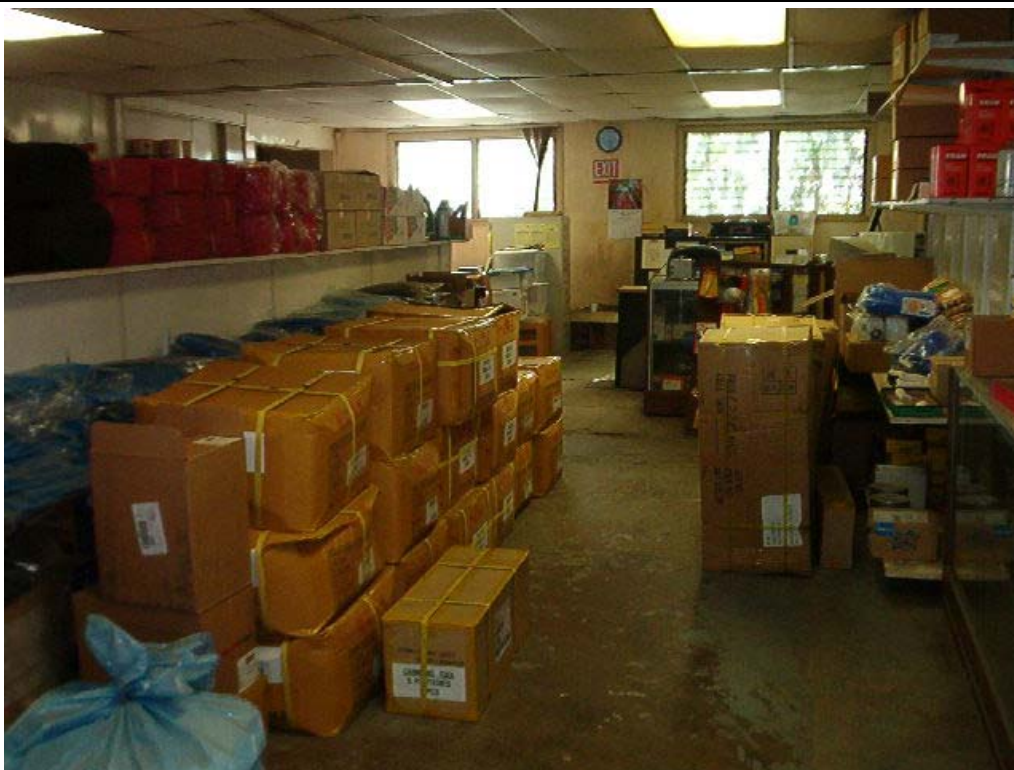
<b>Clayton Project Number</b>  85-06123.00	<b>Description</b>	Aloha Fishing Supply business in building along southeast side of NOAA facility	<b>Photo 115</b>
	<b>Site Name</b>	Site 4, Kaka'ako Waterfront Redevelopment, Honolulu, Hawaii	<b>Photo Date</b>
	<b>Client</b>	Alexander & Baldwin, Inc.	11/1/2005

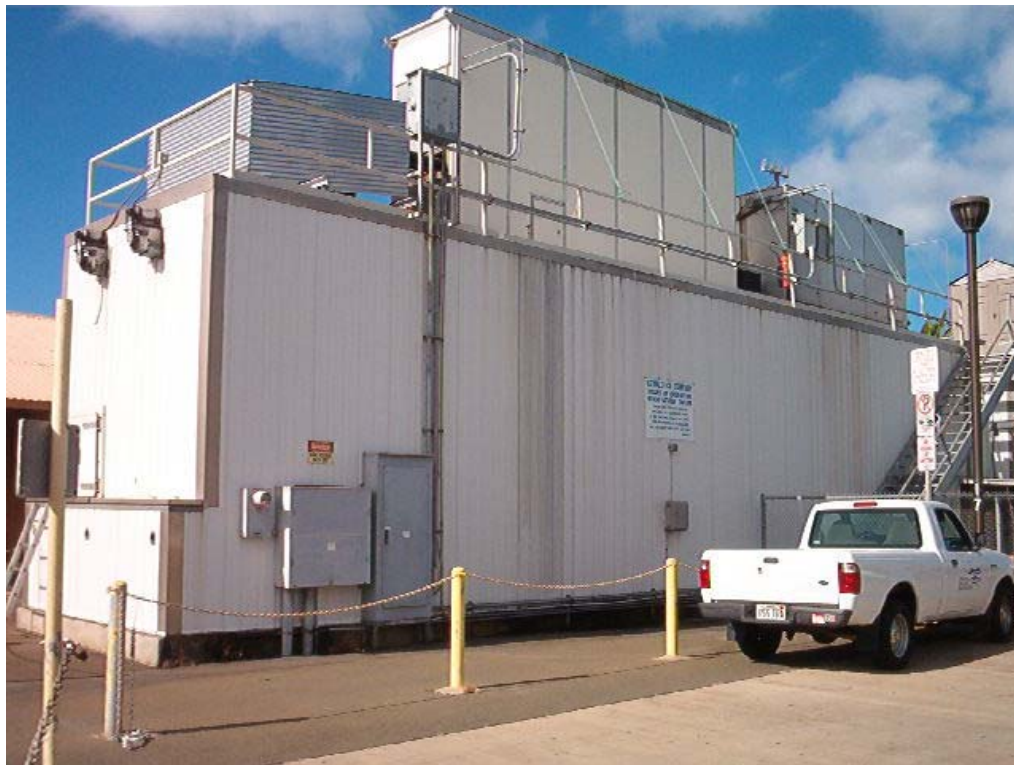
<b>Clayton Project Number</b>  85-06123.00	<b>Description</b>	Kewalo Ice Company structure on northeast side of NOAA facility	<b>Photo 116</b>
	<b>Site Name</b>	Site 4, Kaka'ako Waterfront Redevelopment, Honolulu, Hawaii	<b>Photo Date</b>
	<b>Client</b>	Alexander & Baldwin, Inc.	11/1/2005
