**UNDERGROUND STORAGE TANK CLOSURE
AND RELEASE RESPONSE REPORT**

**400 Keawe Street
Honolulu, Oahu, Hawaii
HEER Case No. 20150218-1515**

ETC Project No. 14-2021

May 2015

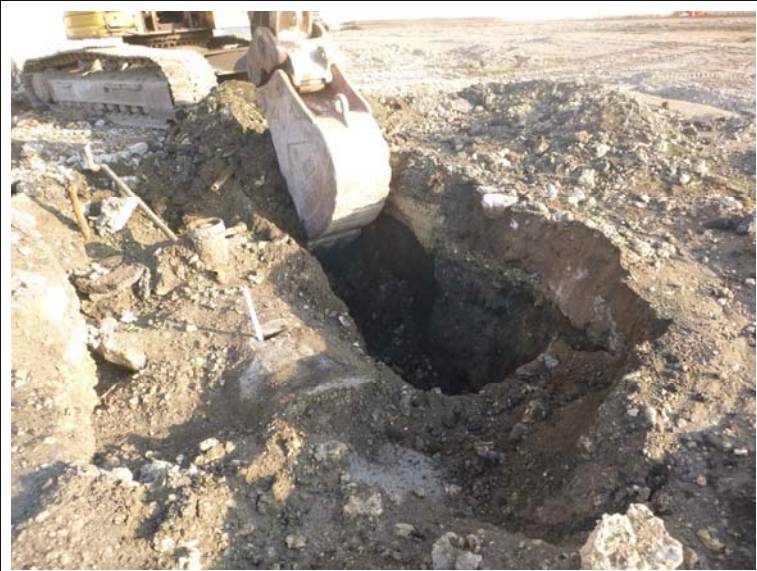
Photograph 1: Initial excavation activities of 500-gallon UST.

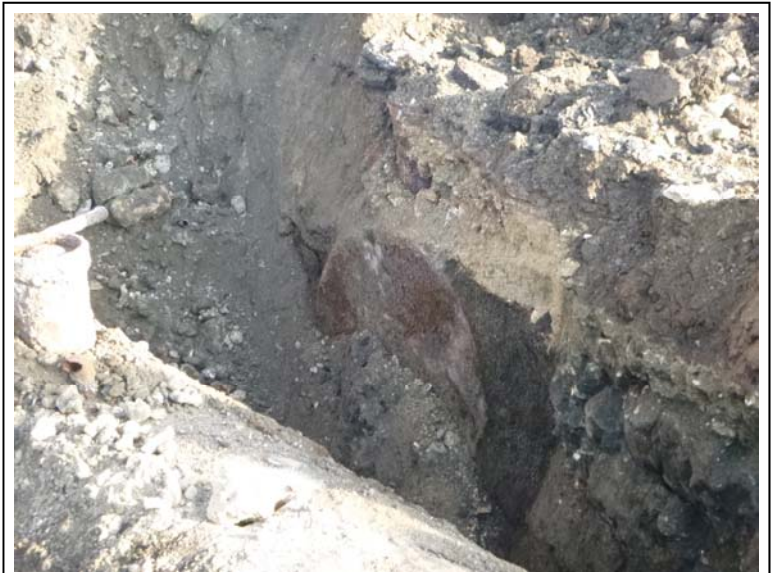
Photograph 2: View of 245-gallon UST discovered in the excavation wall.

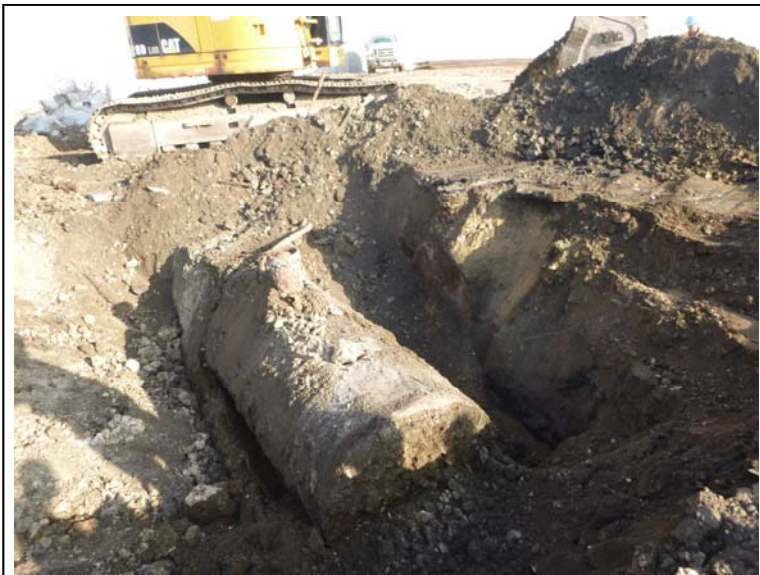
Photograph 3: View of the 500-gallon UST prior to removal.

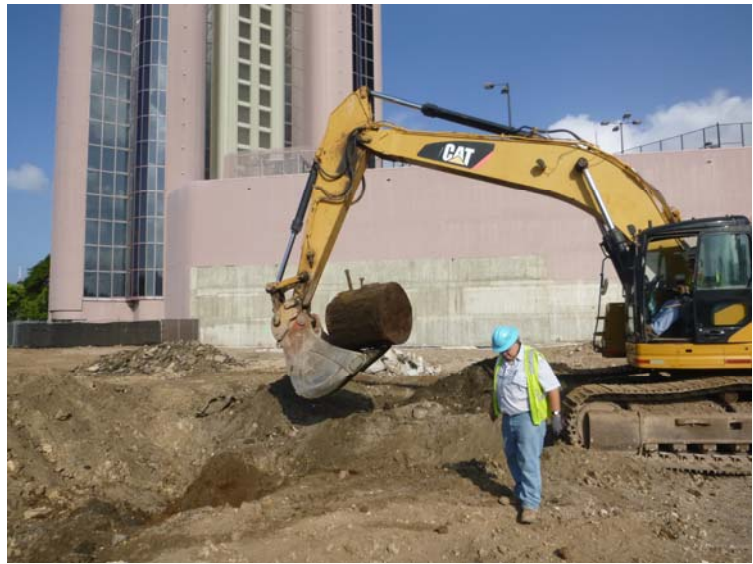
Photograph 4: 245-gallon UST being removed from excavation.

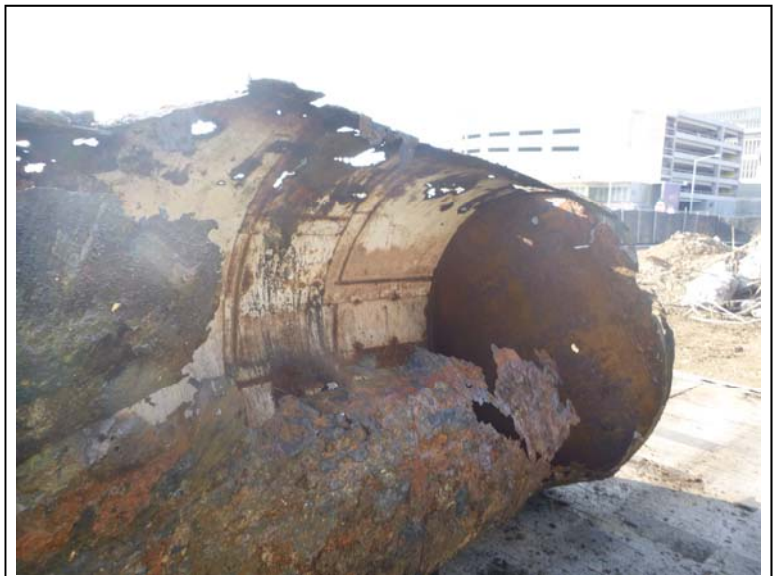
Observations made during excavation of the 500-gallon UST indicated the presence of a petroleum release. Petroleum stained soil was noted at the depths of approximately 5.5 feet bgs and a slight petroleum sheen was observed on the groundwater seeping into the UST excavation at a depth of approximately 6 feet bgs. A petroleum odor could also be detected emanating from the stained soils. The bottom of the UST appeared to be heavily corroded and during removal, it was confirmed that the tank bottom was completely corroded.

While excavating soil on the sides of the UST, indications of a petroleum release were observed. A strong petroleum odor and gray stained soil were noted near the bottom of the UST. Closer examination of the UST indicated that the bottom of the tank was heavily corroded and that groundwater encountered in the excavation had a slight petroleum sheen. Removal of the tank from the excavation confirmed that the bottom of the UST was completely corroded through. Measurements from the 500-gallon UST indicated a diameter of approximately 3.5 feet and a length of approximately 7 feet. The tank shell was placed on HIS's trailer pending transportation off-site.

Photograph 5: Bottom of 500-gallon UST following removal - completely corroded.

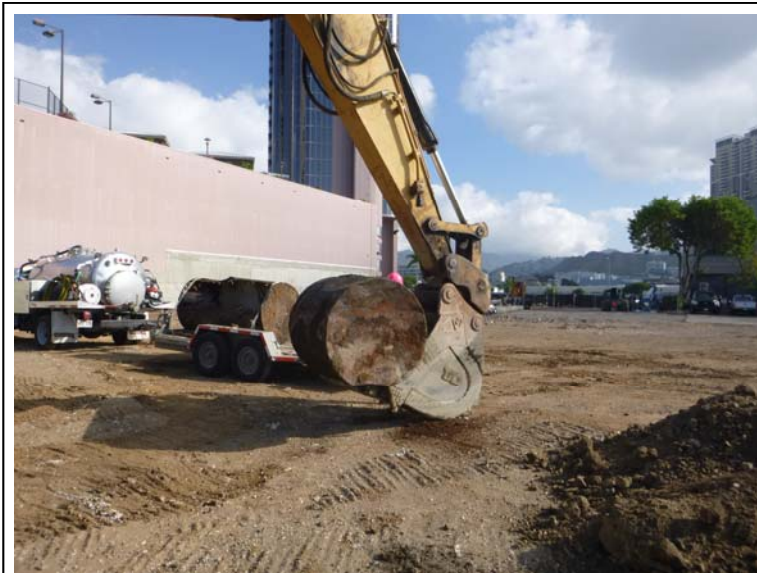
Photograph 6: View of 245-gallon UST being placed on HIS' trailer.

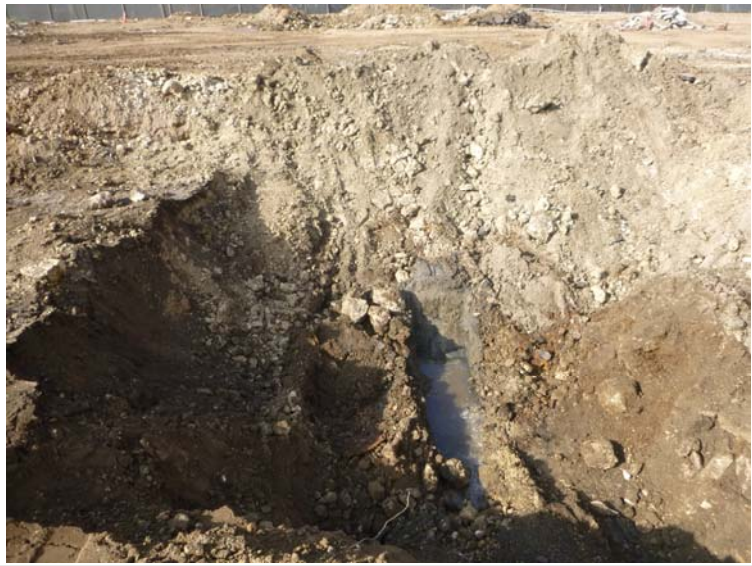
Photograph 7: View of the eastern excavation wall following UST removal.

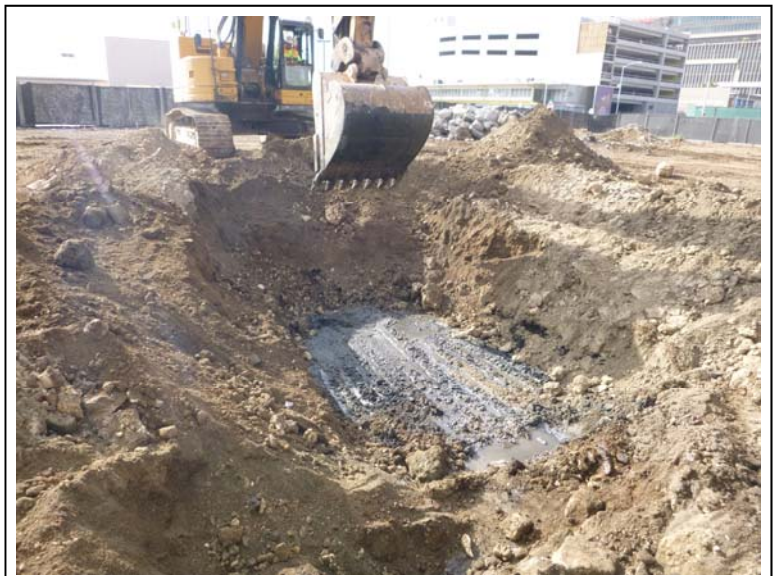
Photograph 8: View of existing soil at beginning of over-excavation activities.

ETC personnel directed CJ Peterson Services operator to start over-excavation of petroleum-impacted soil. In general, the top 5 feet of soil was placed adjacent to the excavation area as “clean” soil since visual and olfactory observations did not indicate the presence of petroleum impacts. Soil from a depth of approximately 5 feet to 6.5 feet bgs was excavated and designated as petroleum contaminated soil. Excavation to depths greater than 6.5 feet bgs was not feasible due to the presence of a consolidated coral “shelf” that could not be readily removed by the excavator. Groundwater was present at a depth of approximately 6- to 6.5-feet bgs.

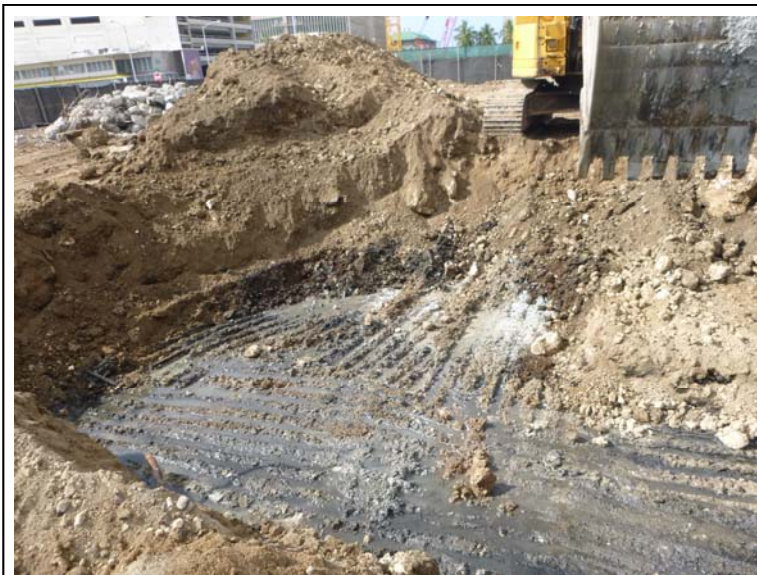
Photograph 9: View of south and east walls.

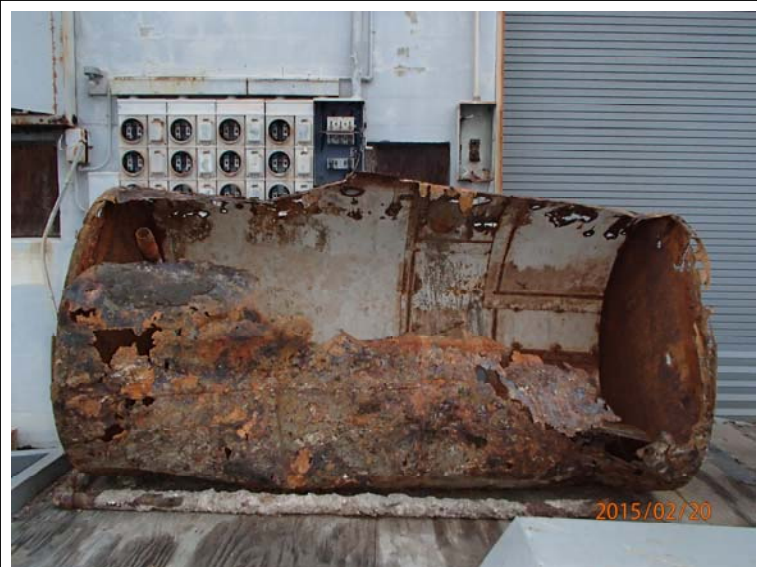
Photograph 10: 500-gallon UST in poor condition.

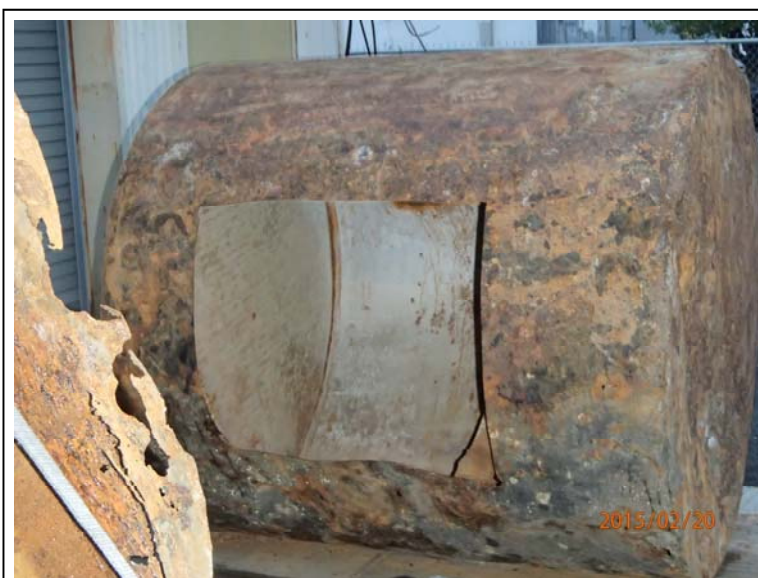
Photograph 11: Access way cut into 245-gallon UST for cleaning activities.

HIS personnel transported the two USTs to their warehouse in Honolulu. The interior of the tanks were inspected and it was noted that there were no visual indications of petroleum or any petroleum odors. The interior of the tanks were wiped down using petroleum absorbent pads and the used absorbent pads were disposed as solid waste. The tanks were then transported to Schnitzer Steel Hawaii Corporation in Kapolei for metal reclamation.

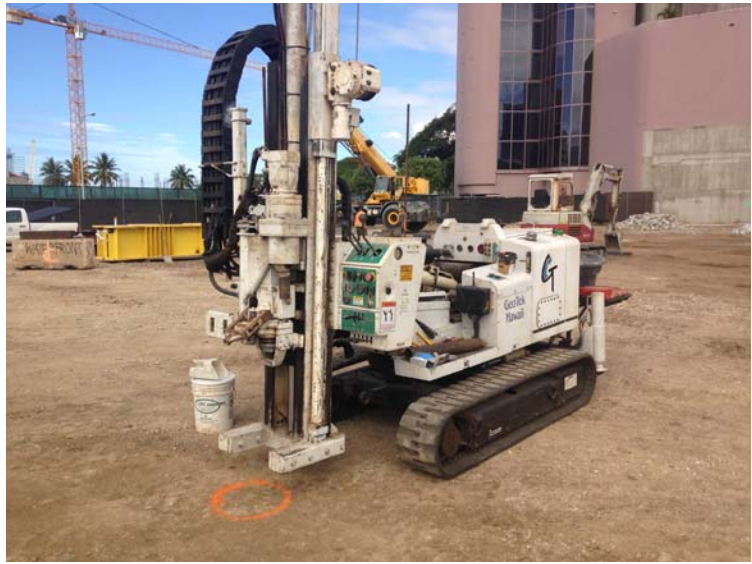
Photograph 12: Installation of temporary monitoring wells.

In order to assess potential petroleum impacts to the groundwater, ETC contracted GTH to install three temporary, 1.5-inch diameter PVC monitoring wells. On February 26, 2015, GTH installed one monitoring well (MW1) in the general area where the 500-gallon UST was located. The two remaining monitoring wells (MW2 and MW3) were installed at the downgradient limits of the final excavation. Each monitoring well was set at 13 feet bgs and was constructed of 10 feet of screen and 3 feet of solid riser. Sand was placed around each well to ground surface.

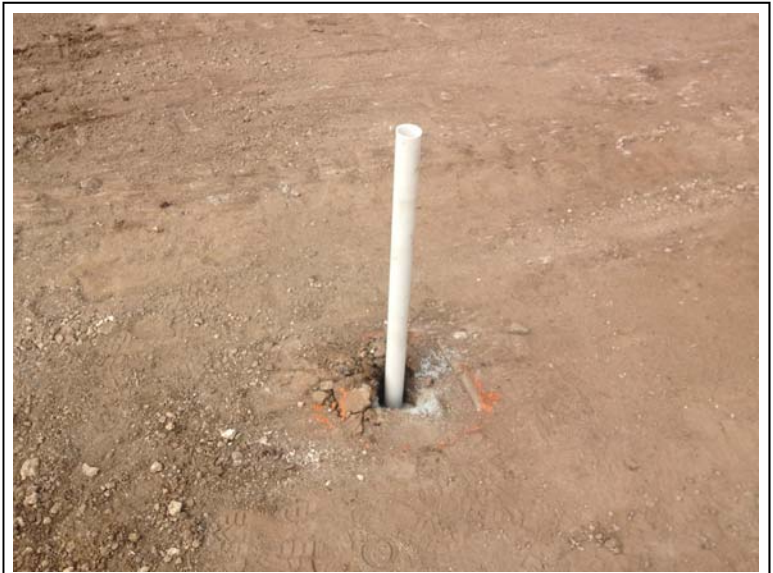
Photograph 13: Temporary monitoring well MW2.

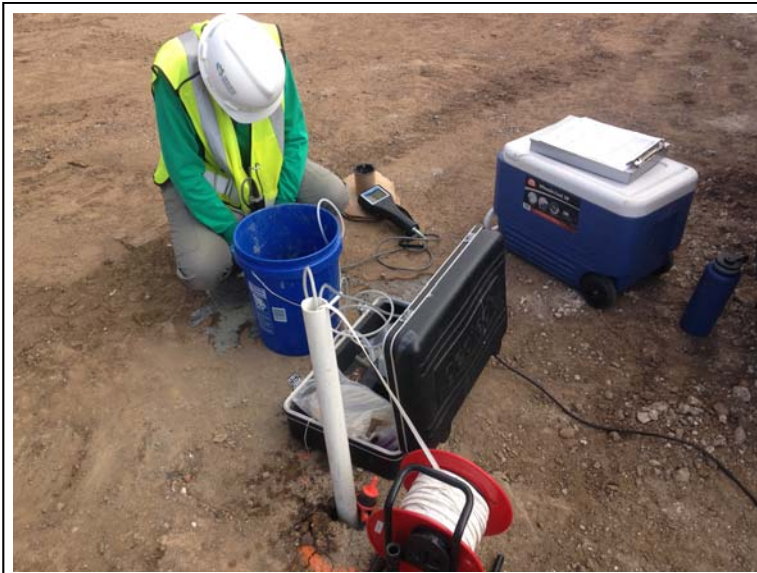
Photograph 14: Collecting groundwater samples from temporary monitoring well MW3.
