# Hydraulic Hoist Closure Assessment

**Oneawa Union 76 Service Station  
153 Oneawa Street  
Kailua, Hawaii 96734**

**DOH HEER Case No. 20070813-1554**

**October 11, 2007**

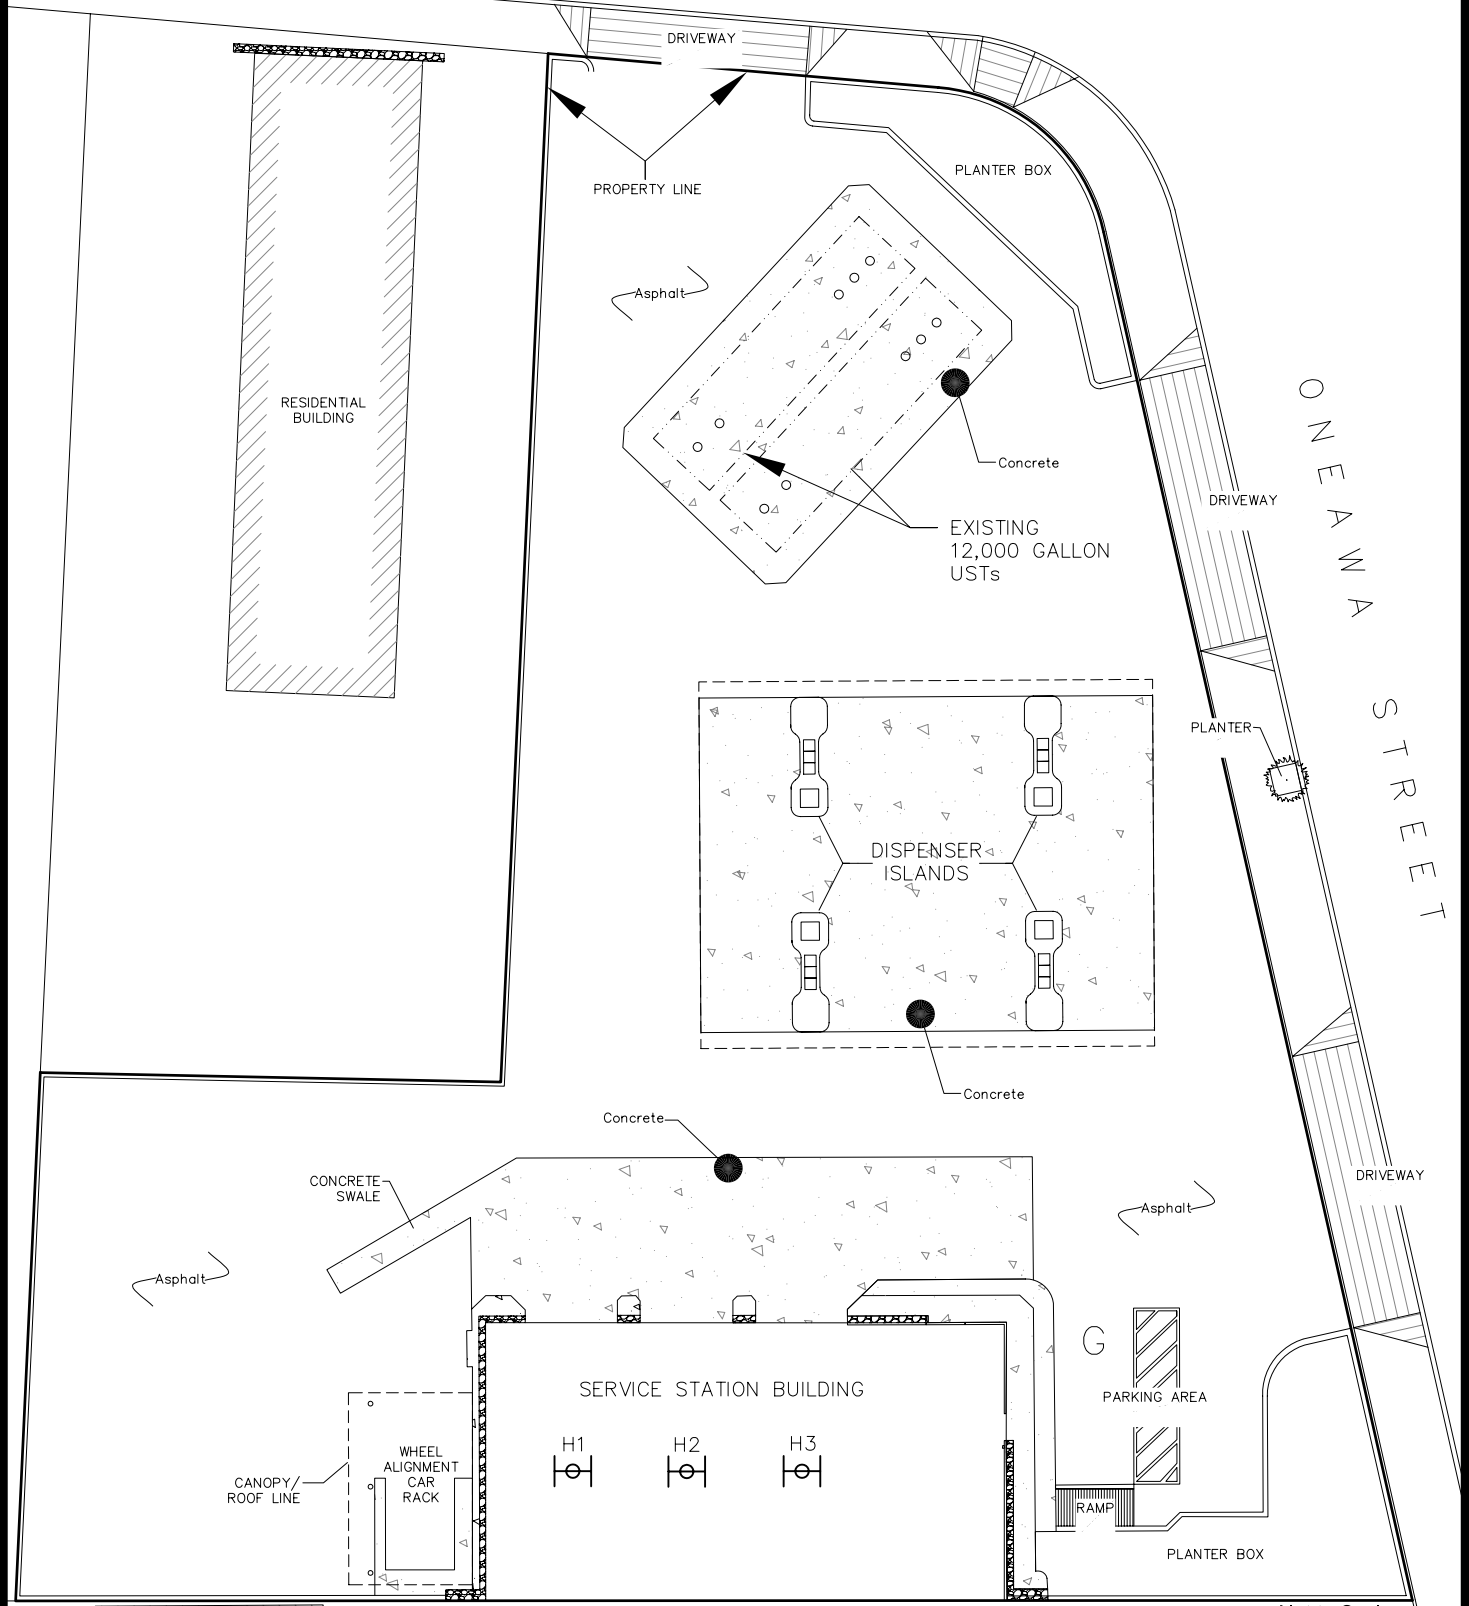
Figure 3

The hydraulic hoist systems consisted of three single-post hydraulic hoists (hoists H1, H2, and H3). The three single-post hoists were located in the middle of the service bay, adjacent to one another. The locations of the hoists are shown in Figure 3.

Site Map

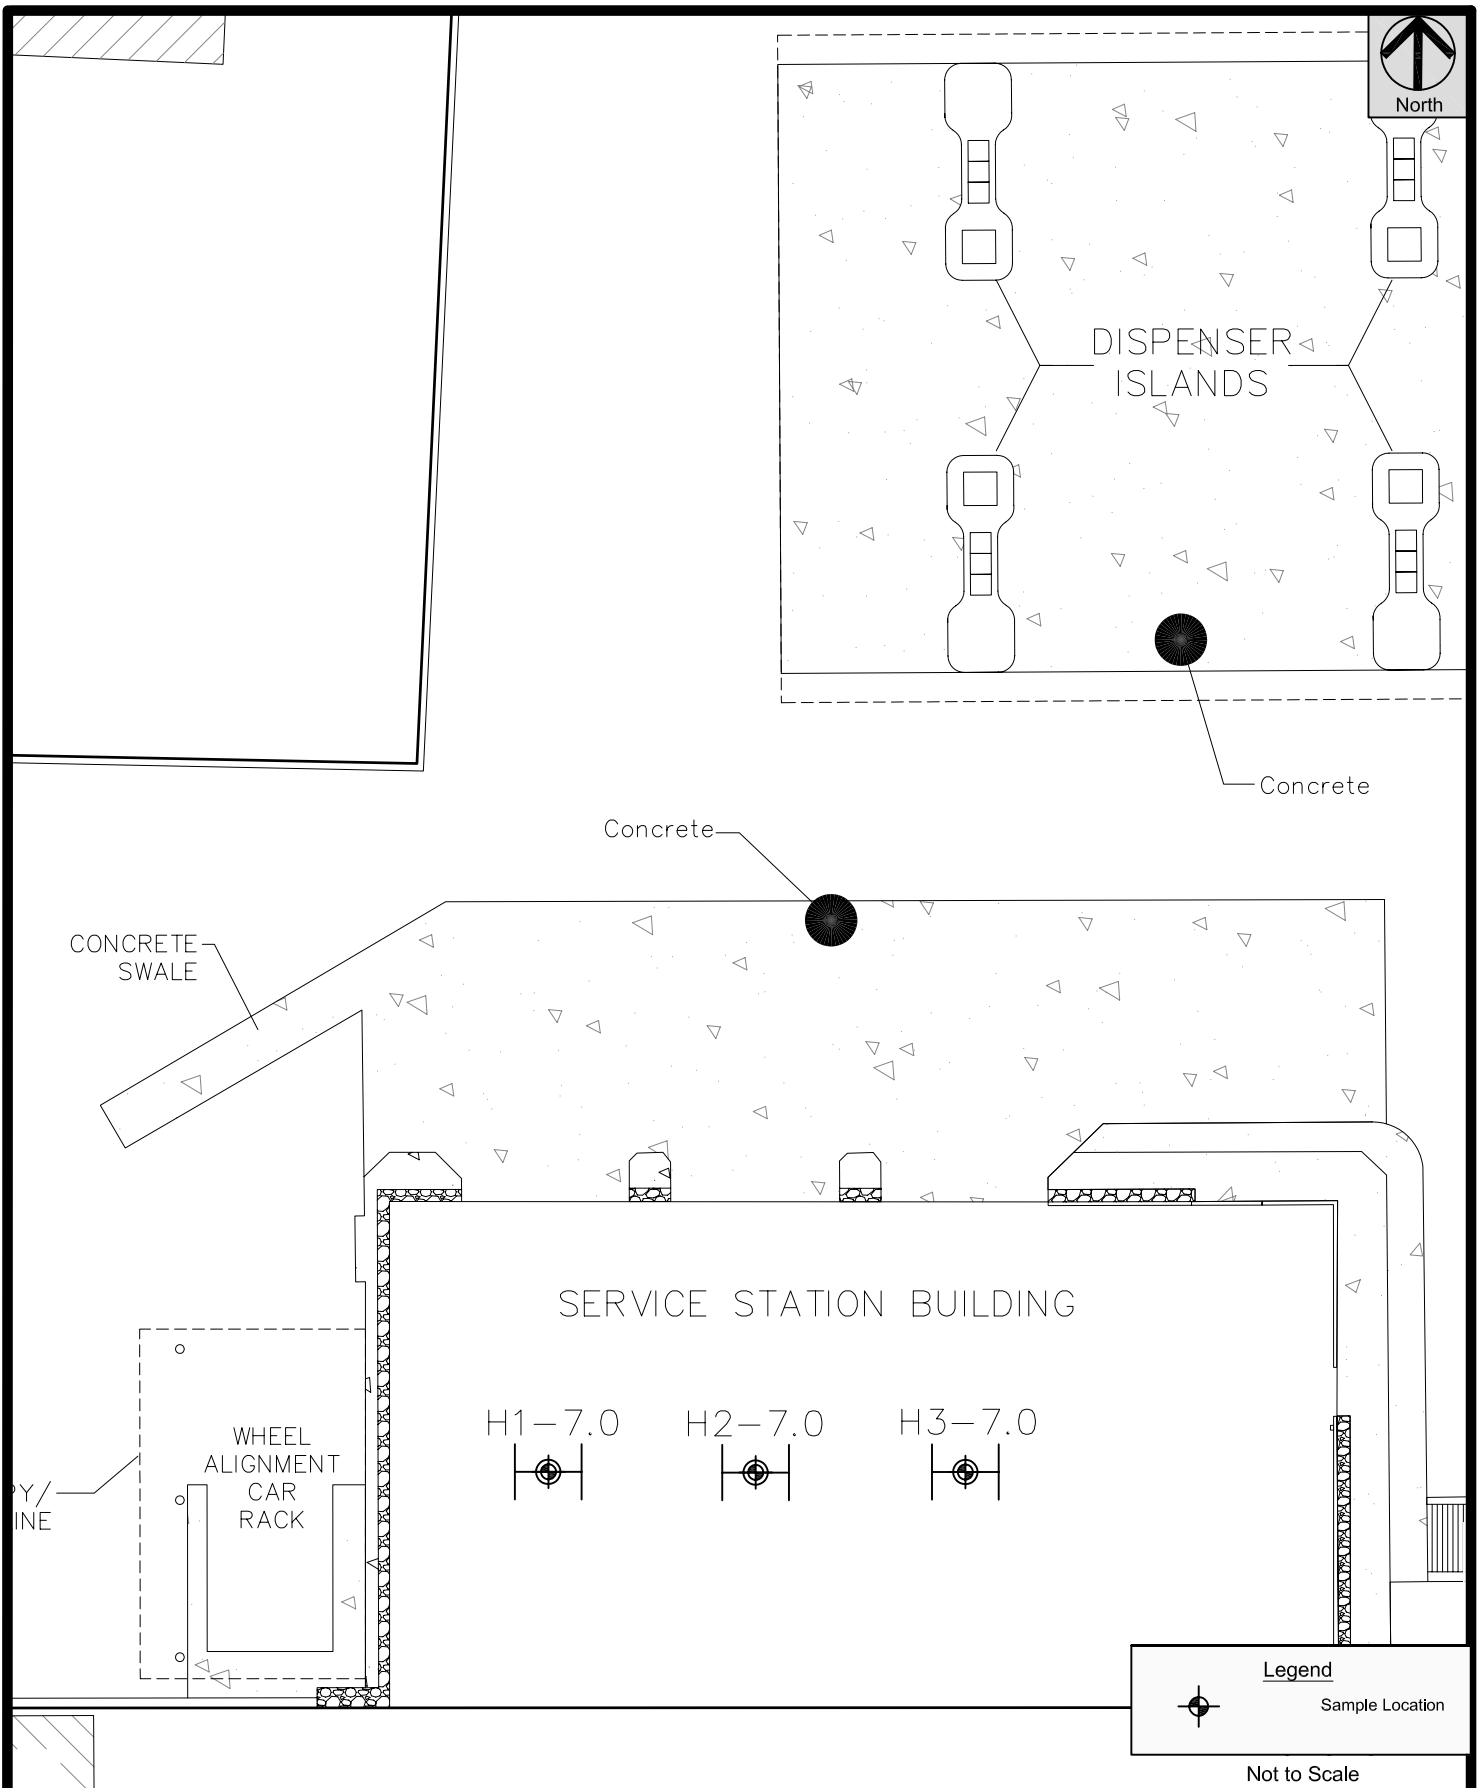
Sample Location Map	ESI Project No. 107062
	Oneawa Union 76 Service Station	Date: 10/11/2007
	153 Oneawa Street, Kailua, Hawaii	Figure 4

On August 1, 2007, ESI personnel (Mr. Travis P. Hiramoto) collected three verification soil samples (samples H1-7.0, H2-7.0, and H3-7.0). Each soil sample was collected at 7.0 feet bgs (directly beneath each hydraulic hoist post). A description of the samples is provided in Table 3.1 and the sample locations are shown in Figure 4.

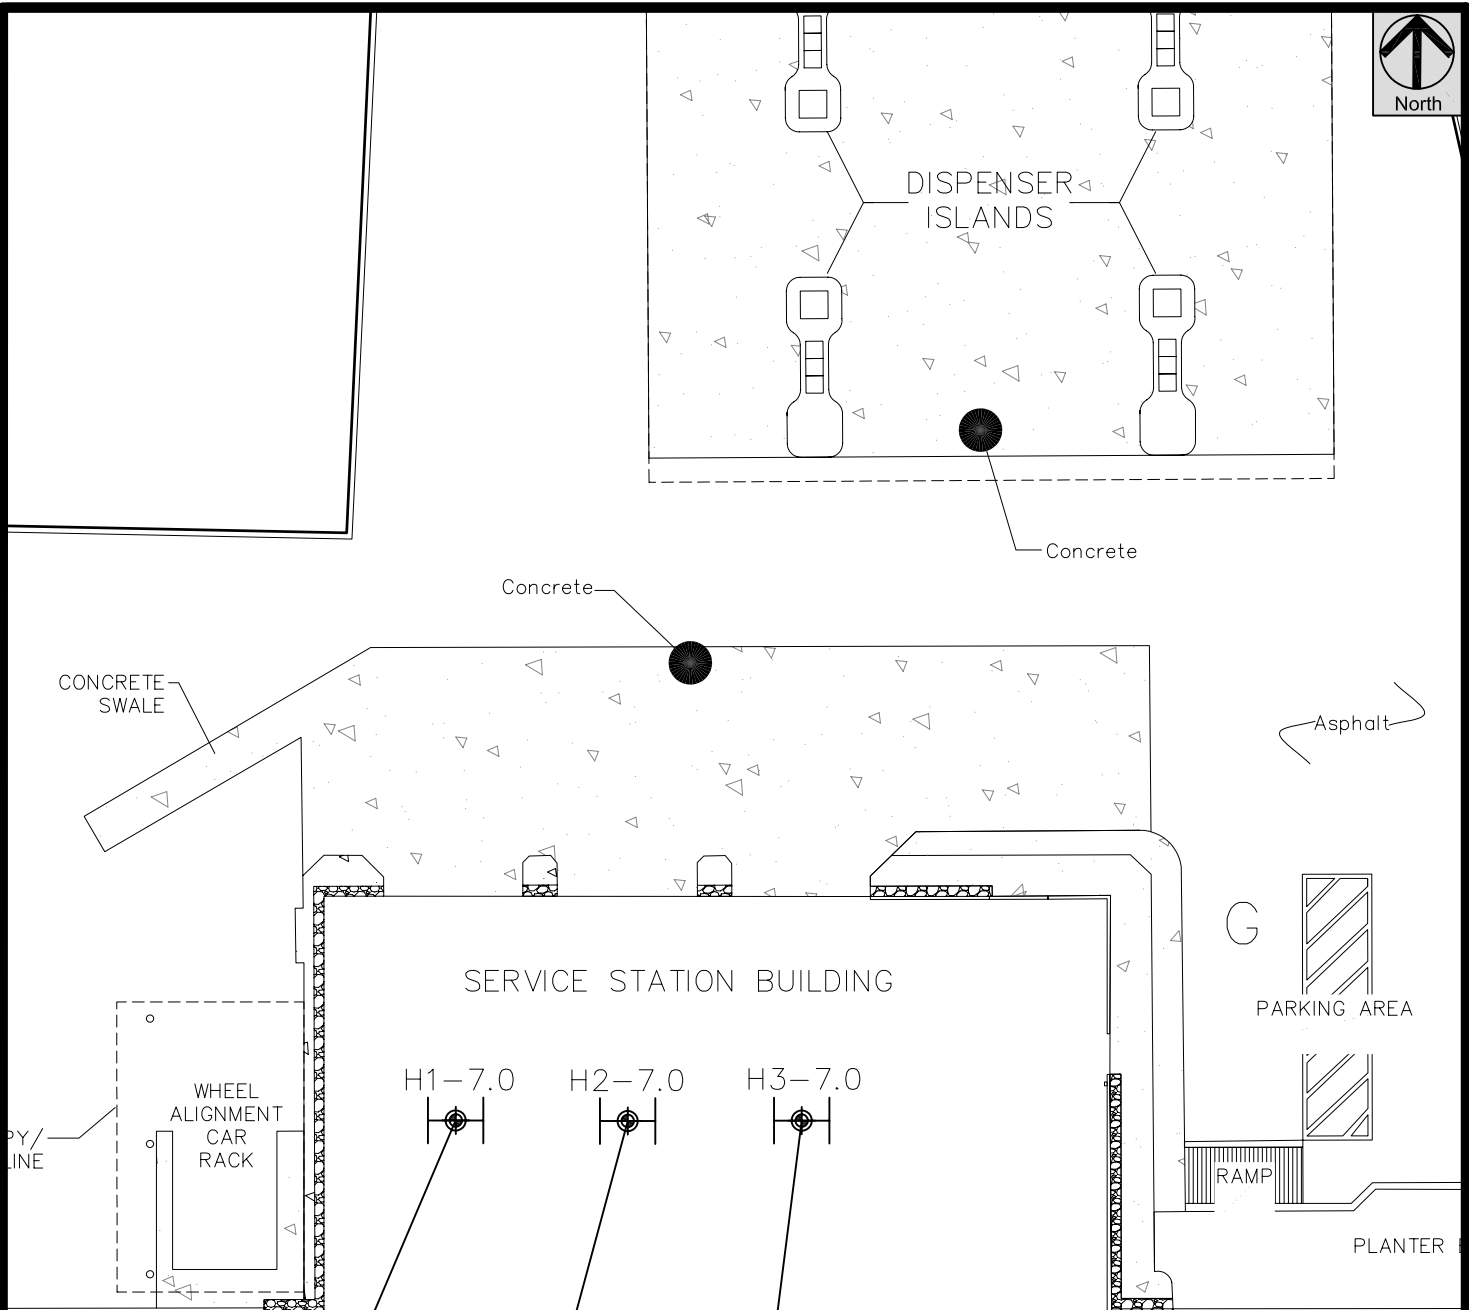
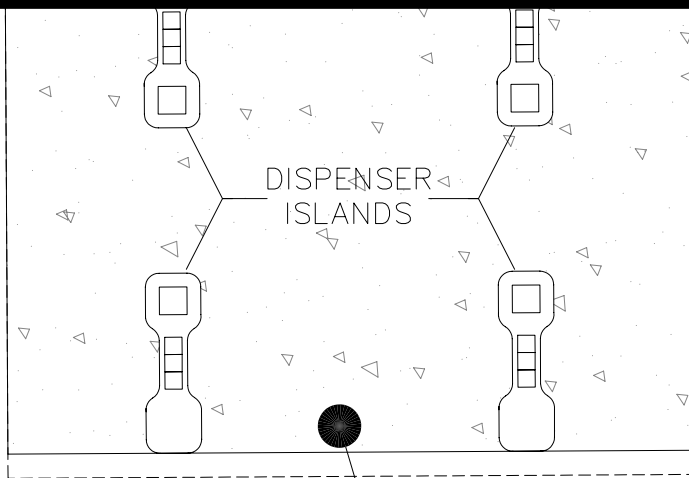
Figure 5

H1-7.0
150
n.d.
n.d.
n.d.
n.d.
n.d.

H2-7.0
n.d.
n.d.
n.d.
n.d.
n.d.
n.d.

H3-7.0
n.d.
n.d.
n.d.
n.d.
n.d.
n.d.

CHEMICAL CONSTITUENTS	RESULTS	DOH EAL
TPH-o	150	5,000
ACENAPHTHENE	n.d.	130
BENZO[A]PYRENE	n.d.	0.62
FLUORANTHENE	n.d.	40
NAPHTHALENE	n.d.	18
PCBs	n.d.	1.1

Summary of Analytical Results for Verification Samples

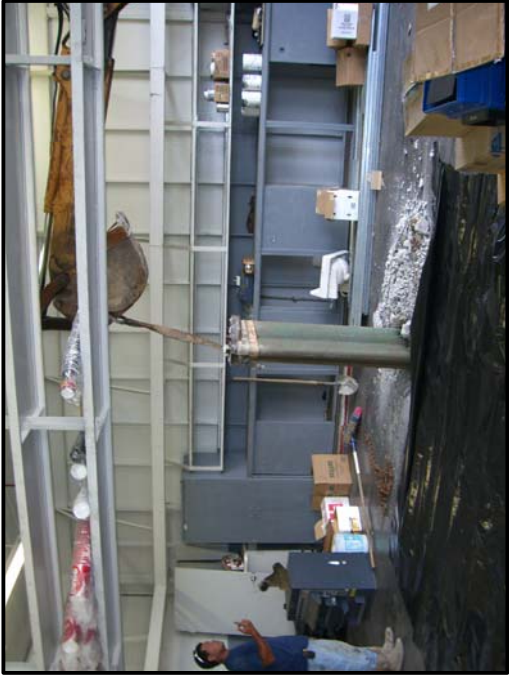
**Photo 1.** M. Nakai personnel removing H1 from the ground.

On August 1, 2007, under the supervision of ESI personnel (Mr. Travis P. Hiramoto), M. Nakai, Inc. [M. Nakai], excavated the area around each hoist (H1, H2, and H3) and removed the hoists from the ground (Photograph 1). The hoists extended from ground surface to approximately 7 feet below ground surface. The hoists were removed from the ground and placed on 6-mil plastic sheeting (Photograph 2).

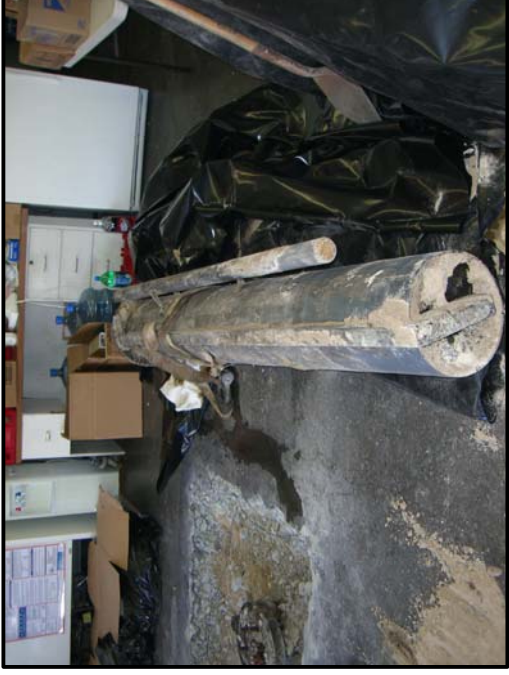
**Photo 2.** H2 placed on 6-mil plastic sheeting.

Following the removal of the hoists, each hoist was properly cleaned, triple-rinsed, and placed on 6-mil plastic sheeting (Photograph 2). On August 1, 2007, the three hoists were loaded onto a flat-bed truck and transported by Phillips Services Corporation [PSC] to Schnitzer Steel Industries [SSI] (formerly Hawaii Metal Recycling [HMR]). The waste disposal manifests are included in Appendix C.

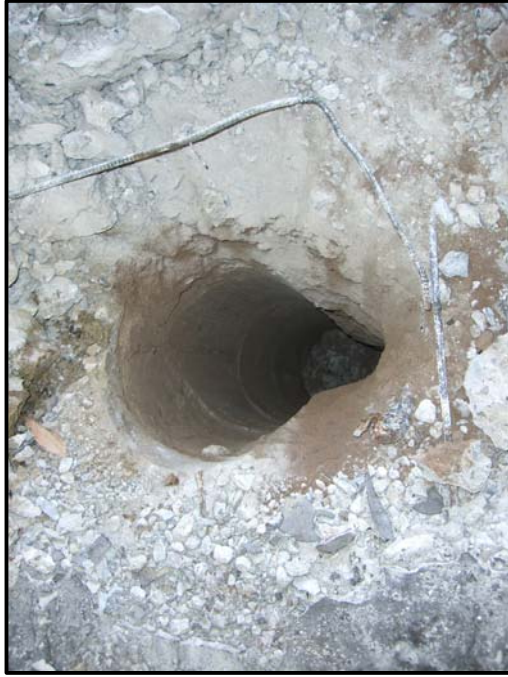
The subsurface soil around each hoist consisted of a brown basecourse fill material from the ground surface to approximately 0.5 feet bgs. Underlying the brown basecourse fill material was a layer of brown silty sand (from approximately 0.5 to 7.0 bgs). Groundwater was not encountered during the excavations. No petroleum hydrocarbon odor or staining were observed in the soil surrounding and beneath the hoists (Photograph 3).

**Photo 3.** The H1 excavation after the removal of the hoist. Note no staining was observed.

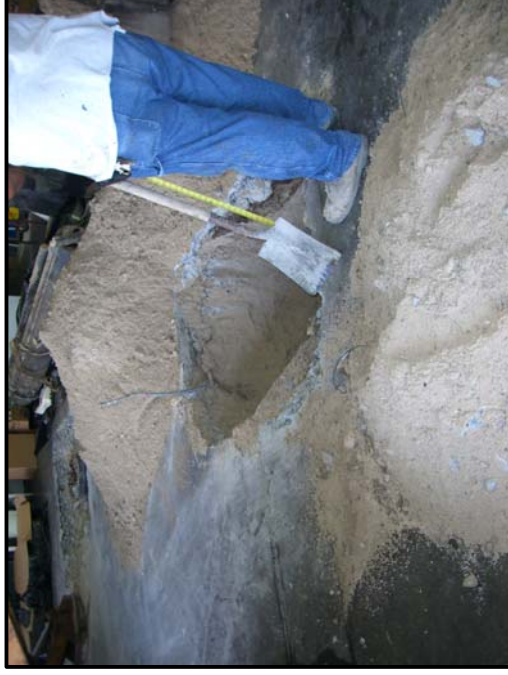
**Photo 4.** M. Nakai personnel backfilling the H2 excavation. Note no staining was observed.

The excavated soil was temporarily stockpiled at the Station. The excavated soil was used to backfill the excavations (Photograph 4).
