Probability Assessment For Munitions and Explosives of Concern

H09HI0484 Makalapa Crater Former Navy Salvage Yard,
Honolulu, Oahu, Hawaii

27 February 2024

Prepared by
**Honolulu District
U.S. Army Corps of Engineers**

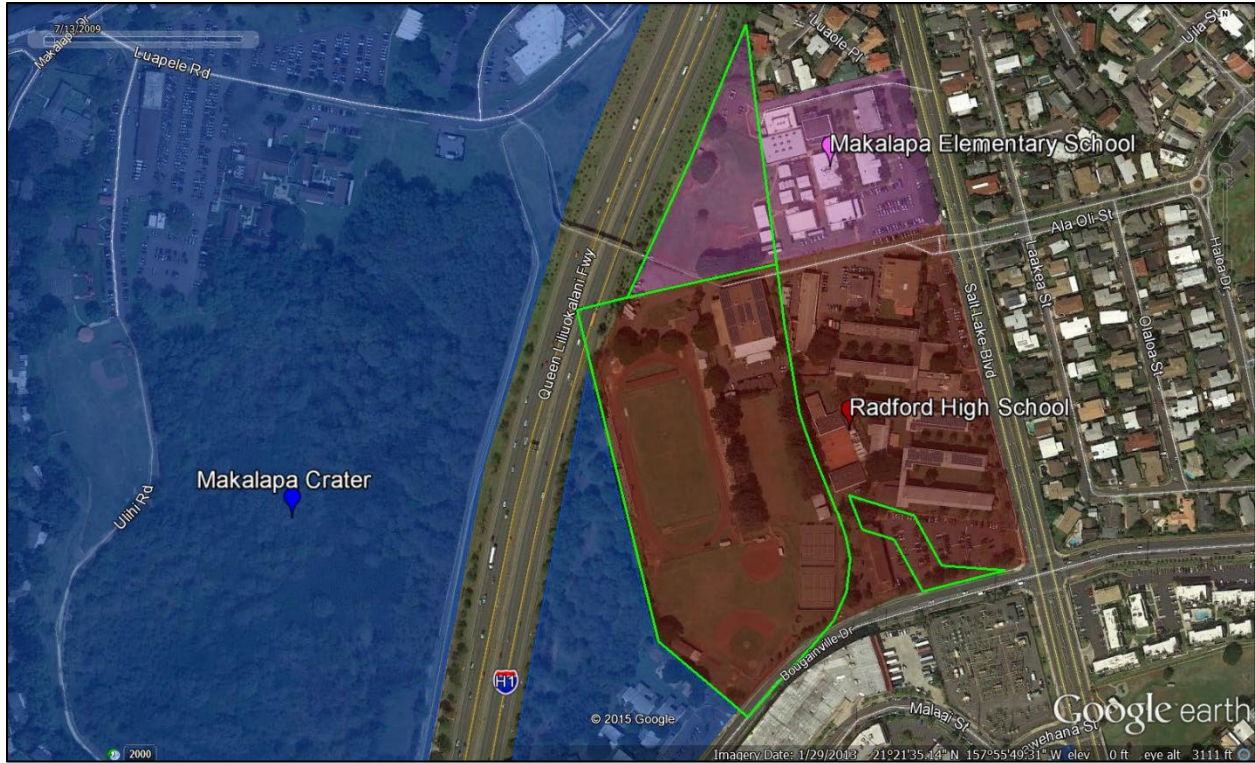
Figure 1 – Makalapa Crater Former Navy Salvage Yard Property Map¹

The Makalapa Crater Former NSY FUDS consists of 19.2705 acres near Halawa, District of Ewa, Island of Oahu, Hawaii, located in Island of Oahu County. The FUDS includes the Radford High School (RHS) Field and Athletic Complex (RFAC) including the RHS football field, gymnasium, soccer/practice field, the baseball and softball fields, tennis courts, and parking areas. It also includes Makalapa Elementary School open fields, basketball courts, parking areas, and playground.

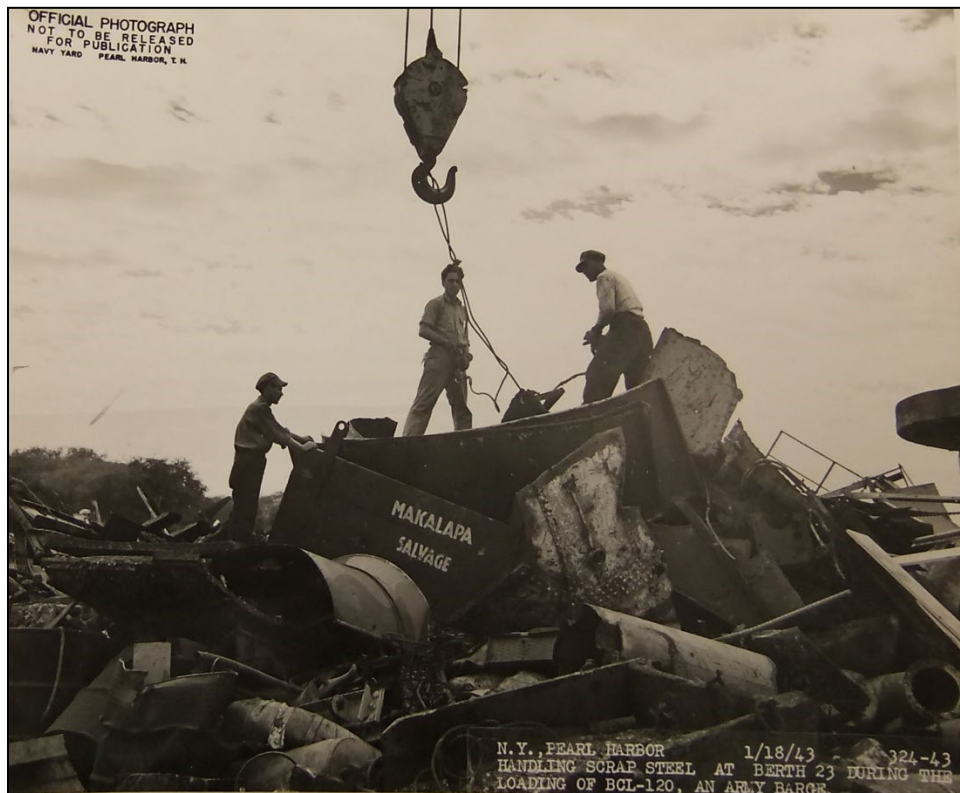
Figure 2 – Handling Scrap Steel at Berth 23 headed for Makalapa Salvage – 18 January 1943⁹

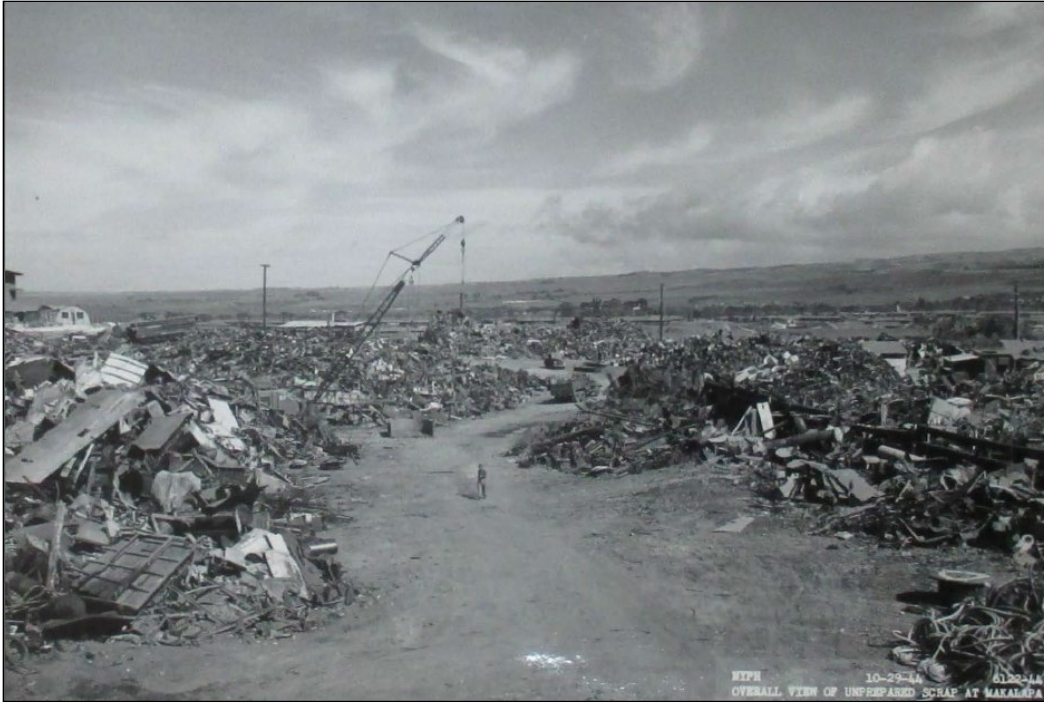
Figure 3 – Unprepared Scrap at Makalapa Salvage Yard – 29 October 1944¹⁰
