UNDERGROUND STORAGE TANK CLOSURE

Former GRG Enterprises Site

115 Ahui Street
Honolulu, Hawaii

Date: November 23, 1998

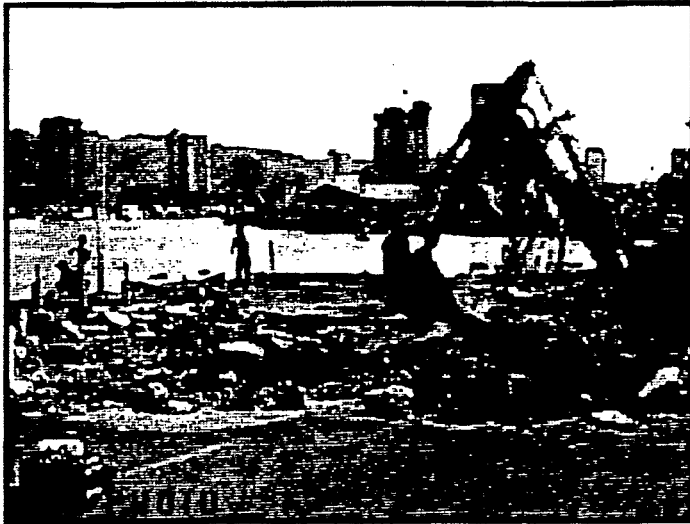
Looking Mauka. Breaking ground over the four USTs. Note the area is surrounded by water on three sides.

Location of dispensers.

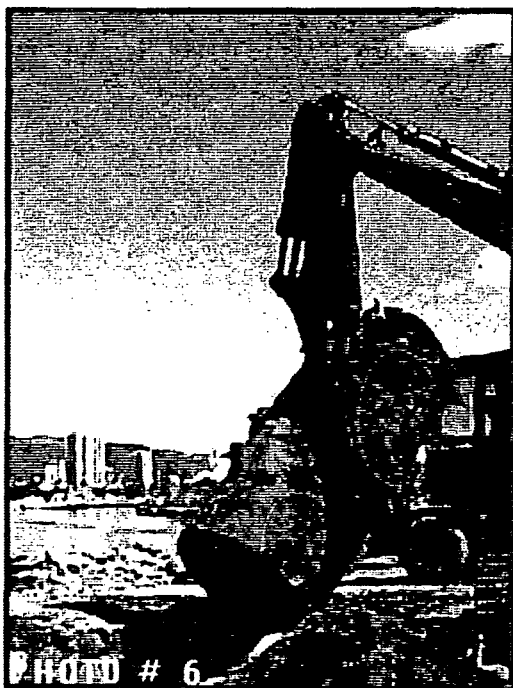
The two gasoline USTs were found to be generally free from corrosion and pitting, in the tank walls. The tank seams were also observed to be intact. The two diesel USTs were found to be corroded and pitted, with numerous holes. We observed holes in the tank walls from 1/2 to 1-inch diameter to 1-foot in diameter clustered along the apparent water level at 6 feet bgs.

Lifting one of the 6,000 gallon tanks.

Note holes in side of tank

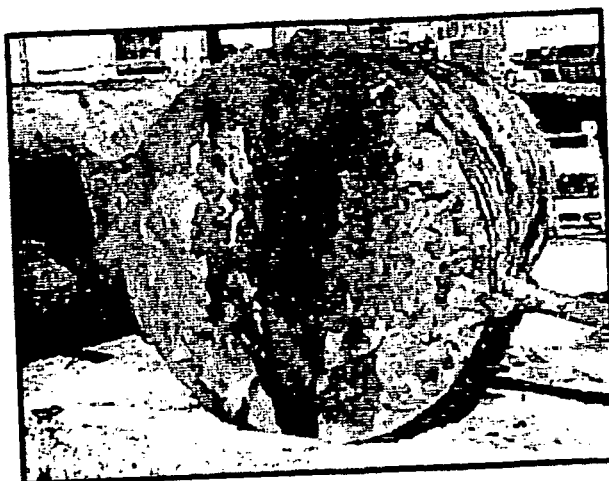
PHOTO # 8

Two 2,000
gallon tanks.

Break in
asphalt
coating.
