**O'AHU
RESOURCE
CONSERVATION &
DEVELOPMENT COUNCIL**

Quarterly Status Reporting Form

Project Title: Buffers and BMPs for Windward Oahu

List of Implemented BMPs
QSR
July 1, 2021 - September 30, 2021

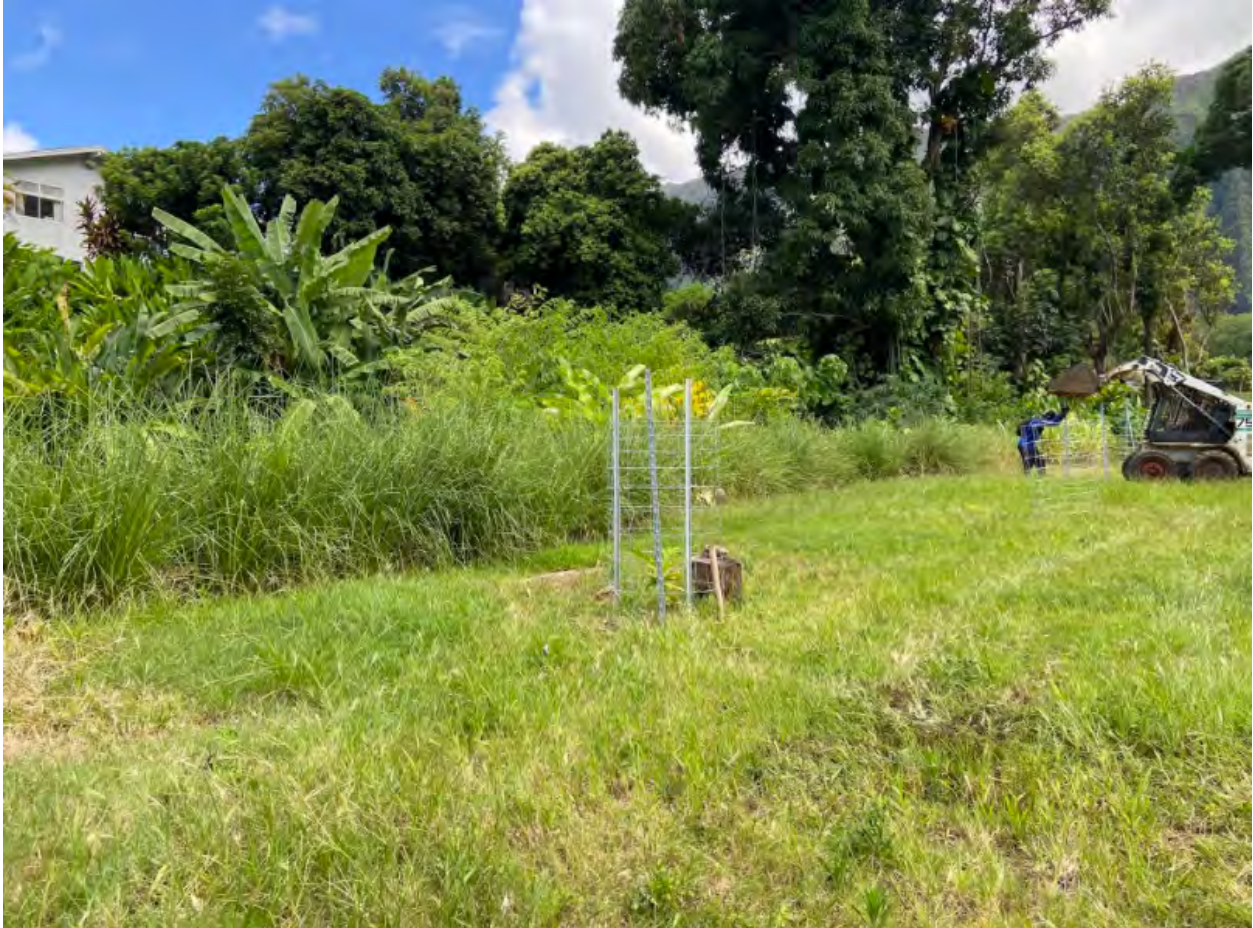
Image above: The conservation cover is in the process of being fully established throughout the project area. The farmer is able to easily maintain the growing ulu trees by weeding and mowing around the conservation cover. In addition to the conservation cover, a vegetative barrier of densely planted vetiver is becoming fully established and is serving as an extra protective measure to slow and filter any potential surface waters that may flow across the field.

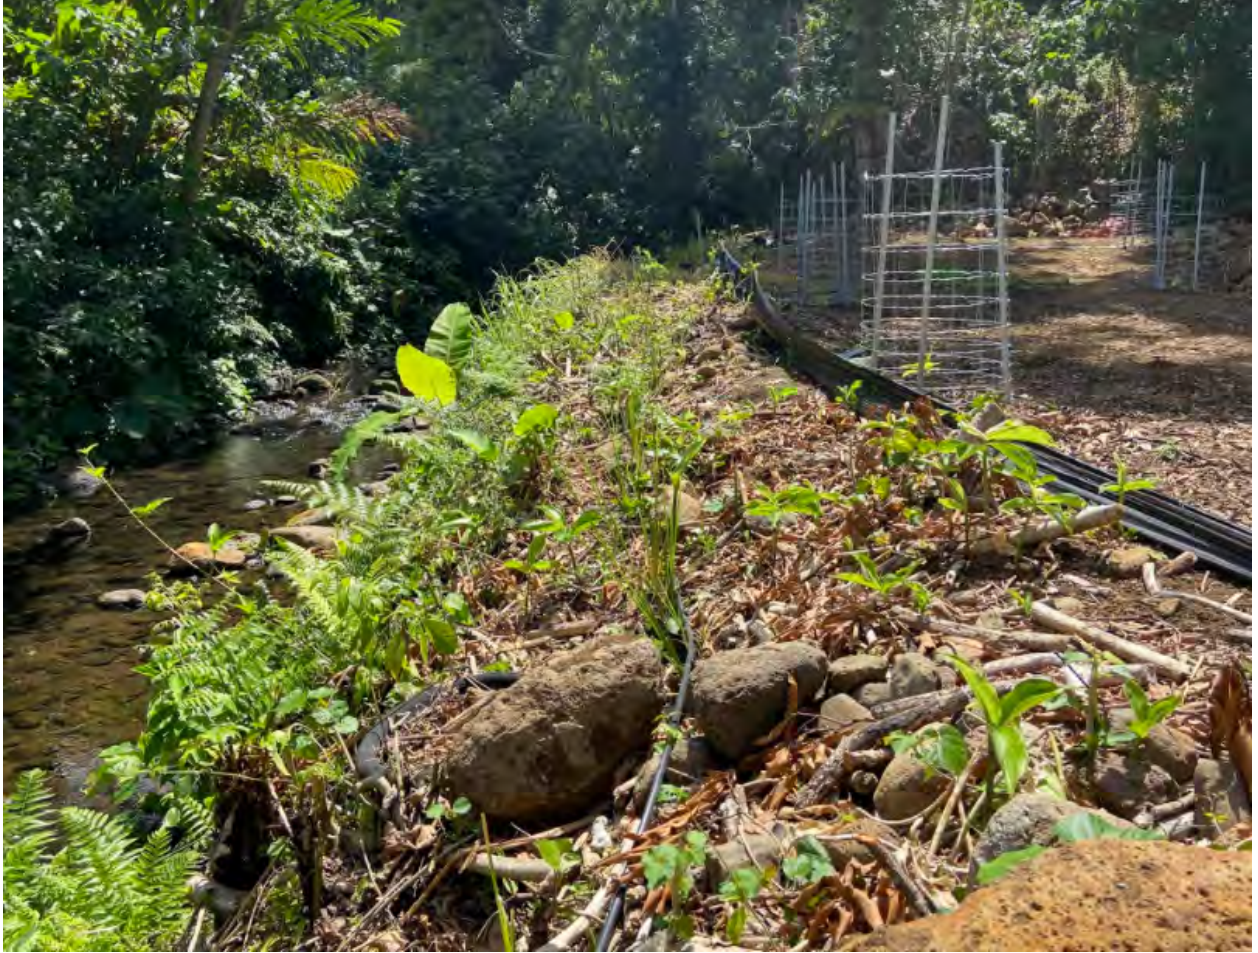
Image above: The vegetative barrier of vetiver and native sedges is establishing to mobilize sediment on the streambank prior to the upcoming winter rains.

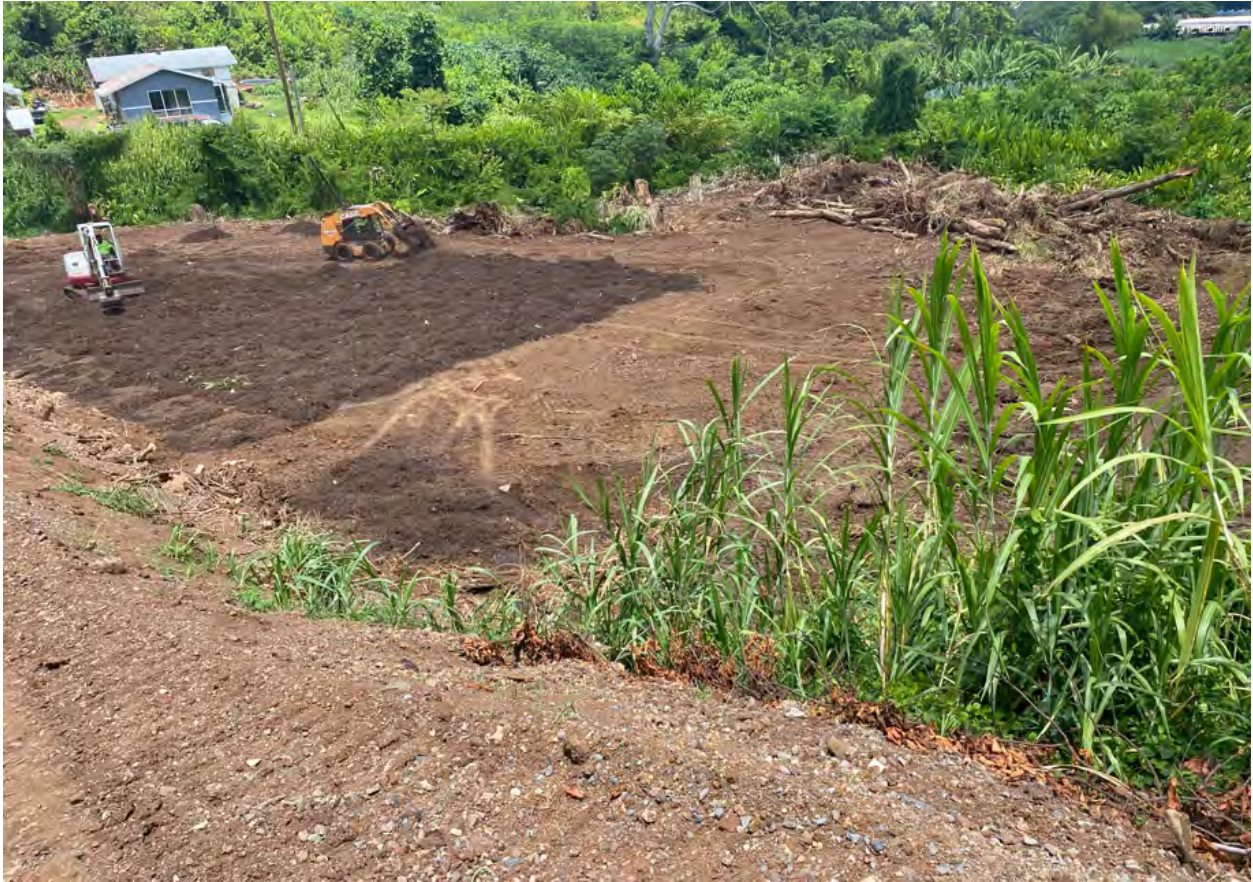
Image above: Brush has been removed and the field has been prepped for a multi-story cropping with an application of 4-6" of mulch.

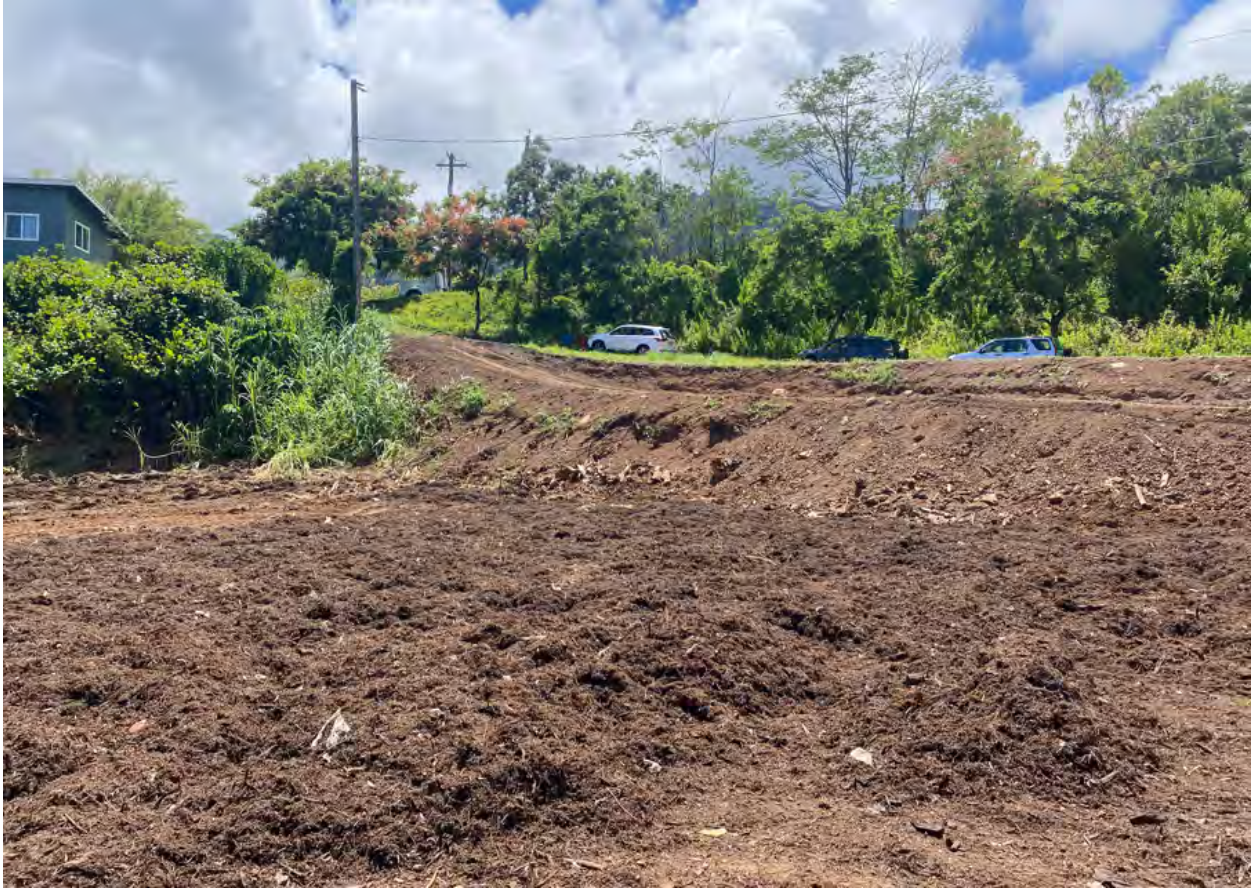
Image above: Smoothing the slope and covering the soil with vegetation will capture and filter runoff water before it enters the abutting wetland. A vegetative barrier will be installed to provide a buffer to any surface waters flowing from the multi-story cropping area to the wetland.
