Quarterly Status Reporting Form

Clean Water Act 319(h) NPS Implementation Program

Project Title: Buffers and BMPs for Windward Oahu

ASO Log No. 19-154
List of Implemented BMPs, QSR 11

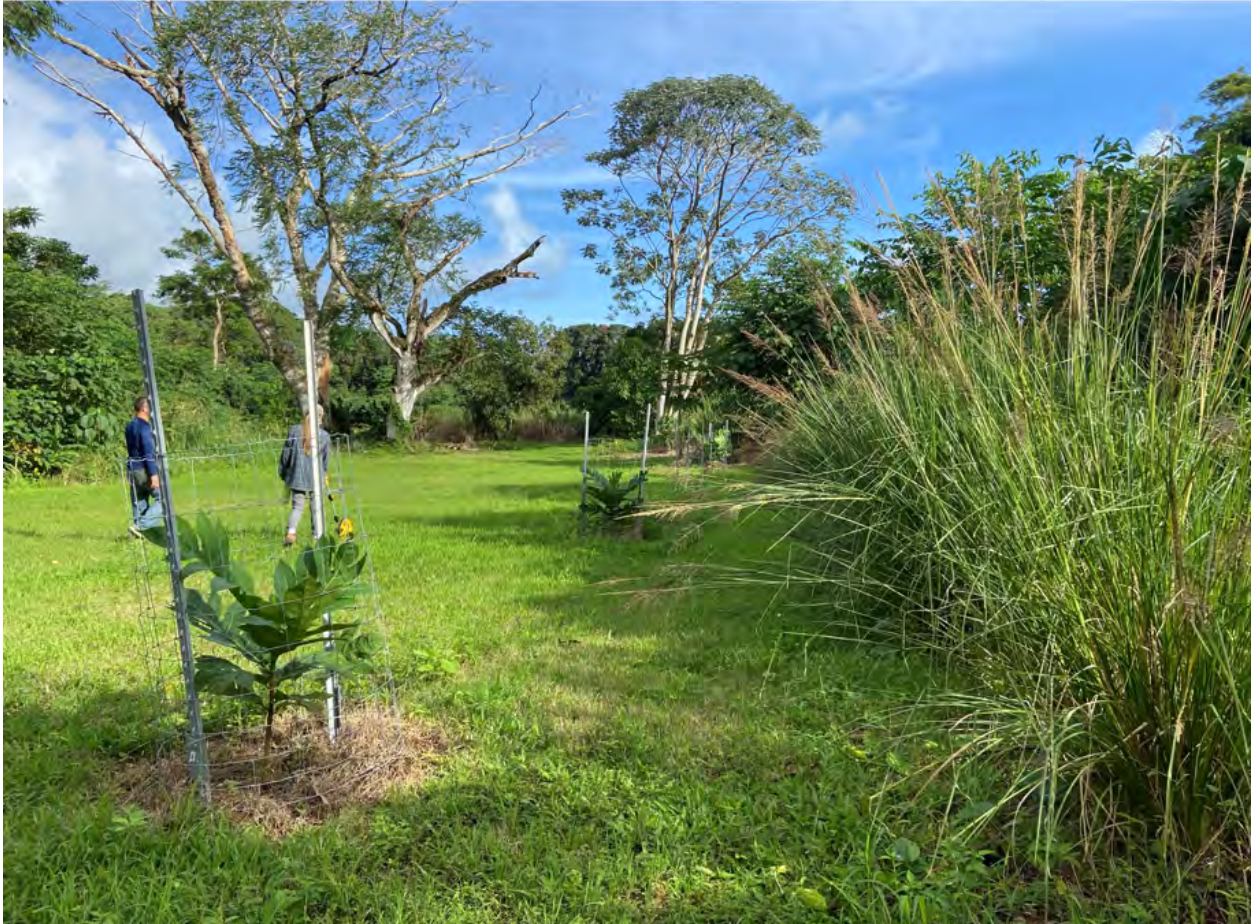
Image above: In addition to the conservation cover, a vegetative barrier of densely planted vetiver is becoming fully established and is serving as an extra protective measure to slow and filter any potential surface waters that may flow across the field and into the stream.

<p>Vegetative Barrier Establishment of 200 slips of vetiver grass or similar native sedge (e.g. ahuawa, carex) in one densely planted row to stabilize banks, slow runoff and prevent sediment delivery to the stream.</p>	100%	150 vetiver slips have been planted along 165 linear feet of the streambank, with an additional row of vetiver planted in the most critical areas.
<p>Conservation Cover Purchase and install grass and/or another type of ground cover to protect critical areas and flood areas.</p>	100%	Bermuda and El Toro grass are fully established and are actively being maintained with a lawn mower.

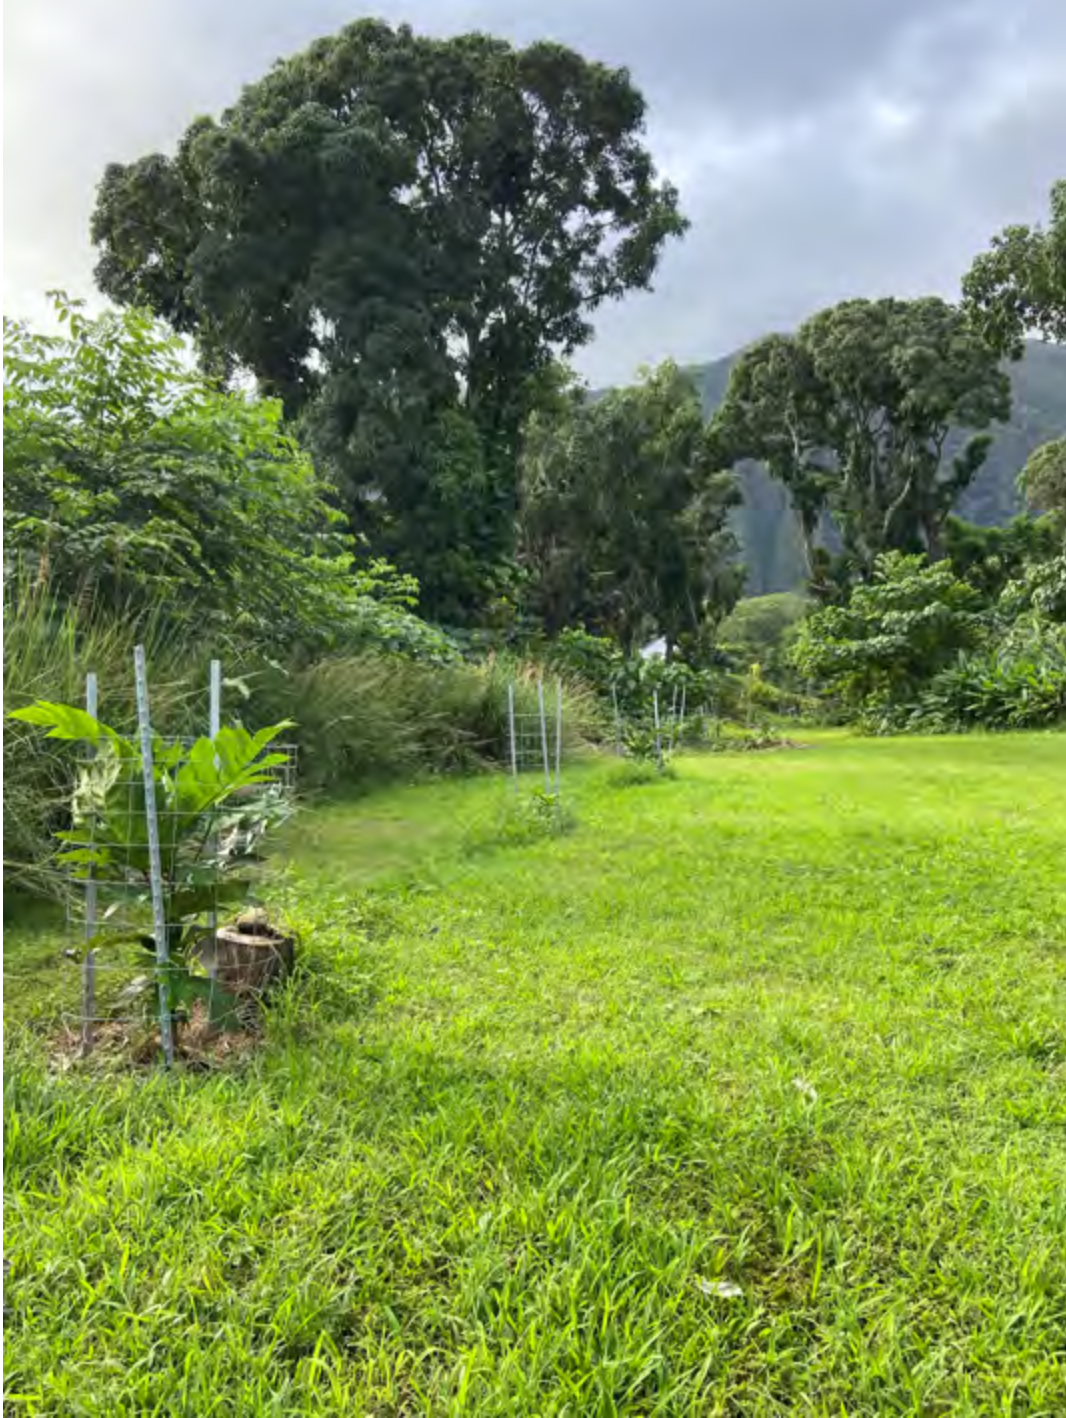
Image above: The brush removal is complete, the land has been smoothed and planted successfully with a conservation cover of Saint Augustine grass. These conservation practices are routinely maintained with a mower. The ulu trees have been successfully maturing with the protection of the cages. The cages will soon be removed.

BMP	Status	Notes
<p>Brush Management Removal of 9 large stature invasive trees and understory to prepare for planting low to medium stature riparian buffer.</p>	100%	Mechanical removal of invasive trees, including False Makani, Java Plum, Albizia, Gunpowder, and Umbrella tree, leaving trunks and root systems in place to mitigate bank erosion.
<p>Micro-irrigation To service the establishment of the riparian forest buffer and vegetative barrier.</p>	100%	Irrigation has been established for 45 ulu trees and a majority of the vegetative barrier.
<p>Land Smoothing Prepare land for conservation cover planting, ensuring adequate drainage and grade that can be maintained by mowing.</p>	100%	Following brush removal, the land has been smoothed and prepared to plant a conservation cover. The grade will be easily maintained by mowing and allow for proper drainage.
<p>Tree/Shrub Establishment Establishment of at least 40 perennial trees to suppress invasive weeds and stabilize soils. All trees to be caged.</p>	100%	45 ulu trees have been installed and caged along 725 linear feet of the stream channel. A second row of these ulu trees have been planted along 165 linear feet at the mauka border of the area designated for conservation cover.

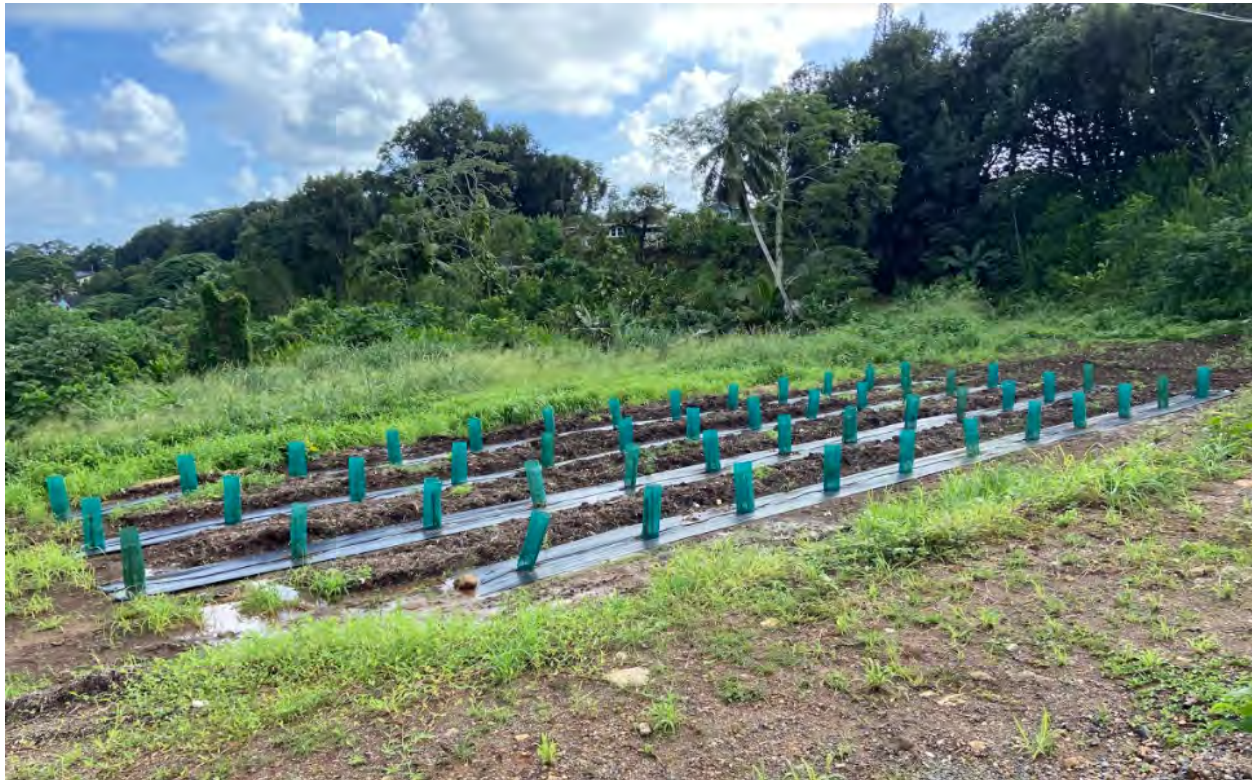
Image above: 50 cacao plants have been planted and caged in four rows, each 100 ft. in length. Mulch has been applied to a depth of 6" to keep the bare soil covered and prevent erosion. A vegetative barrier will also be installed upslope of the waterways to capture any sediment or nutrients that might runoff during heavy winter rain events.

BMP	Status	Notes
<p>Multi-story Cropping Establishment of minimum 50 perennial tree and shrub crops, resulting in a diversified forest or cropping system.</p>	100%	50 cacao trees have been successfully installed and caged in 4 rows, each 100 ft. in length.
<p>Brush Management Prepare land for multi-story cropping and insuring adequate drainage and a grade that can be easily maintained.</p>	100%	Invasive trees and shrubs have been removed from the project area. Roots have been left in the ground to stabilize the soil.
<p>Micro-irrigation To service the establishment of multi-story cropping and vegetative barrier.</p>	80%	Micro-irrigation has been installed to feed the multi-story cropping. The system is setup to irrigate the vegetative barrier, which is not yet established.
<p>Mulching Applying 4-6" of wood mulch to improve soil health and facilitate the multi-story cropping establishment while reducing erosion and suppressing weeds.</p>	100%	Trees and shrubs removed during brush management were chipped in place. Bare soil has been covered appropriately with up to 6" inches of soil. Thick layers of mulch are serving to suppress weeds, retain moisture, increase water infiltration and build soil health in project area for the multi-story crop.

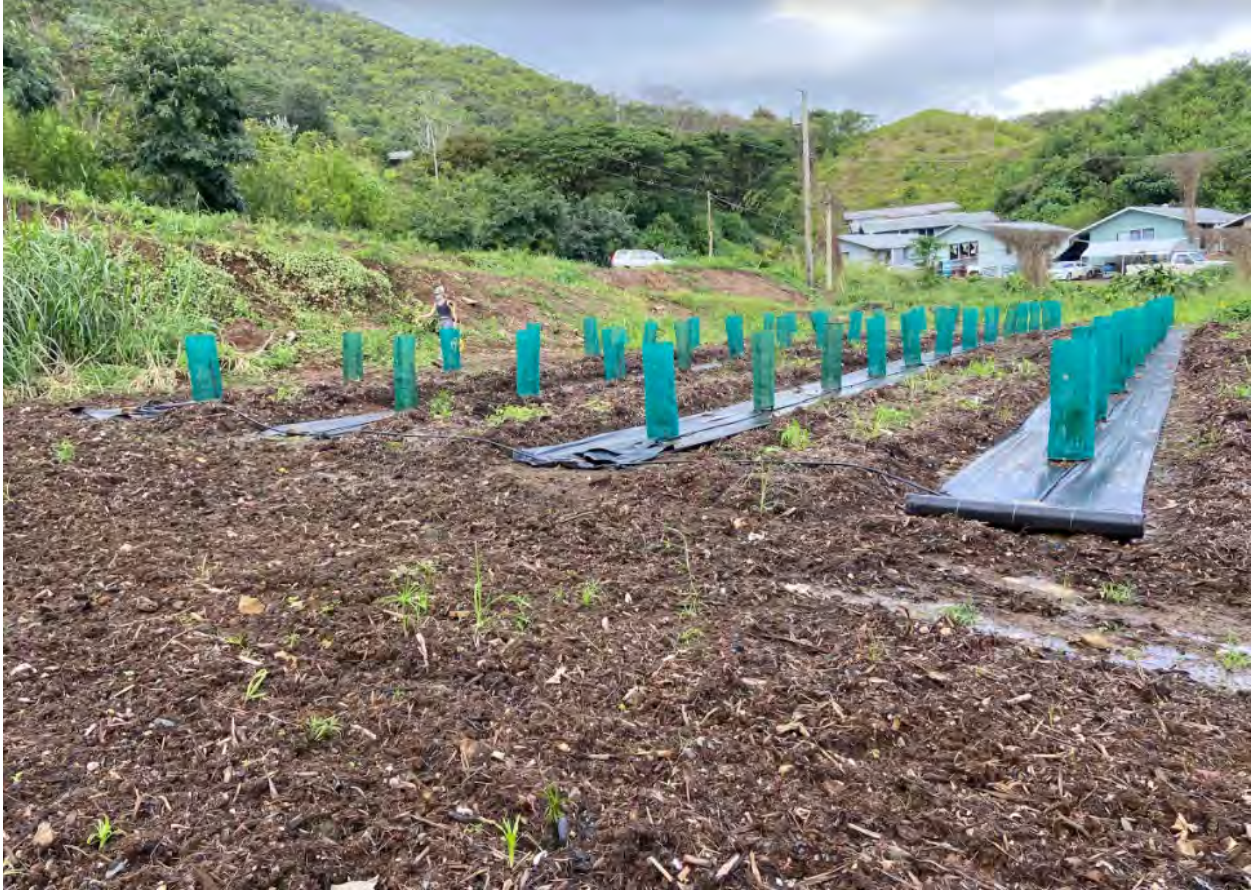
Image above: The slope above the cacao orchard will be stabilized through a critical area planting. This additional conservation practice will slow and filter surface waters that runoff from the mountain and prevent the slope from eroding and sediment from entering the waterways.

Critical Area Planting Establishment of a minimum 4 rows of vetiver along the 1,250 sq. ft. of exposed slope below access road, planted at a density of every 6".	0%	
---	----	--
