Clean Water Branch- Polluted Runoff Control Program

Quarterly Status Reporting Form
Clean Water Act 319(h) NPS Implementation Program

Project Title: MANOA WATERSHED IMPROVEMENT PROJECT

Albizia Threat on Waihi Stream

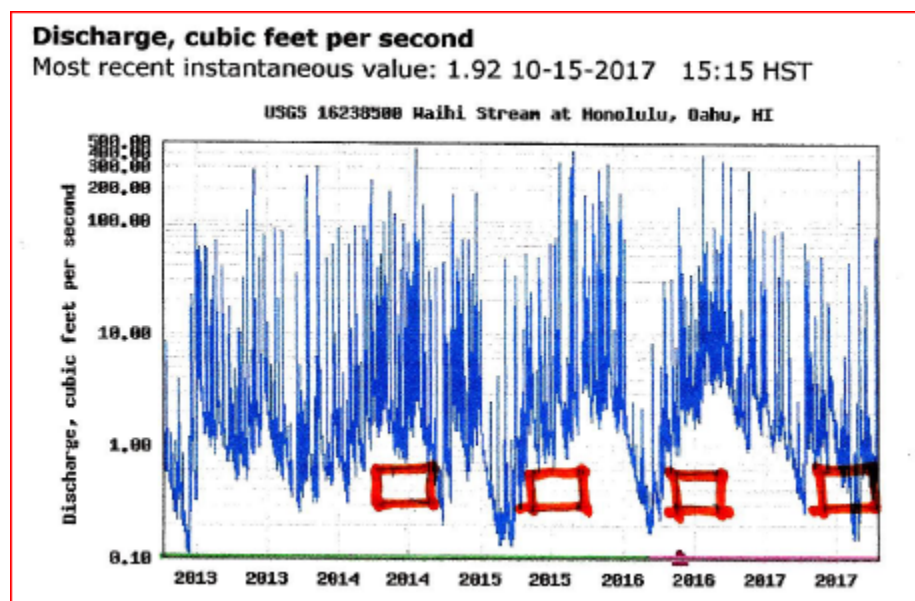
A. Weather Conditions: Streamflow

Ground preparation and planting window: May-September, just before rainy season. Orange boxes are the windows. USGS data shows that in 2014, 2015, and 2016, the water

level in Waihi stream was far above safety and operational conditions. 2017 is the first year since 2013 that the water levels were low enough to do substantial streambank work.

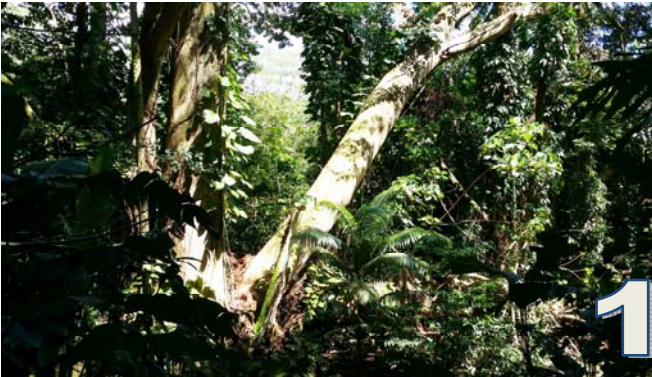
[1] fallen albizia in B-3 (February) is leaning more precariously as branches decay, right across from planned stream entry.

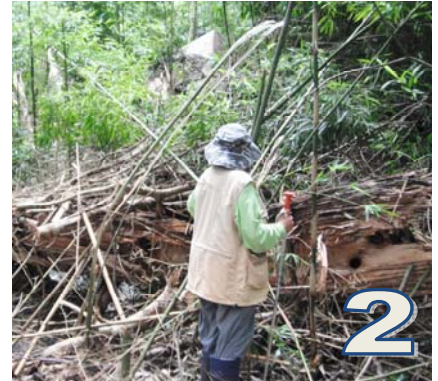
[2] fallen albizia branch right next to entry to B-2 area; about 4' high and 40' horizontally.

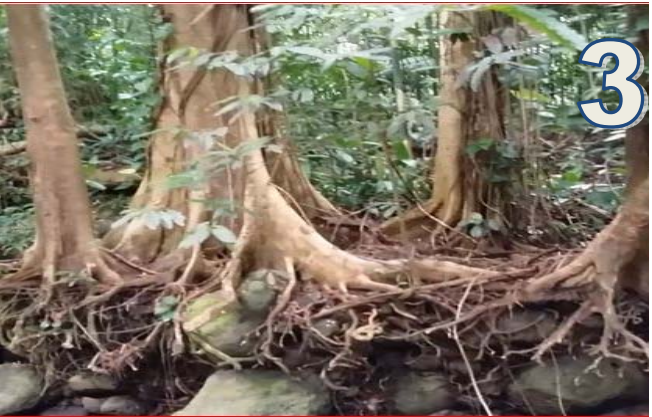
[3] Area B-2, B-3, and B-4: streambank root structures of albizia trees, contributing to falling trees. The stream has undercut the ground below and trees are susceptible to falling at any time.

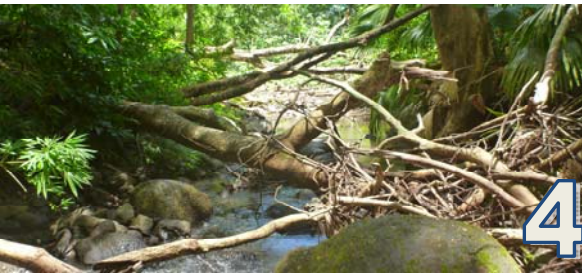
[4] Stream shot of B-4. This area was later cleared of movable branches in early July 2017. In the background is the dam, since cleared, built up by fallen branches.

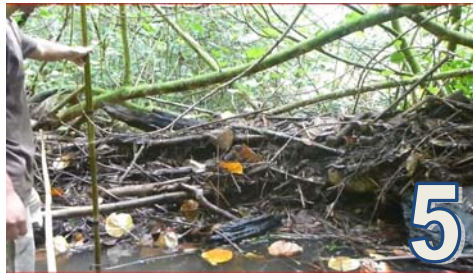
[5] Close up of dam; person on left is holding up a 4' marker.

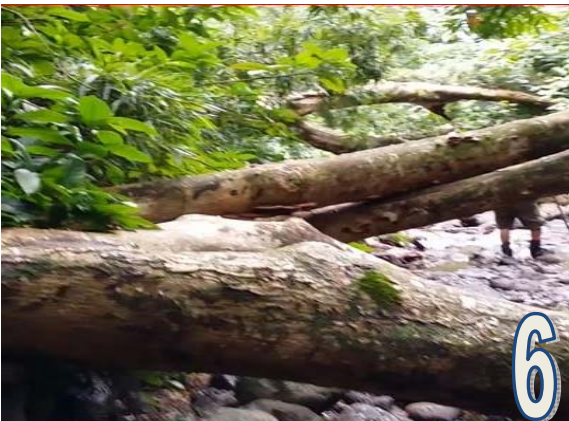
[6] Close up of size of trees/branches in [4]. Note legs of stream worker standing behind logs, giving an idea of how large they are. While we have removed the smaller branches, these are beyond our capacity to cut and move. Tree trimmers have also expressed hesitation on cost of removal since they cannot get excavators into the site.

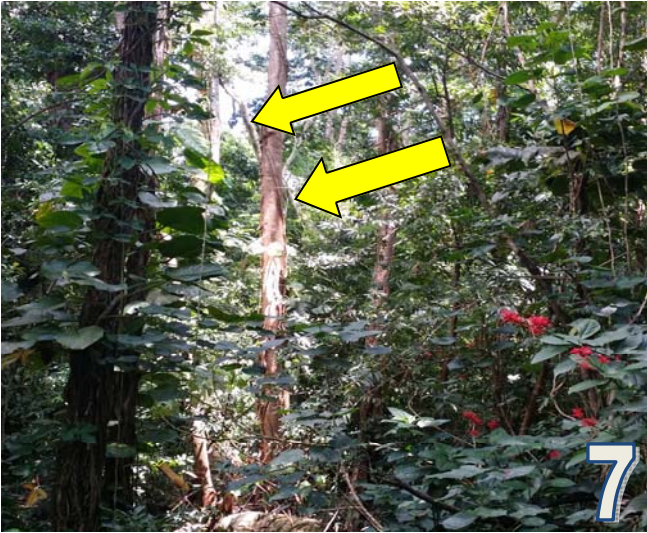
[7] Albizia leaning across Waihi stream from west bank, supported only by branches of a tree on the opposite bank. Fall is imminent. Tree is right next to the stream entry in [8].

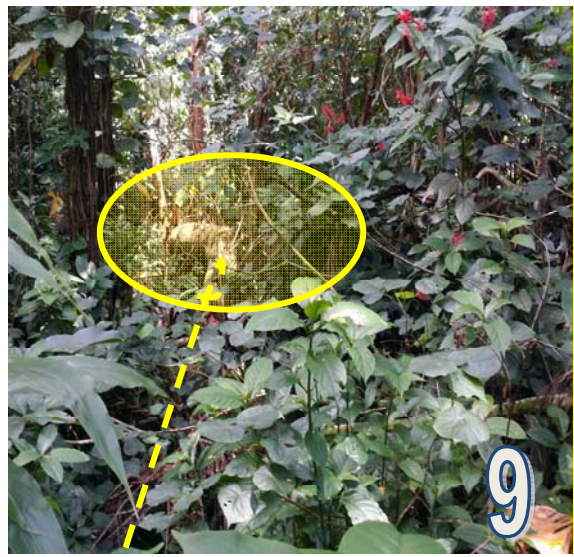
[9] Entry path to B-4 to Waihi Stream, view from forest along Kamoawaa Stream. A tree fell, completely blocking entry path, less than 2 weeks after crews cleaned Area B-4 of movable branches and dams.

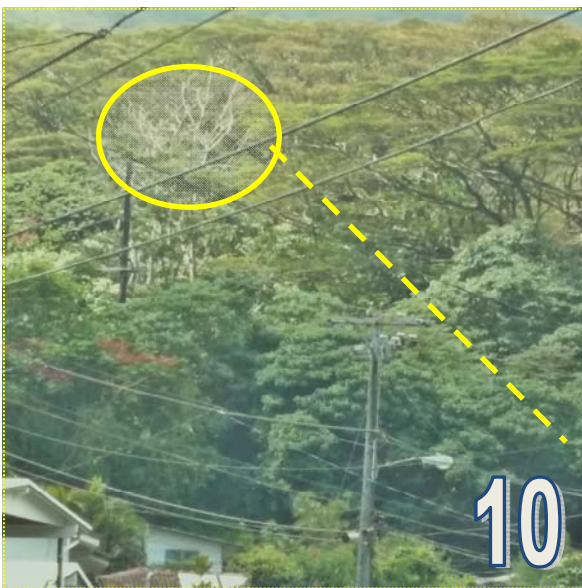
[10] View from residential area below forest.

Circled: skeletons of dead albizia trees with branches continuously falling off. These are within reach of the stream.

Line: approximate path of Waihi Stream through the albizia forest.

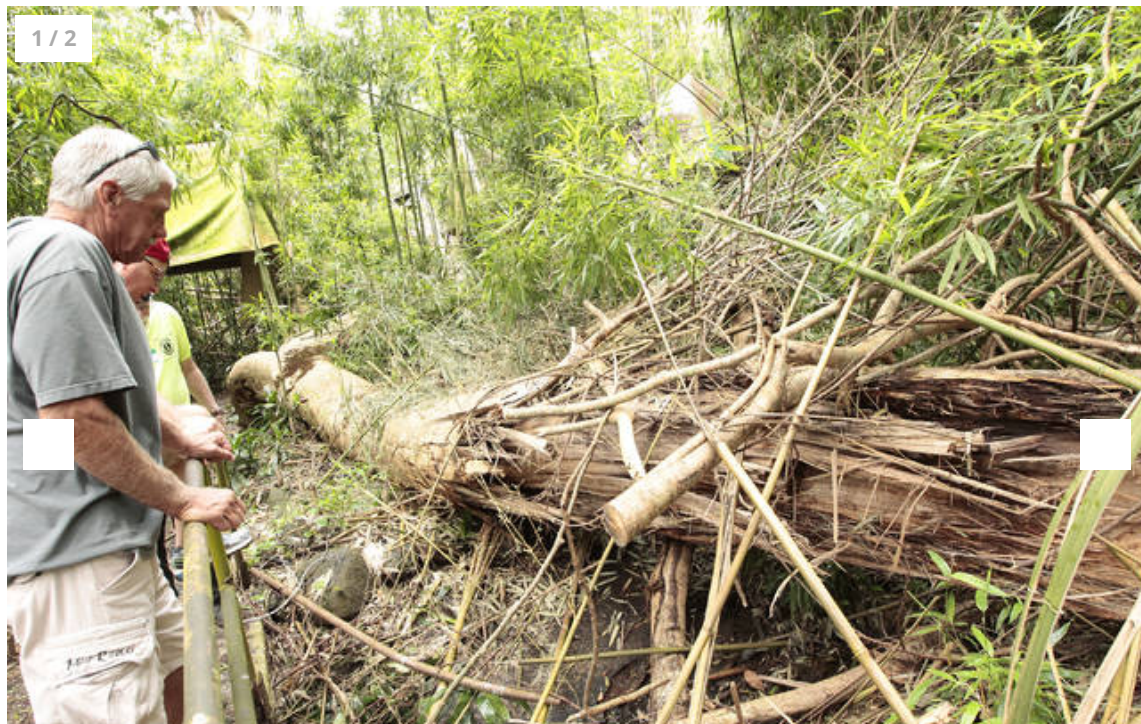
Volunteer Frank Dietsch looks at a felled albizia branch in Manoa. The Ala Wai Watershed Association is working with several organizations and Paradise Park's owners, Warren and Napua Wong, to remove fast-growing plants and overhanging trees to shore up crumbling banks at the two streams in the area with the aid of a \$298,000 grant from the state DOH.
