Quarterly Status Reporting Form

Project Title: Buffers and BMPs for Windward Oahu

ASO Log No. 19-154
List of Implemented BMPs, QSR 9

Buffers and BMPs for Windward O'ahu
O'ahu Resource Conservation and Development Council

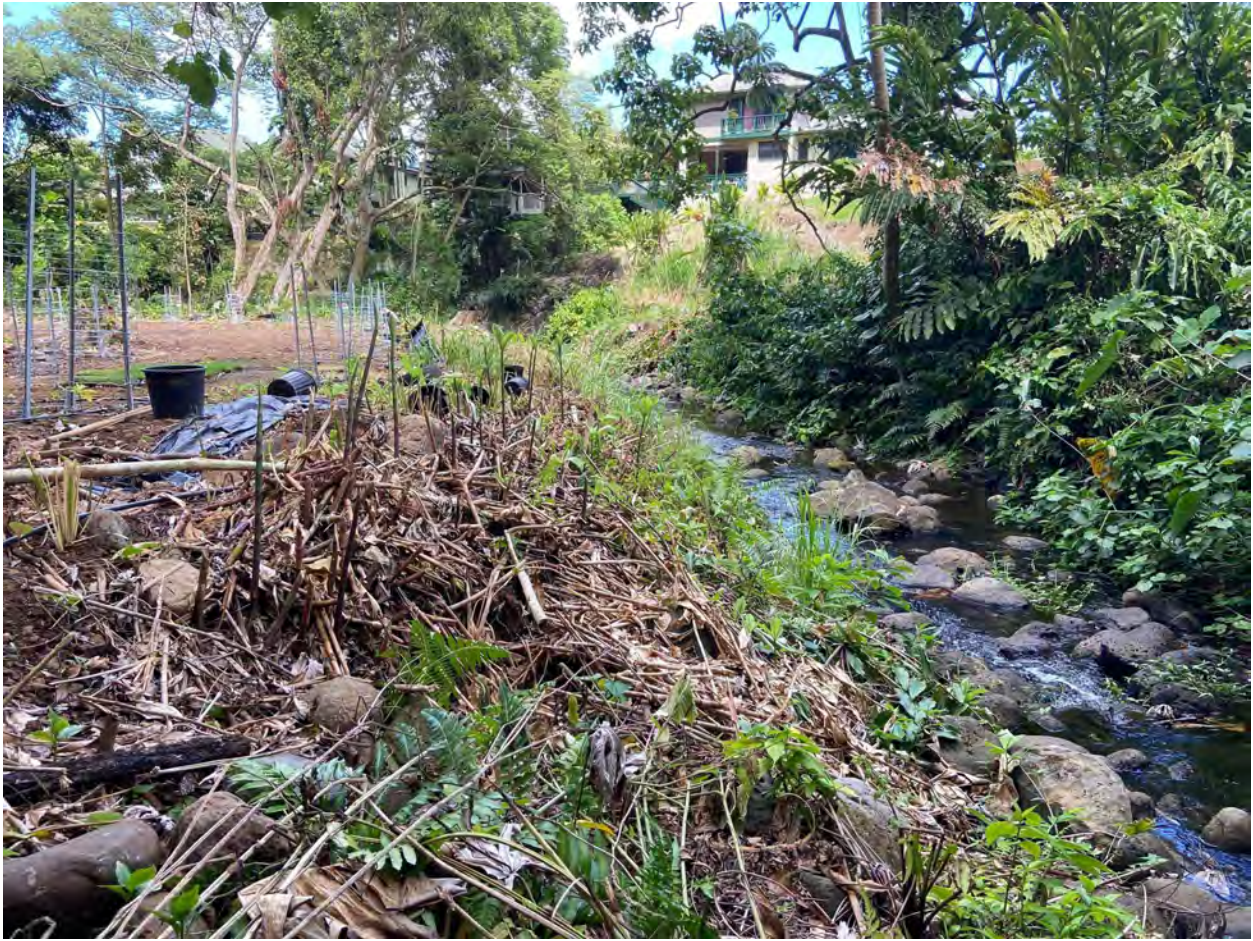
Image above: A vegetative barrier of vetiver has been planted along critical areas of the streambank. 45 ulu trees have been planted along 725 linear feet of the stream. Micro-irrigation is established to supply both of these plantings with adequate water. Heavy-duty tree cages have been installed to protect the new planting from pigs.

Vegetative Barrier Establishment of 200 slips of vetiver grass or similar native sedge (e.g. ahuawa, carex) in one densely planted row to stabilize banks, slow runoff and prevent sediment delivery to the stream.	80%	150 vetiver slips have been planted along 165 linear feet of the streambank, with an additional row of vetiver planted in the most critical areas.
Conservation Cover Purchase and install grass and/or another type of ground cover to protect critical areas and flood areas.	5%	Bermuda and El Toro sod have been planted as a test plot to determine if these grasses will do well in the area designated for conservation cover.

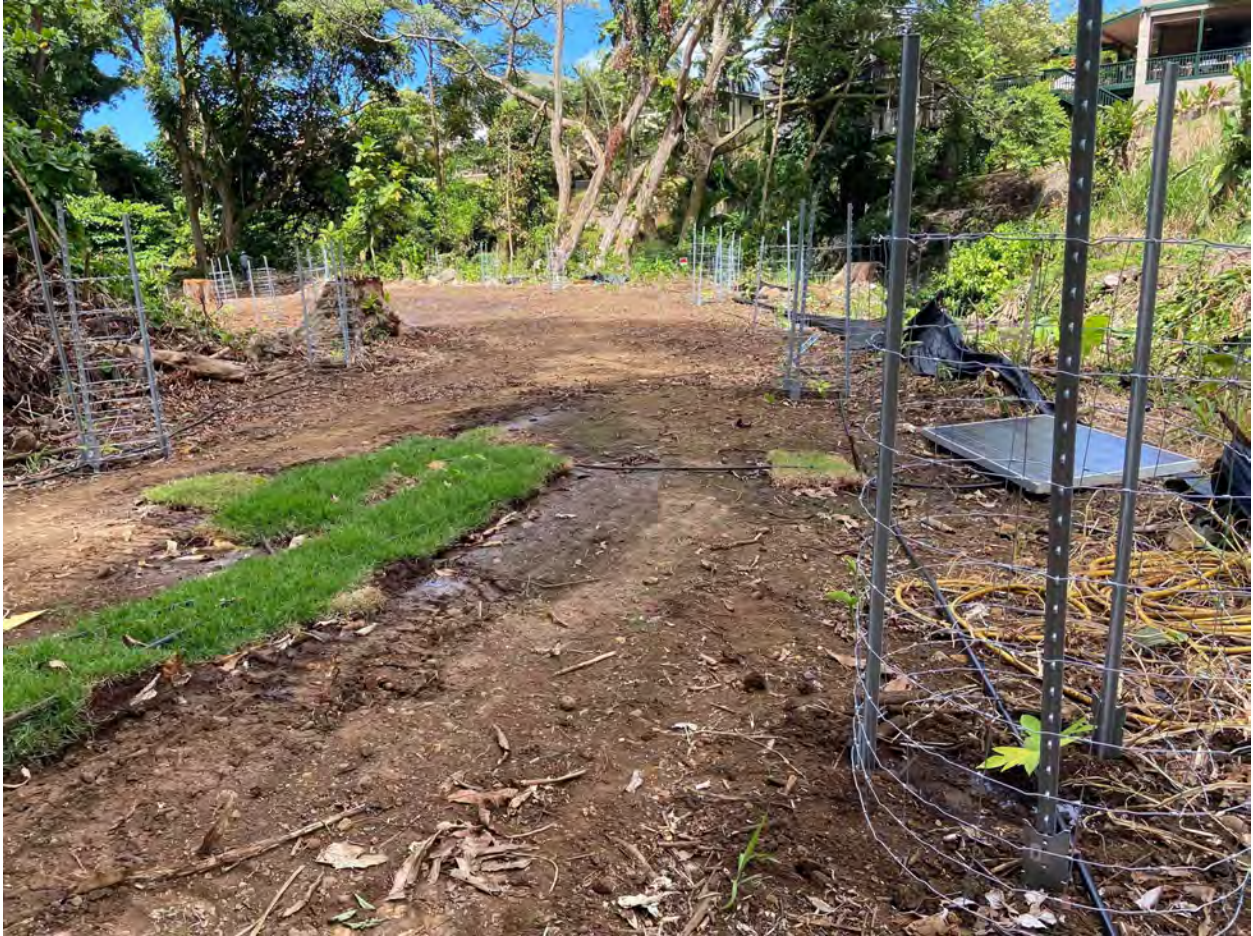
Image above: 10,800 sq. ft. has been cleared of invasive trees, including False Makani, Java Plum, Albizia, Gunpowder and Umbrella trees. 725 linear feet along the stream has been planted with 45 ulu trees. Micro-irrigation and tree cages have been used to properly establish this crop. A test of plot with Bermuda and El Torro sod has been tested in the area designated for installing a conservation cover.

BMP	Status	Notes
Brush Management Removal of 9 large stature invasive trees and understory to prepare for planting low to medium stature riparian buffer.	100%	Mechanical removal of invasive trees, including False Makani, Java Plum, Albizia, Gunpowder, and Umbrella tree, leaving trunks and root systems in place to mitigate bank erosion.
Micro-irrigation To service the establishment of the riparian forest buffer and vegetative barrier.	80%	Irrigation has been established for 45 ulu trees and a majority of the vegetative barrier.
Land Smoothing Prepare land for conservation cover planting, ensuring adequate drainage and grade that can be maintained by mowing.	100%	Following brush removal, the land has been smoothed and prepared to plant a conservation cover. The grade will be easily maintained by mowing and allow for proper drainage.
Tree/Shrub Establishment Establishment of at least 40 perennial trees to suppress invasive weeds and stabilize soils. All trees to be caged.	100%	45 ulu trees have been installed and caged along 725 linear feet of the stream channel. A second row of these ulu trees have been planted along 165 linear feet at the mauka border of the area designated for conservation cover.

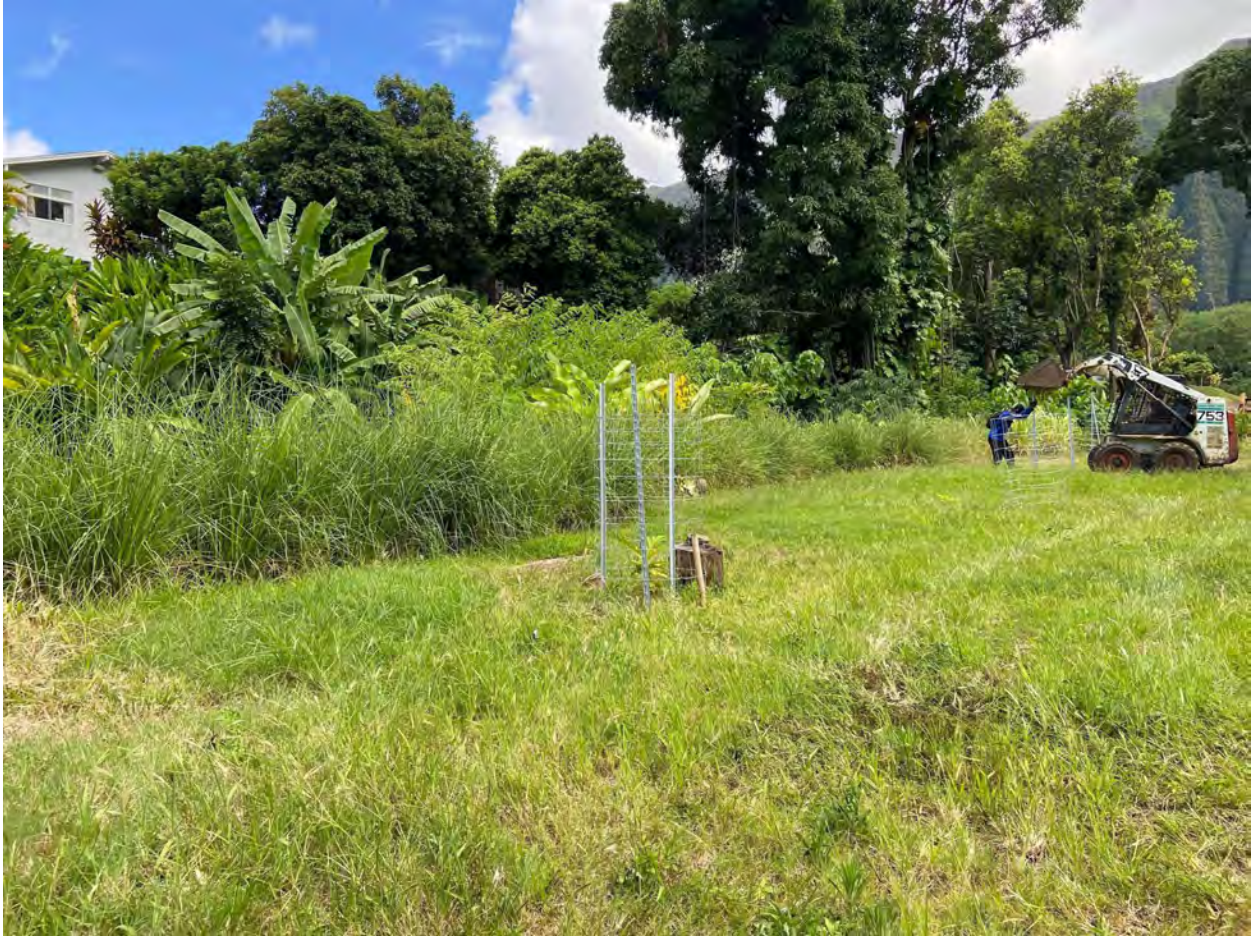
Image above: This landowner received prior funding to implement conservation practices along 300 linear feet downstream of the current project site. He has completed his original contract and Operating and Maintenance Plan and his conservation practices are well established and easily maintained. Additional funding has been provided to enable this landowner to restore the remaining segment of stream that abuts his property. As part of this additional funding, ulu trees have been planted upslope of the established vegetative barrier. Between the two restoration projects, 725 linear feet of the stream abutting this property will be protected from erosion and runoff.

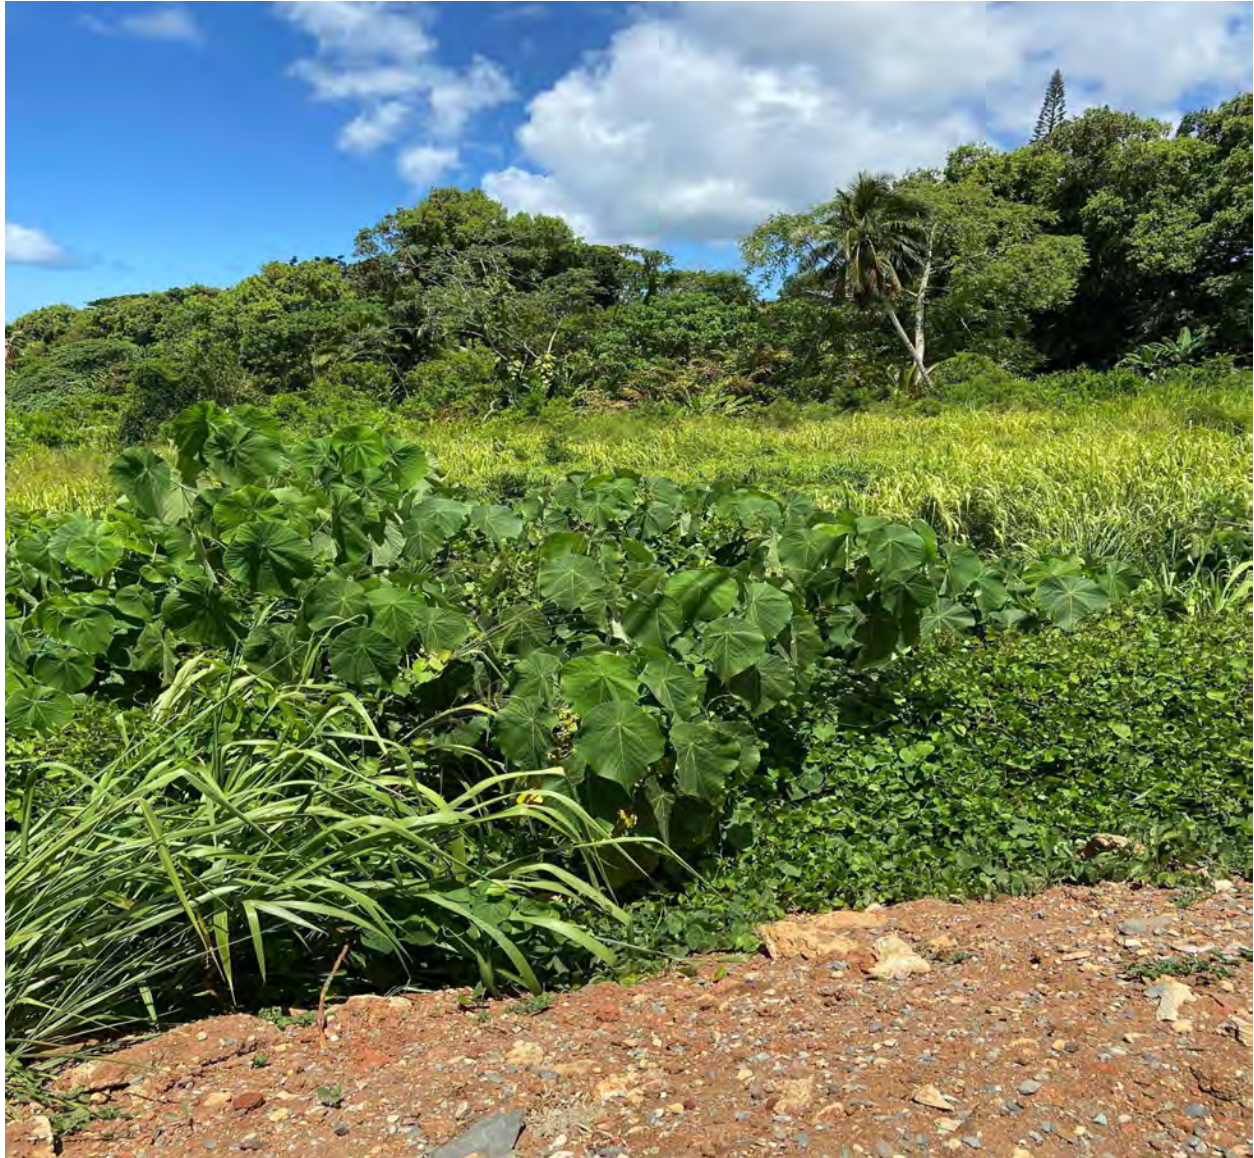
Image above: A multi-story cropping and micro-irrigation system will be installed in this higher-elevation area which abuts to the onsite wetland. A minimum of 50 perennial trees and shrub crops will be planted in this area, along with a application of 4-6" of mulch.

BMP	Status	Notes
Multi-story Cropping Establishment of minimum 50 perennial tree and shrub crops, resulting in a diversified forest or cropping system.	0%	
Brush Management Prepare land for multi-story cropping and insuring adequate drainage and a grade that can be easily maintained.	0%	
Micro-irrigation To service the establishment of multi-story cropping, orchard and vegetative barrier.	0%	
Mulching Applying 4-6" of wood mulch to improve soil health and facilitate the multi-story cropping establishment while reducing erosion and suppressing weeds.	0%	
Vegetative Barrier Establishment of vetiver grass or similar native sedge (e.g. ahuawa, carex) in two densely planted rows to slow runoff and prevent sediment delivery to wetland or stream.	0%

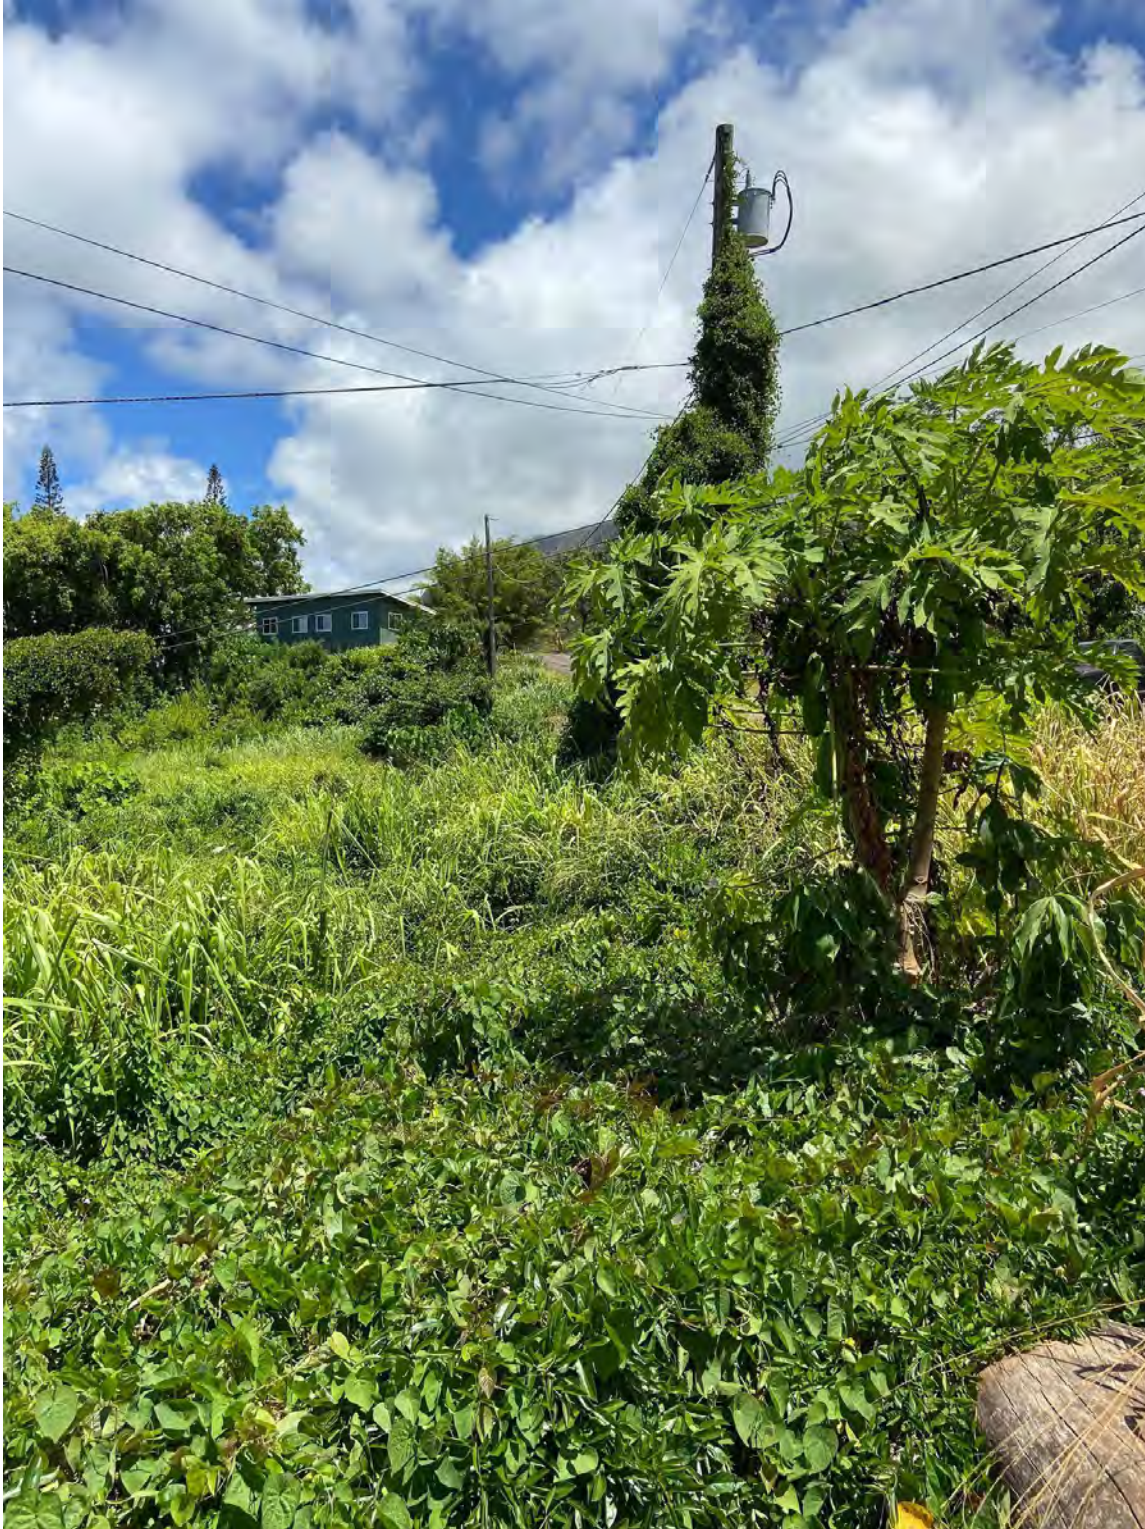
Image above: Far north west corner of the project area, facing the location where a vegetative barrier will be installed. This is one of the locations where freshwater feeds the onsite wetland.
