FINAL
RESPONSE ACTION MEMORANDUM

Hakalau Beach Park
Hakalau, Hawaii
TMK (3) 2-9-002:080

Prepared By:
Kealamahi Pacific Consultants, LLC.
111 Hekili Street, Ste A601
Kailua, Hawaii 96734

October 2023

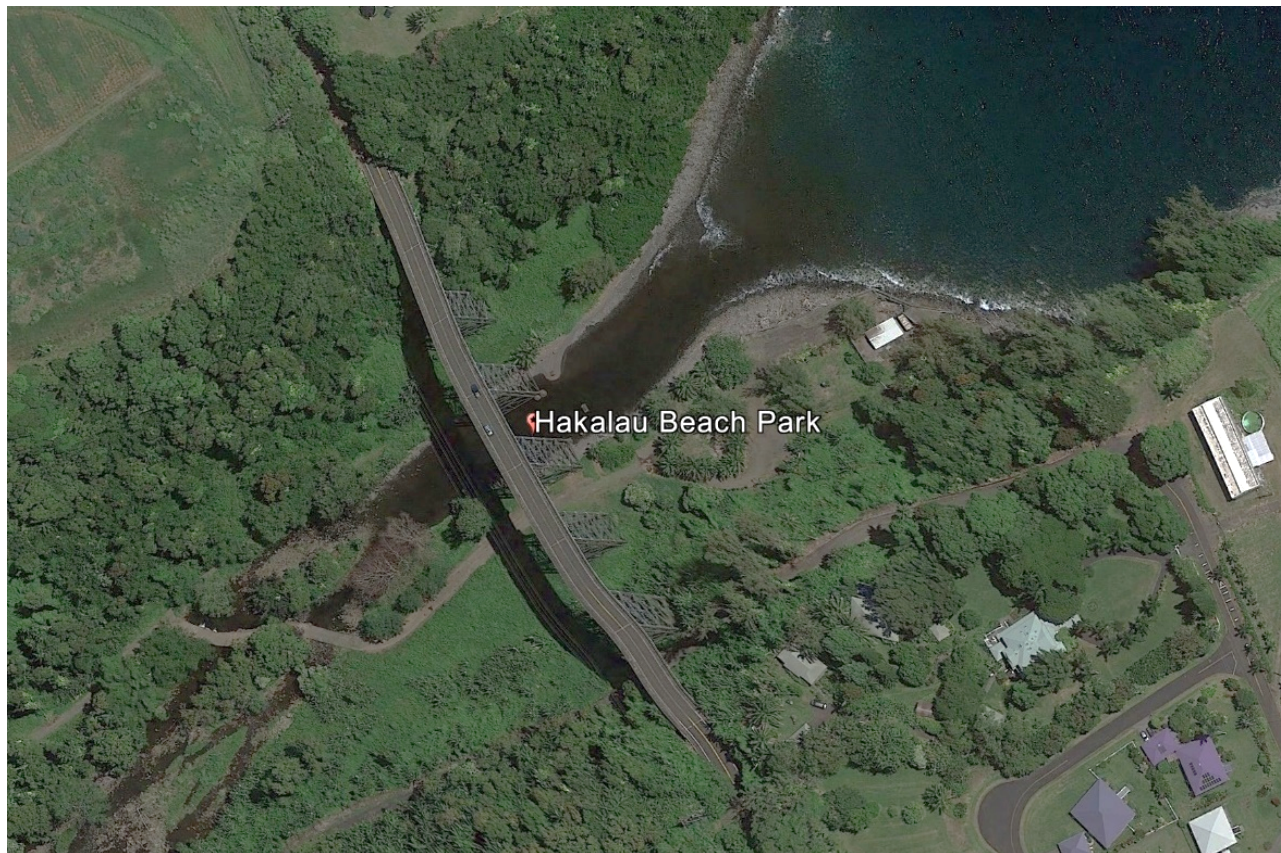
Figure 2-1: Site Location Hakalau Beach Park

TCLP analysis results for three of the DUs exceeded the RCRA listed hazardous waste criterium of 5 mg/L (DU-1B, 11A, and 21A), see Figure 2-1. All of these are located on the southern embankment, under the middle girder (KPC 2022). However, it is estimated that DU2 could also fail TCLP based on the high total lead concentrations.
